Annual Environmental Management Report

Banksmeadow Transfer Terminal

June 2018

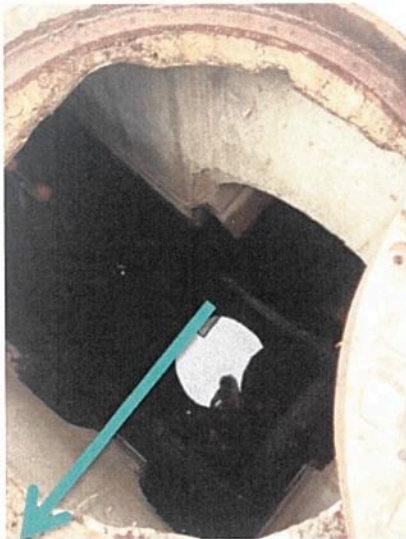
On the 2 February 2018 an external stormwater consultant identified stormwater backflow from the Council drain into Monitoring Point 1. Evidence of this backflow effect is shown in photos and survey levels of the water levels. Veolia noted water levels in the Council drain and Monitoring Point 1 were the same across the two drains.

<p>Monitoring Point 1 on 28/2/2018 showing back up of water</p>

Immediately following the identification of this issue, Veolia contacted Bayside Council to investigate potential blockages in the council stormwater system. A concrete block resulting in 40% blockage of the system was found and removed by Council. However subsequent observations noted the backflow effect was still occurring at Monitoring Point 1.

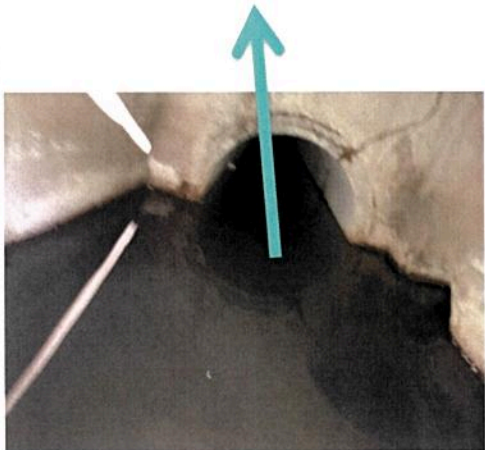
<p>Council Drain on 28/2/2018 showing back up of water</p>
Water Level RL (m AHD)	3.49 m	3.55 m

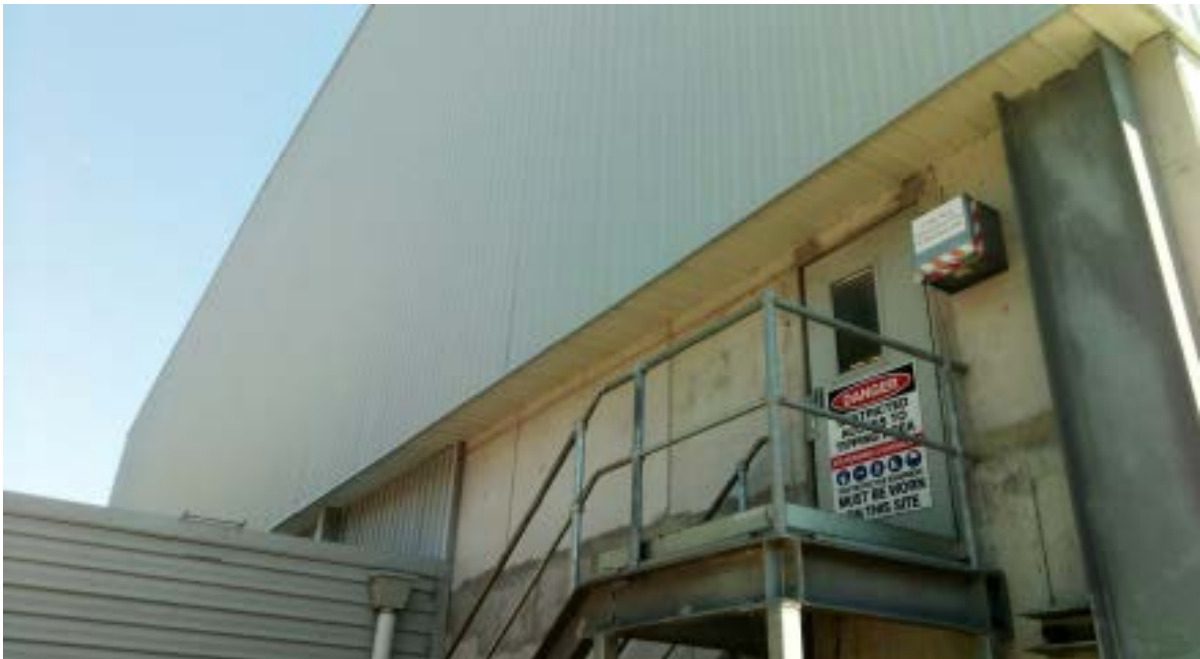
Figure 1- Sealed southern breezeway of the waste shed at the Terminal

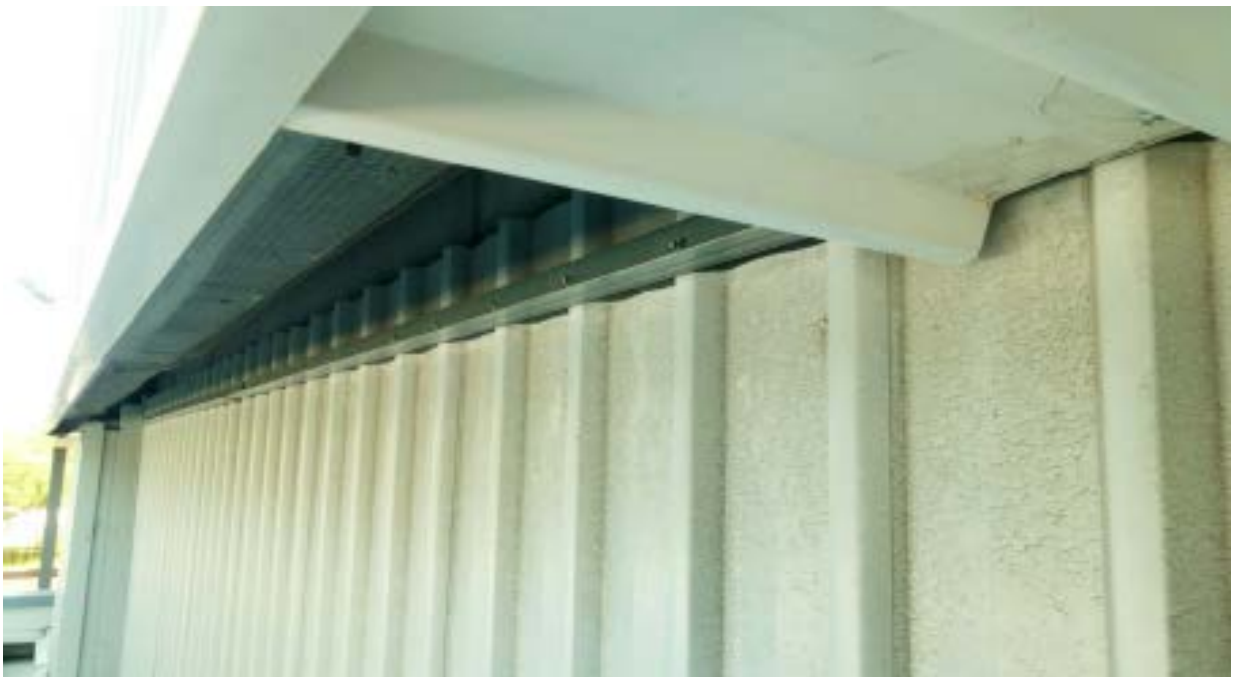
Figure-2 - Sealed South-eastern breezeway of waste shed at the Terminal

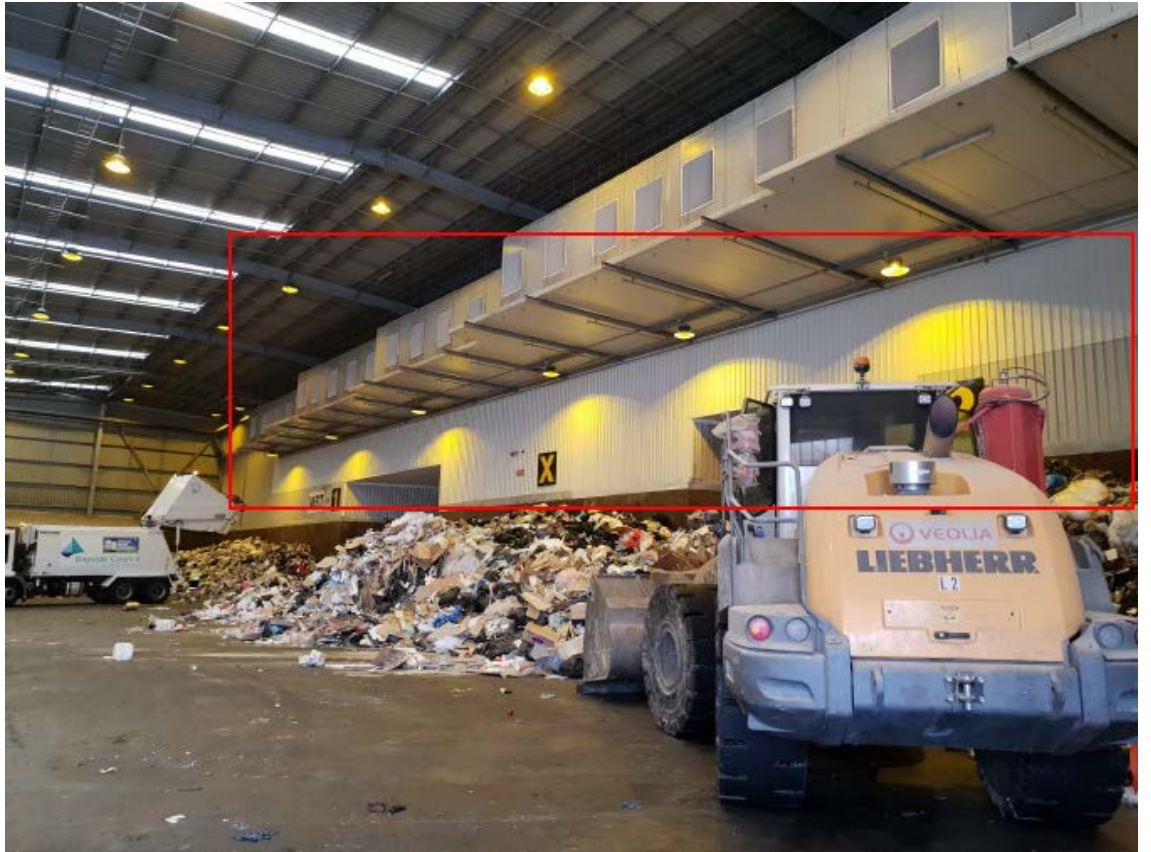
Figure 3 - A view of the completed sealing up of the gap opening between the interface of the waste floor and compactor pit areas at the Terminal
