Veolia Environmental Services (Australia) Pty Limited

Clyde Waste Transfer Terminal

Odour Audit XVIII

May 2012

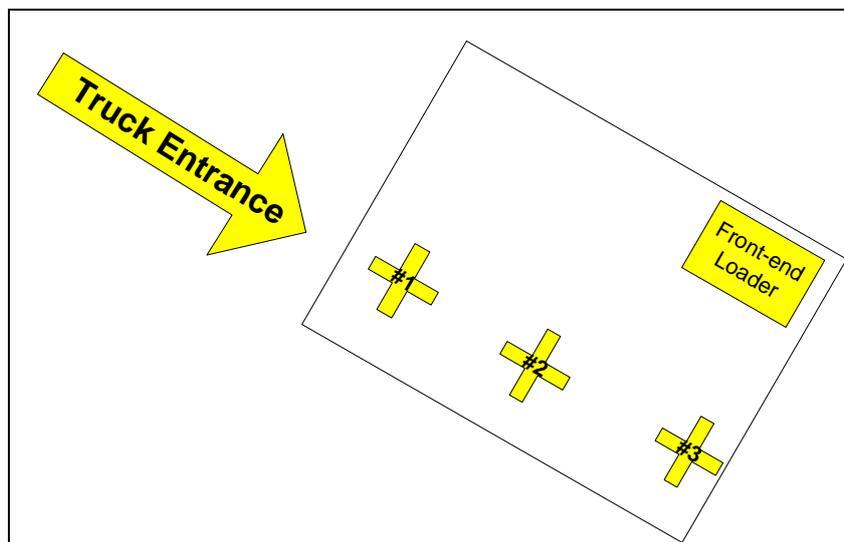
Figure 2.1: Smoke testing release points within the Transfer Building.

Smoke testing was carried out at the truck entrance and the smoke was observed to initially move upwards towards the roof and then towards the extraction fan. There was no observed movement towards the truck entrance.

Smoke released from the second point initially moved upwards in eddies and was gradually drawn into the extraction system.

Smoke released at this point initially rose gradually before being drawn upwards to the extraction system.

The overall finding of the smoke testing was that the extraction system was effective in maintaining the stack as the main emission point of air from the building, with no evidence of any fugitive odour releases.

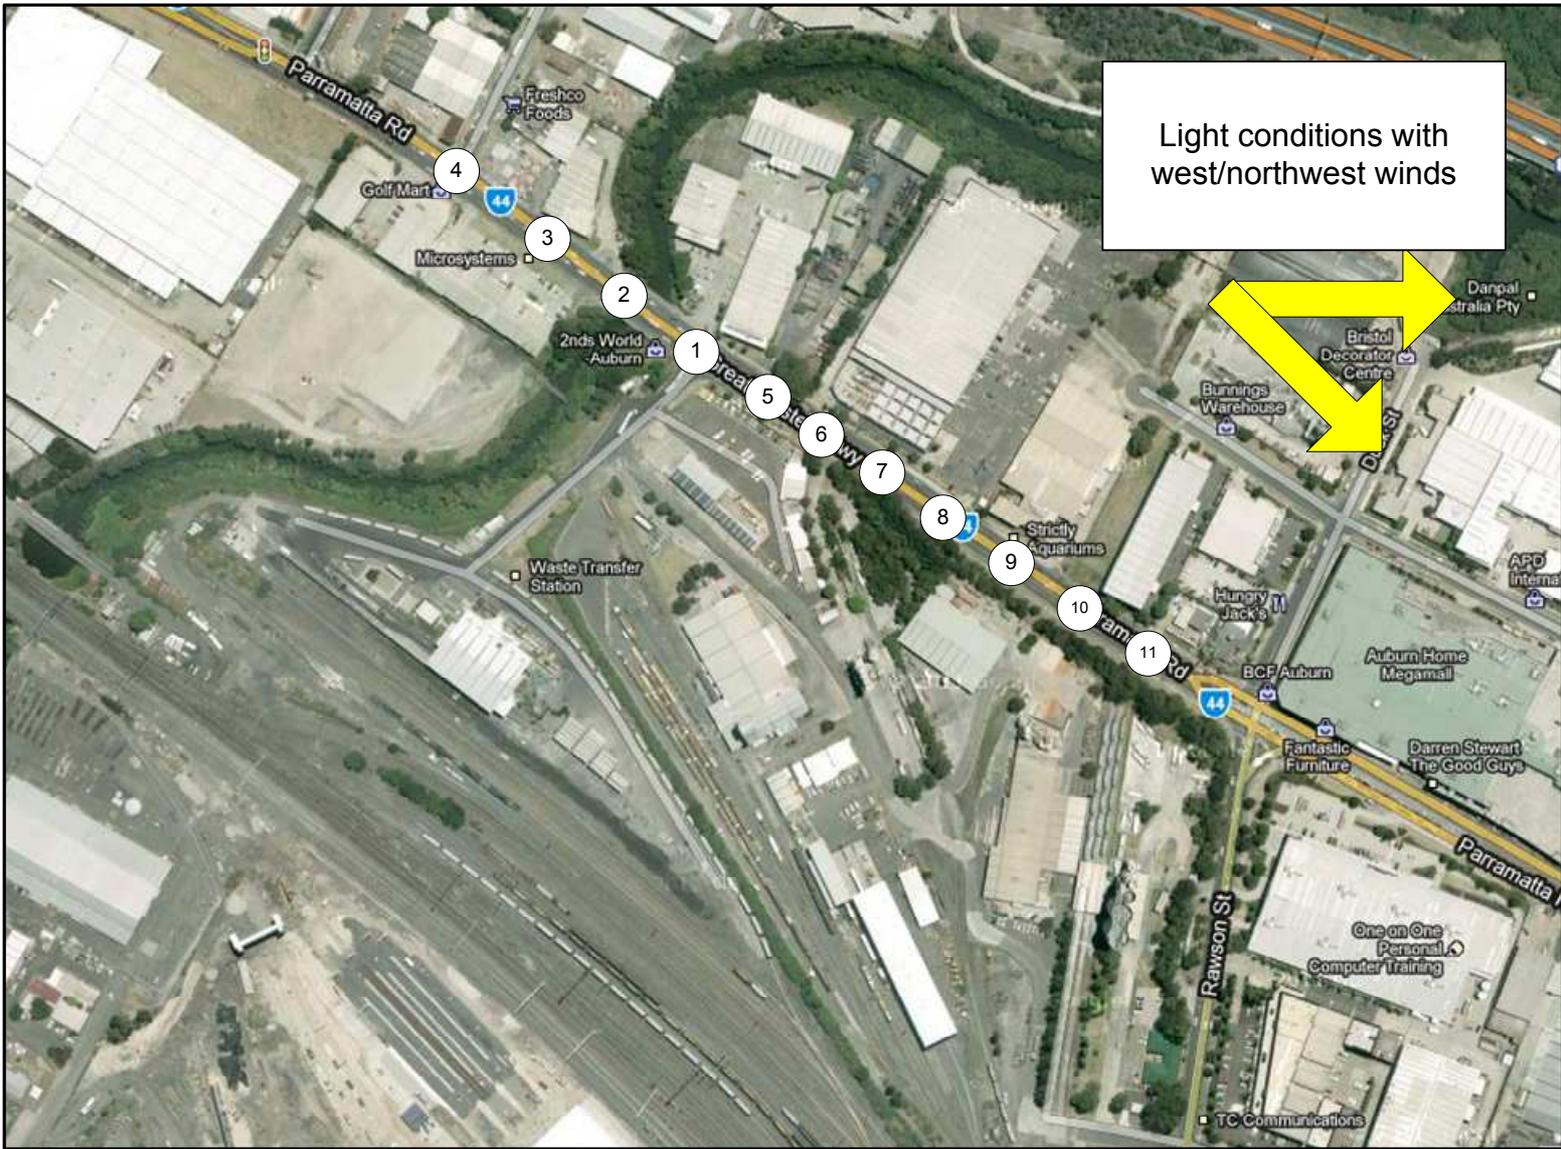
The results from the FAOA survey conducted during this Audit found that no odours were detected offsite that could be linked back to the Transfer Station. The field log sheets and odour impact map are attached as **Appendix C**.

Light conditions with west/northwest winds
