Veolia Environmental Services (Australia) Pty Limited

Clyde Waste Transfer Terminal

Odour Audit XX

November 2012

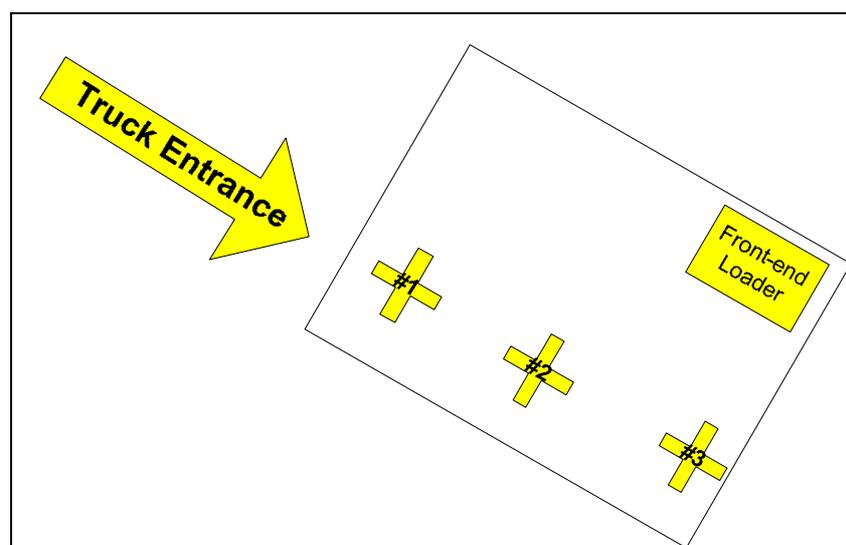
Figure 2.1 - Smoke testing release points within the Transfer Building.

Smoke Testing Point #1

Smoke testing was carried out at the truck entrance and the smoke was observed to initially move upwards towards the roof and then towards the extraction fan. There was no observed movement towards the truck entrance.

Smoke Testing Point #2

Smoke released from the second point initially moved upwards in eddies and was gradually drawn into the extraction system.

Smoke Testing Point #3

Smoke released at this point initially rose gradually moving towards the truck entrance before rising to the roof and moving towards the extraction system. No smoke was observed to escape the building. The smoke testing at this point revealed that there could be a possibility that the western section (closest to the truck entrance) of the fan extraction collection system is sub-optimally capturing air than the eastern section (furthest from the truck entrance). The reason for this should be investigated. TOU had informed VES personnel on the same day smoke testing was carried out.

The overall finding of the smoke testing was that the extraction system is working at a satisfactory capacity, however, it appears that the system may not be operating as effectively in some sections as the previous Audit. The reason for this could be related to the cleaning works and should be investigated as a matter of priority. Notwithstanding this, there was no evidence to suggest fugitive odour releases from the Transfer Terminal Building.

It is recommended that the performance of the odour extraction system be checked to determine if it is adequately working. The Audit smoke testing did demonstrate some tendency for sub-optimal capture at some of the ventilation extraction points (see **Section 2.1.3**) of the Transfer Terminal Building. The reason for this should be investigated as a matter of priority. The next Audit will review the service logs to ensure that the minimum stack velocity of 19.1 m/s is being achieved. It is envisaged that all the maintenance works will have been completed by that time.

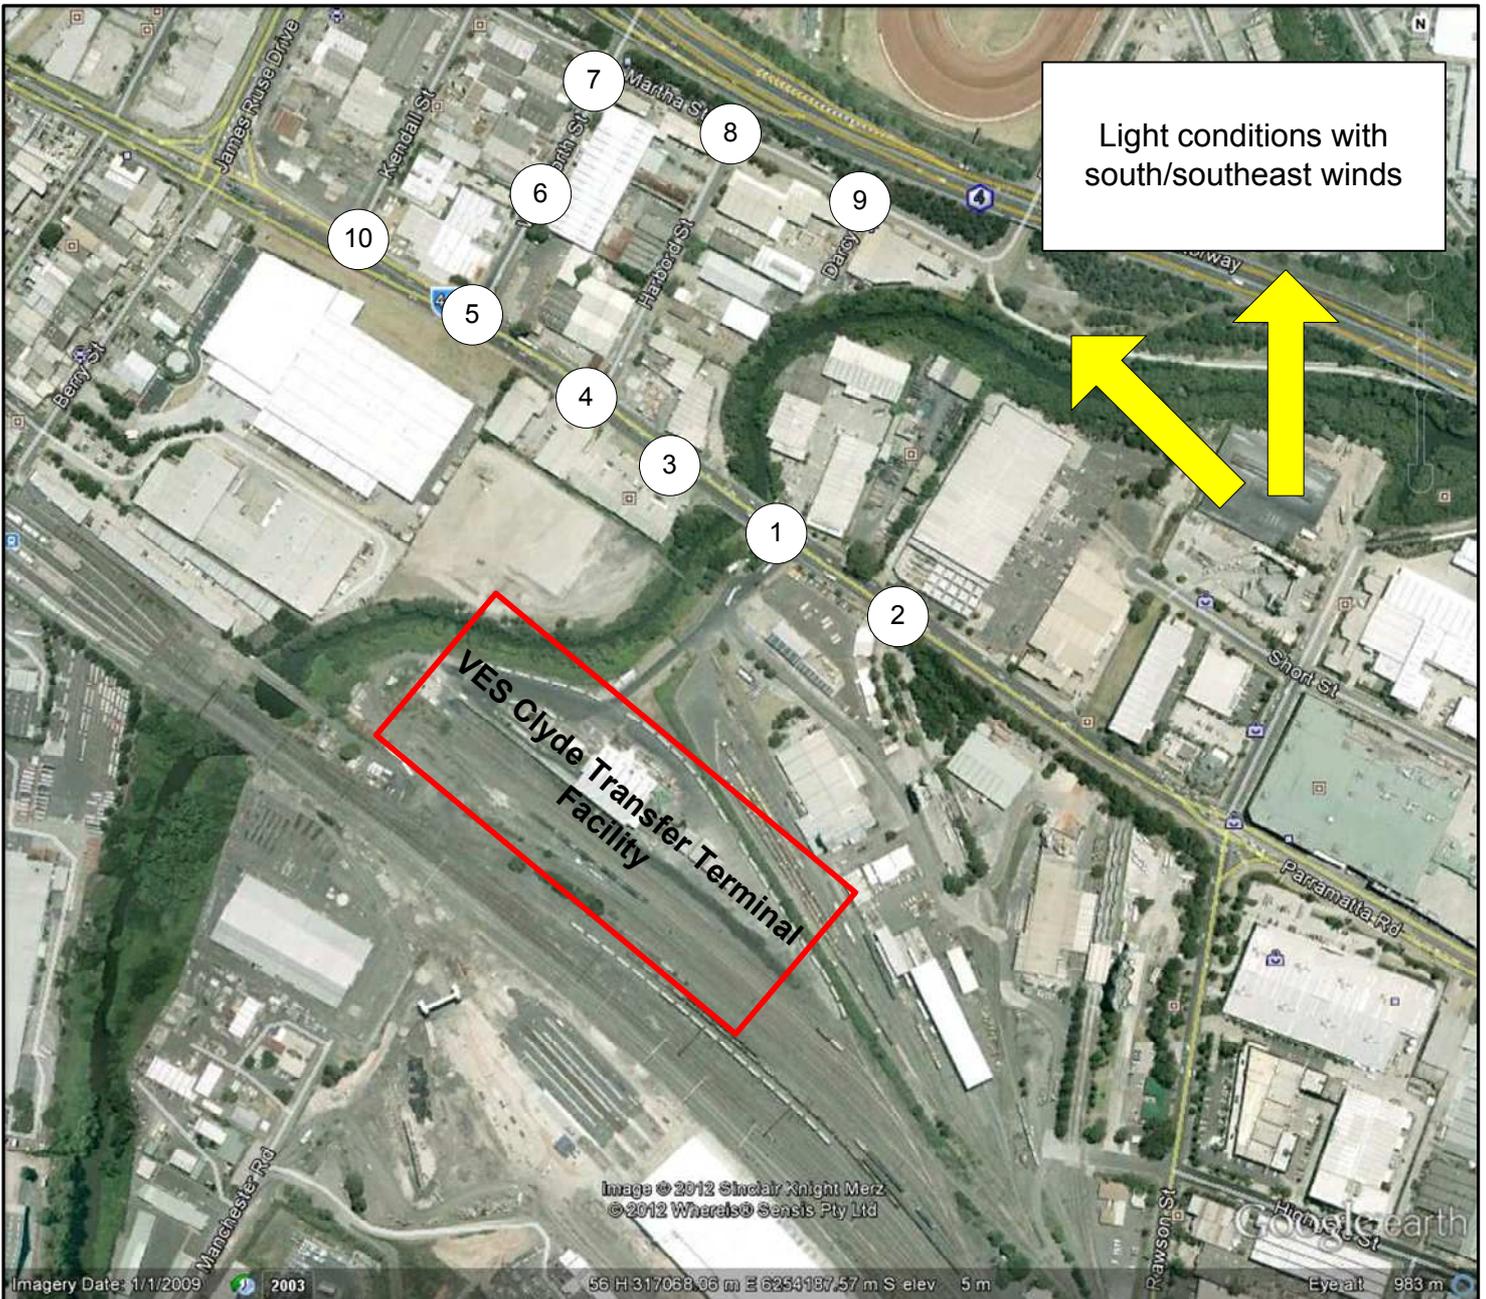
Field Ambient Odour Assessment Plot and Field Sheets

The results from the FAOA survey conducted during this Audit found that no odours were detected offsite that could be linked back to the Transfer Station. The field log sheets and odour impact map are attached as **Appendix C**.
