Veolia Environmental Services (Australia) Pty Limited

Clyde Waste Transfer Terminal

Odour Audit XXII

**Final Report
January 2014**

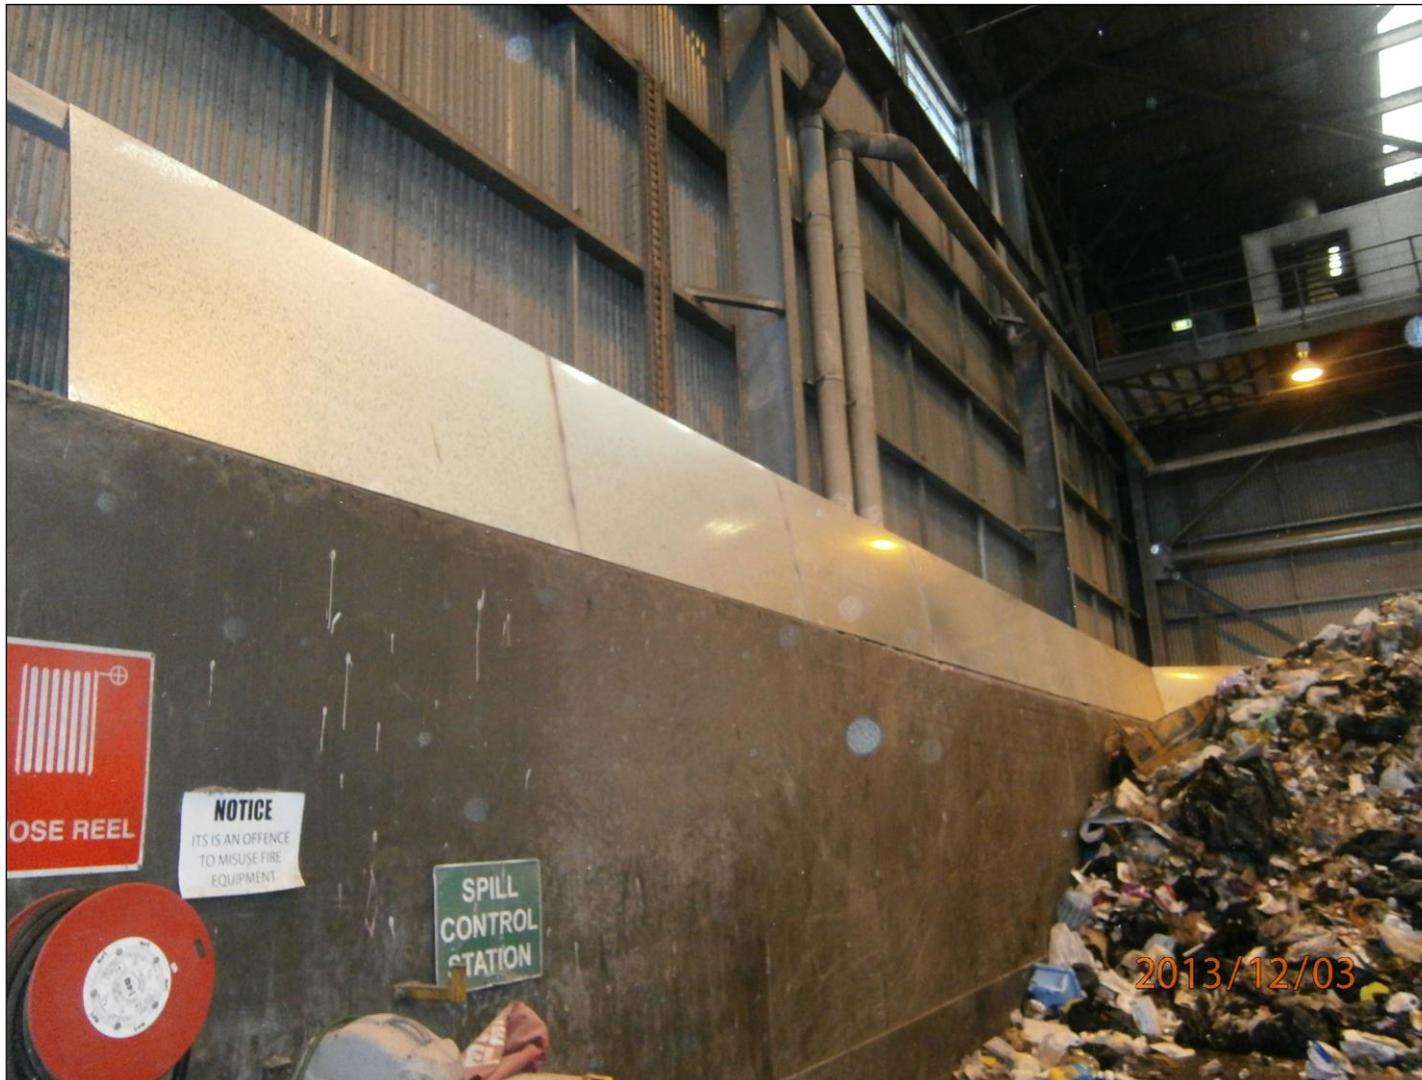
As indicated in the previous Odour Audit, VES had advised plans to replace the rubber mats that seal the TTB breezeways with fixed metal plates. The auditor was advised that the reason for this new installation is in response to practical issues associated with the rubber mats use in recent times with the mats consistently falling due to waste build-up on the surface (identified in several consecutive Odour Audits) and safety issues and access difficulties during their maintenance. The installation of metal plates was completed in December 2013. **Photos 2.1 & 2.2** show this new installation at the TTB.

Photo 2.1 – New fixed metal plates on the western end of the TTB

The on-going issue with the rubber mats sealing the breezeway of the TTB has been resolved by the installation of fixed metal plates. This installation should be effective in permanently sealing the breezeways and thereby reducing fugitive odour emission release from the TTB. This new installation will be inspected in the next Odour Audit. Additionally, repair and attention of the missing/damaged truck entrance strips should be carried out as soon as a suitable supplier is sourced.

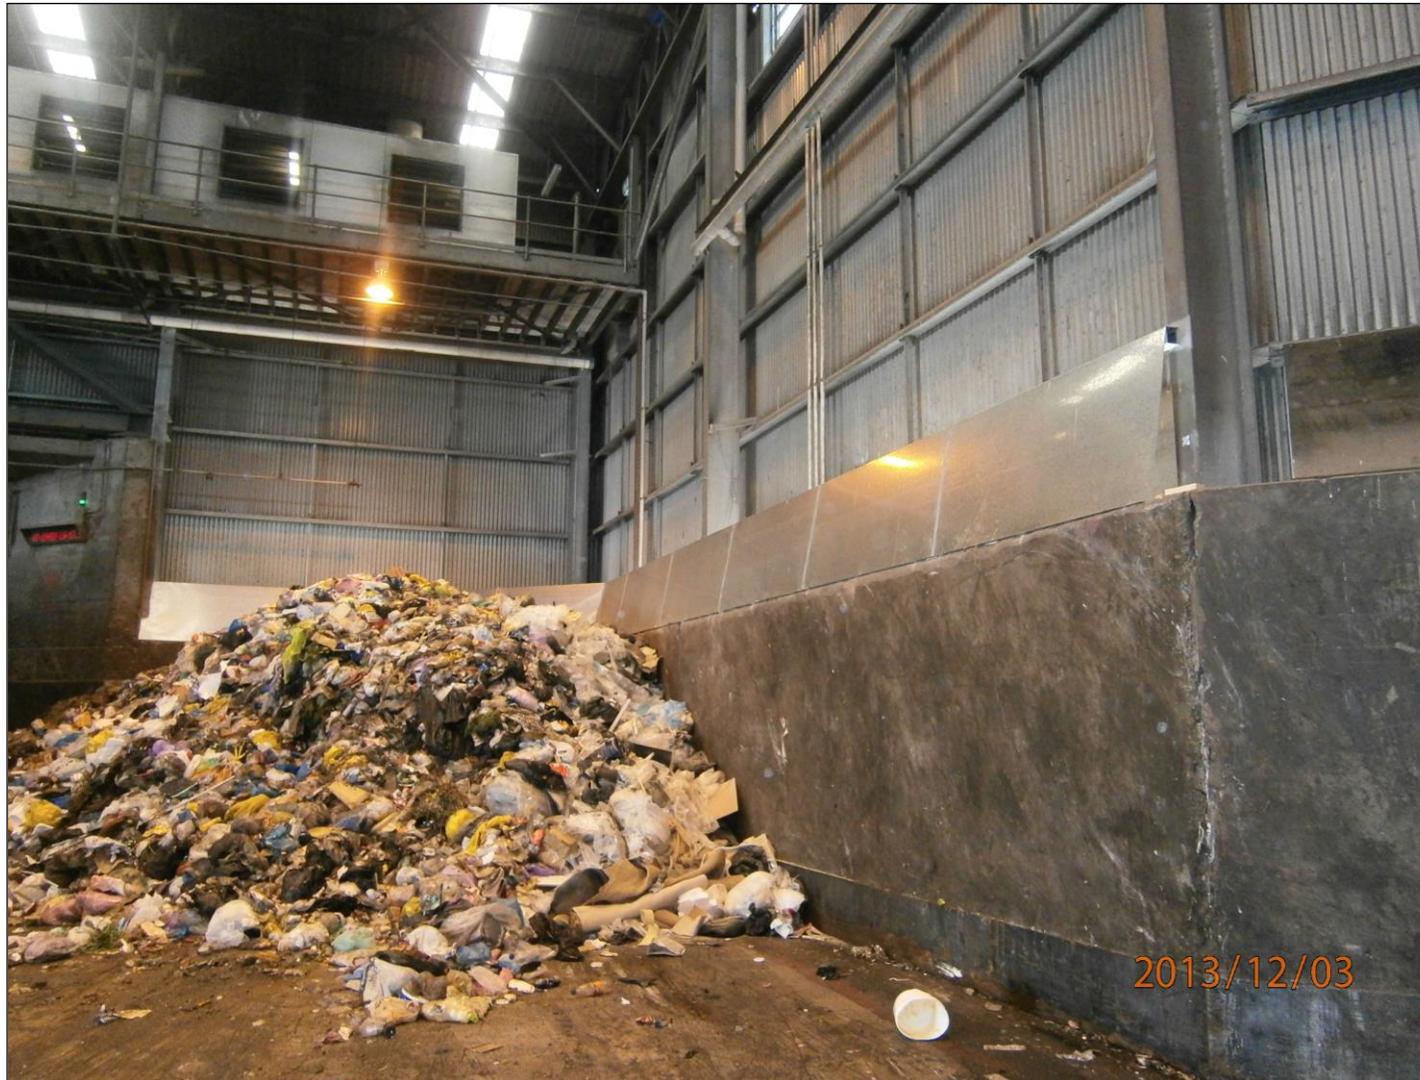
Photo 2.2 – New fixed metal plates on the eastern end of the TTB

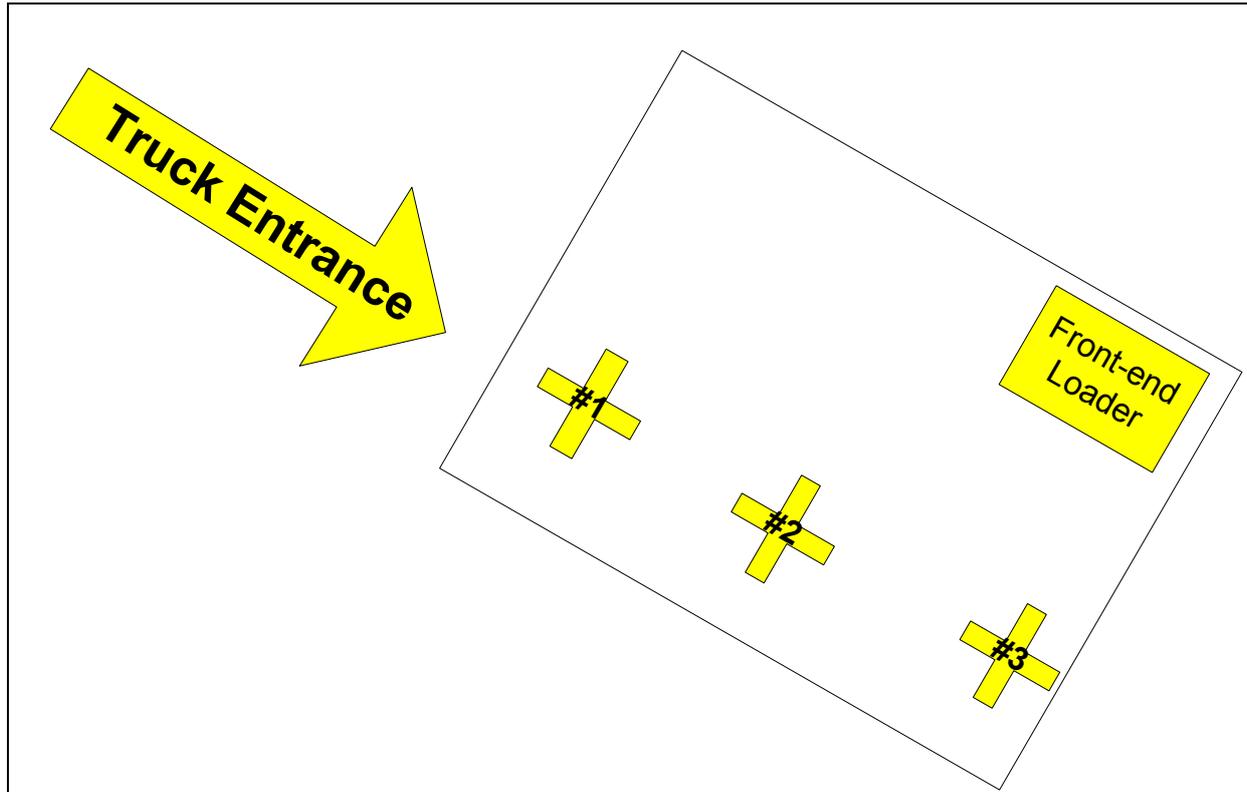
Figure 2.1 - Smoke testing release points within the TTB

Smoke released at this point initially rose gradually moving towards the truck entrance before rising to the roof and moving towards the extraction system. The smoke testing at this point revealed however that not all the smoke was being extracted suggesting that there could be a possibility that the fan extraction system is sub-optimally capturing air from the TTB at this point. This matter should be followed up with the fan technician. In light of this smoke testing result there will be need for the technician to determine if adequate airflow capture is occurring at the overhead air capture points across the entire overhead common collection duct within the TTB. Additionally, the discharge velocity at the fan extraction system stacks should be measured to determine that the minimum exit air velocity of 19.1 m/s has been achieved. This matter will be followed up in the next Odour Audit.

Smoke released at this point revealed a similar result to smoke testing point #1, with sub-optimal air capture was being visually observed. This should be followed up as per previous advice.

Smoke released at this point revealed a similar result to smoke testing point #3, with sub-optimal air capture being visually observed. This should be followed up as per previous advice.

Notwithstanding the above smoke testing results, and based on the fact that no odour complaints have been received by the Site (see **Section 2.2.1**) and the positive Field Ambient Odour Assessment (FAOA) Survey results (**Section 2.3.1**), it appears that there is no significant fugitive odour emission release occurring from the TTB.

The service logs indicate that all required maintenance works on the odour extraction system since the last Odour Audit has been carried out successfully, and the system is operating well. The smoke testing did however identify some tendency for sub-optimal capture at several of the ventilation capture points (see **Section 2.1.7** for details) of the TTB. Given the finding in the Odour Audit, it is recommended that a follow-up investigation is carried out to ensure that the system is operating in an optimum condition. Next to this, the stack velocity should be measured in the next fan extraction system service date to confirm that the minimum stack velocity of 19.1 m/s is being achieved.

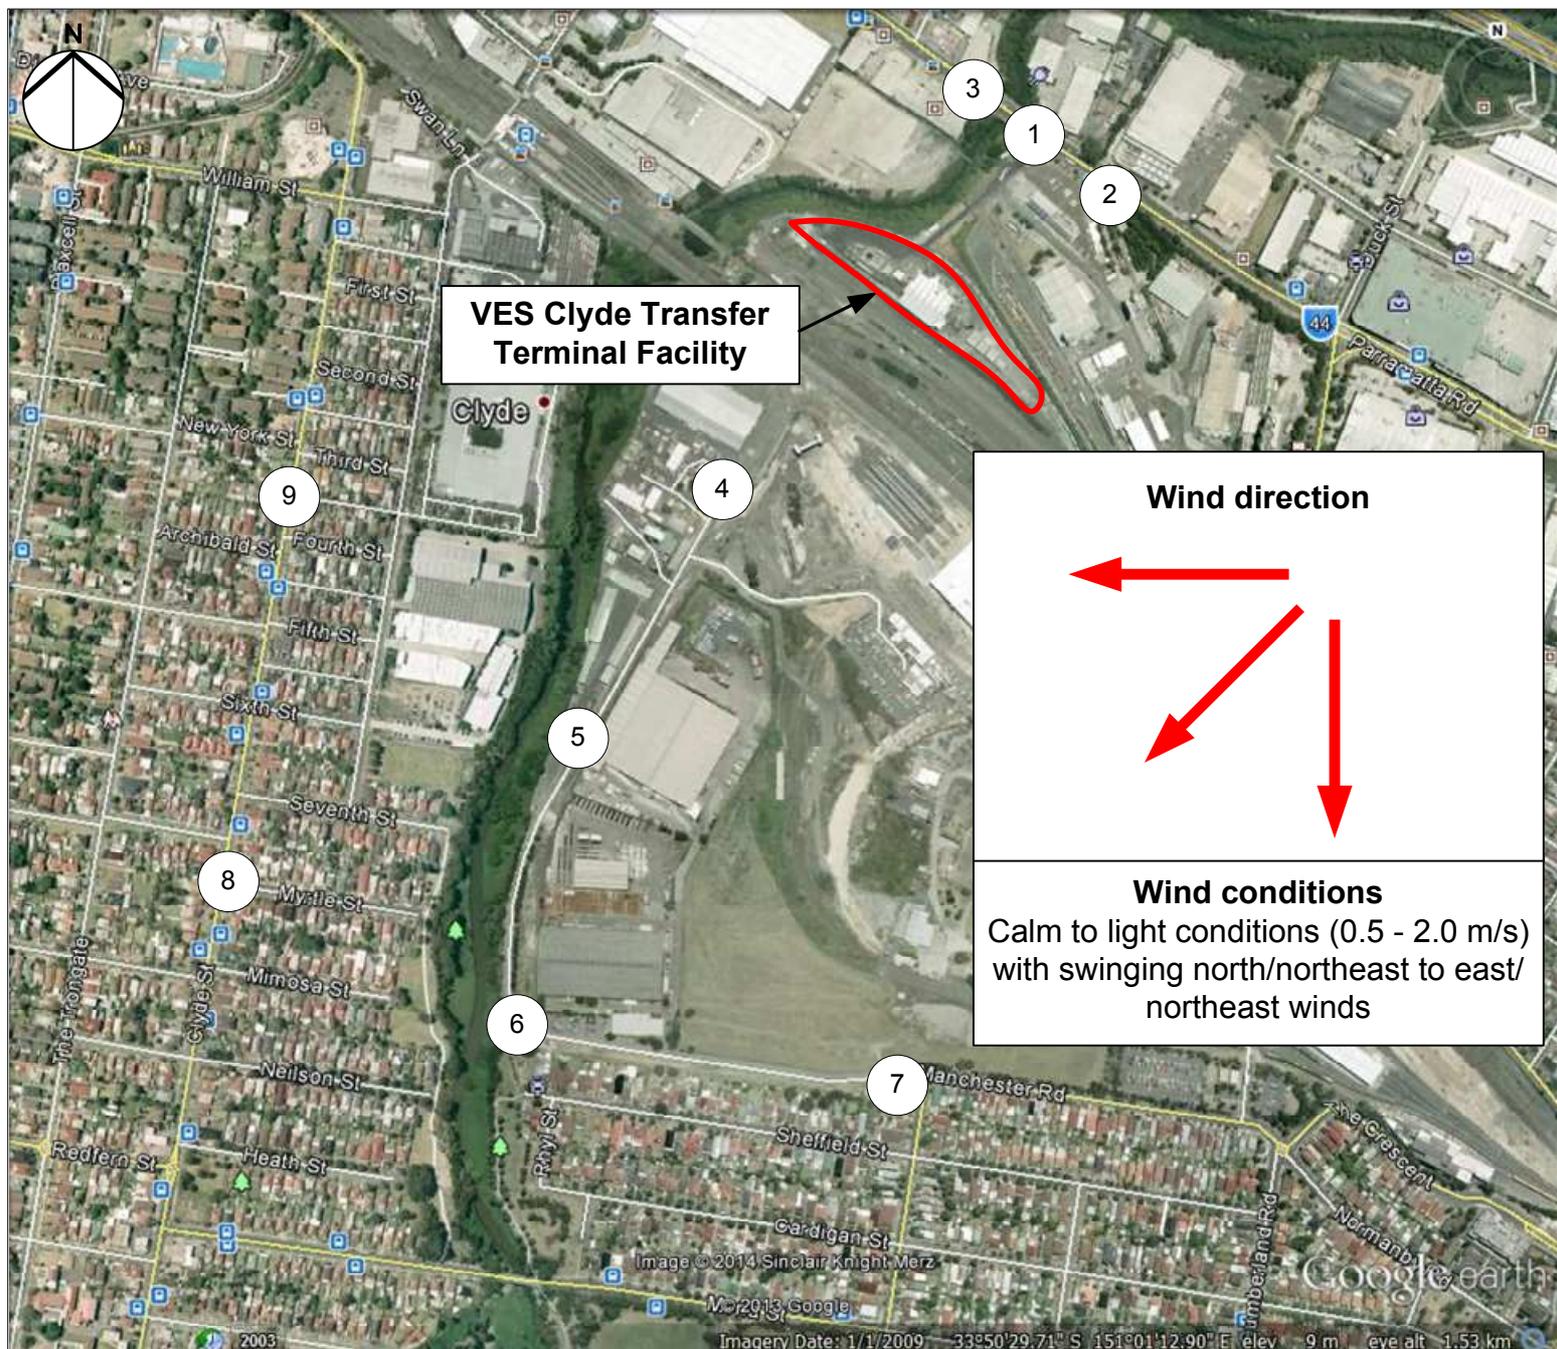
Field Ambient Odour Assessment Map Plot and Field Logsheet

The results from the FAOA survey conducted during the Odour Audit found that no odours were detected off-site that could be linked back to the Transfer Terminal Station. The field log sheets and visual survey plot have been attached as **Appendix C**.

Wind conditions
Calm to light conditions (0.5 - 2.0 m/s) with swinging north/northeast to east/northeast winds
