Clyde Waste Transfer Terminal

Odour Audit XXXIV

Final Report

January 2020

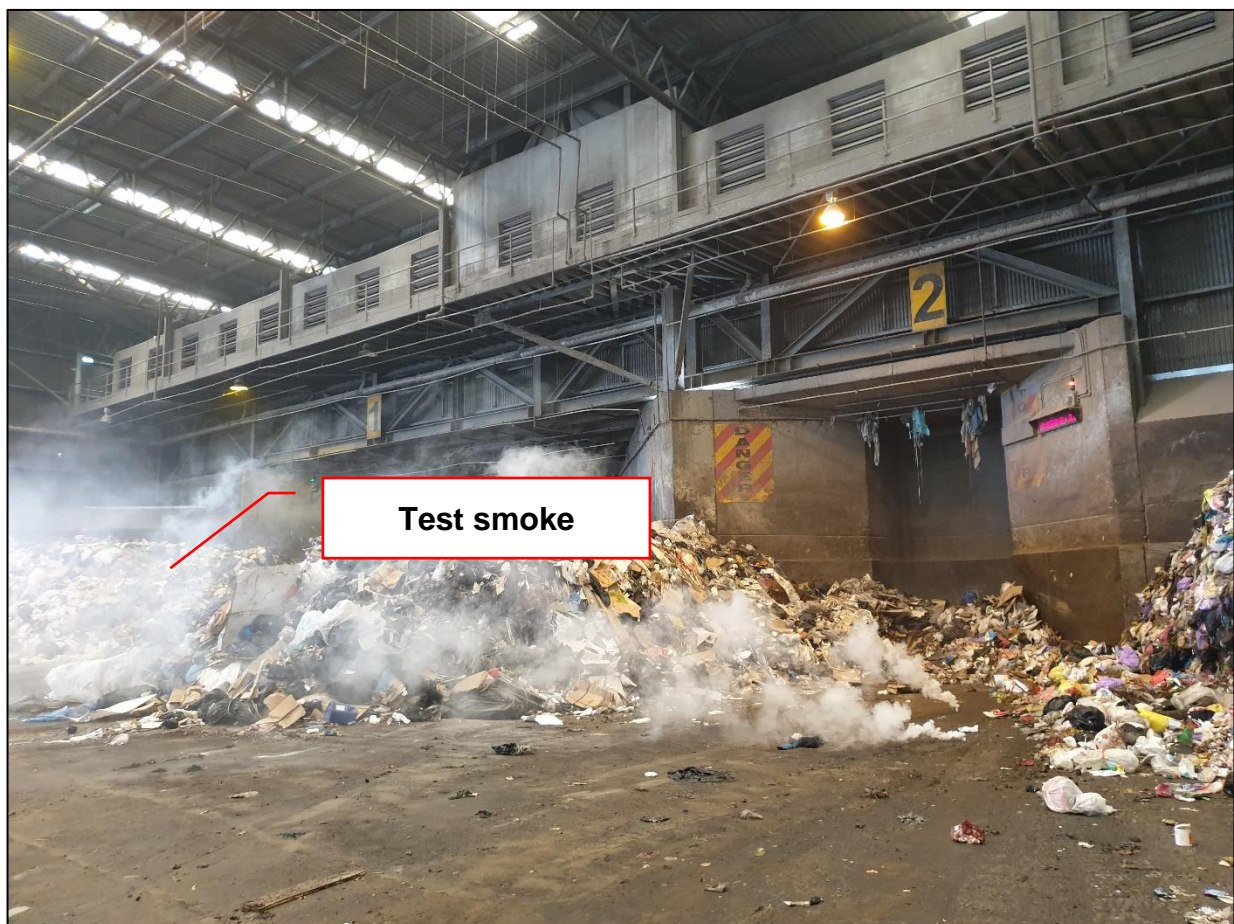
During the Odour Audit visit, there were approximately 250 to 300 tonnes of waste on the floor. This tonnage is considered to be within the normal operating range of the Transfer Terminal Building (TTB). The TTB floor area not covered by waste material was observed to be reasonably clean, with little evidence of leachate or aged material. General housekeeping procedures of the TTB were good, as found during several truck-unloading sequences. It was also observed that the TTB's front-end loaders cleared the floor area of waste on a regular basis, minimising the exposed area of waste.

As with previous audits, and consistent with TOU's experience at other waste transfer stations, there was a weak to distinct level of odour observed within the TTB. A photo of the waste on the floor as found during the Odour Audit visit is shown in **Photo 2.1**.

Photo 2.1 – TTB waste on-floor as found on 27 November 2019

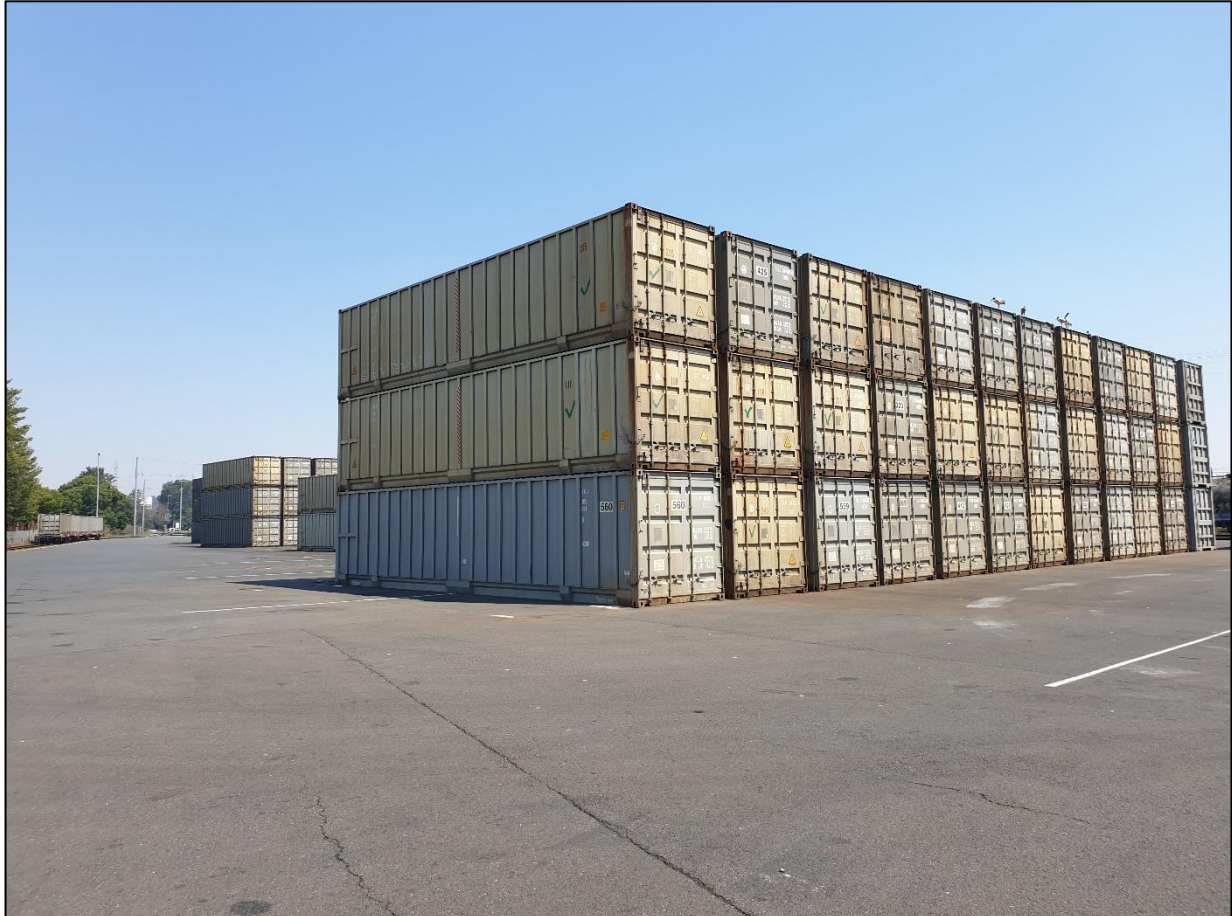
and remain so while at the Site. All containers used are required to be in good condition, and unused/returned containers adequately clean. A view of the condition of the compactor area as found on 27 November 2019 is shown in **Photo 2.2**.

The Audit finds that this continues to be current practice at the Site.

Photo 2.2 – A view of the compactor area as found on 27 November 2019

The general housekeeping around the compactor area was observed to be of high quality, with no evidence to suggest otherwise. As with previous Odour Audits, the container compacting/train packing area had a weak to distinct odour that was intermittently detectable but was found to be confined to this area only.

- **No further action is required at this stage.**

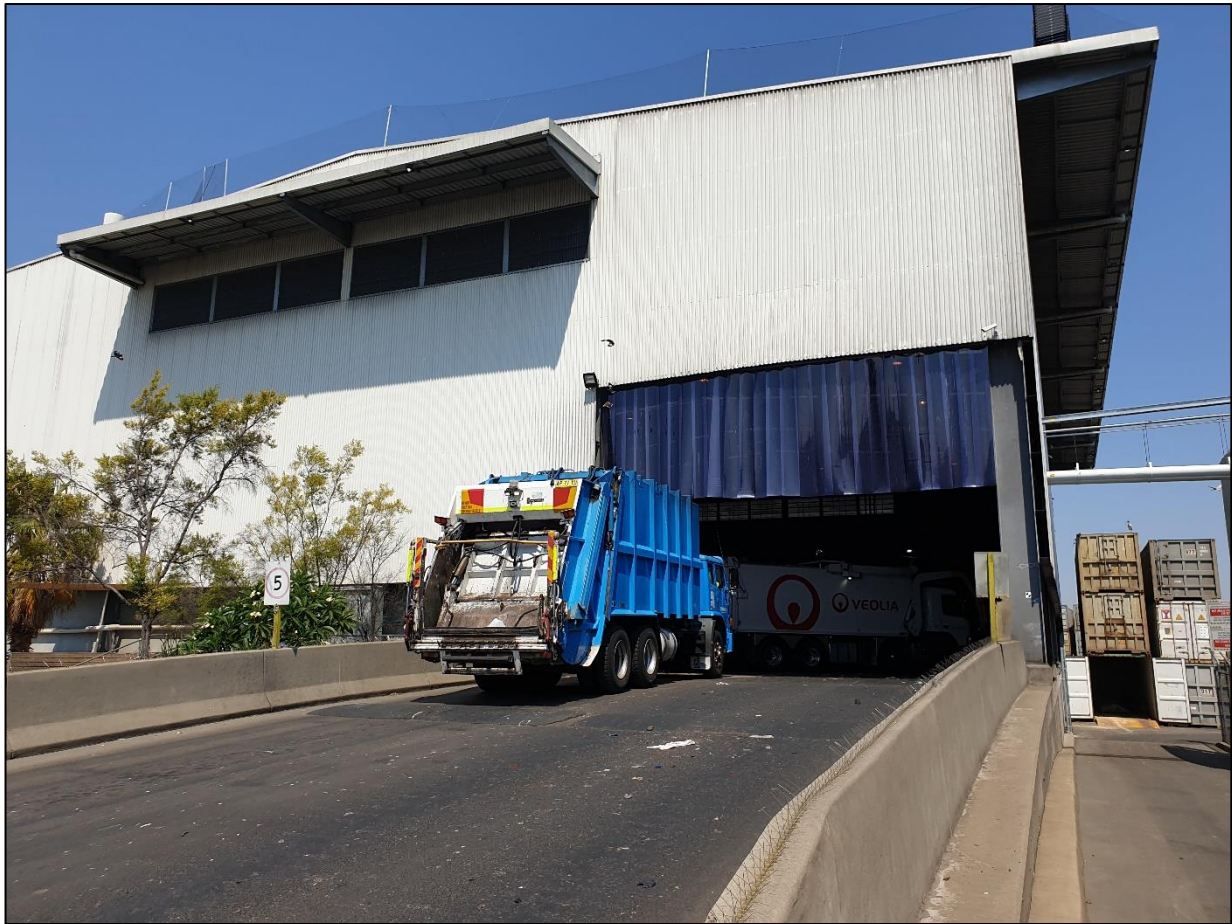
The truck entrance plastic strips of the TTB, used to reduce odour escaping through the opening, were found to be intact and in good condition.

Photo 2.3 – A view of the truck entrance plastic strips as found on 27 November 2019

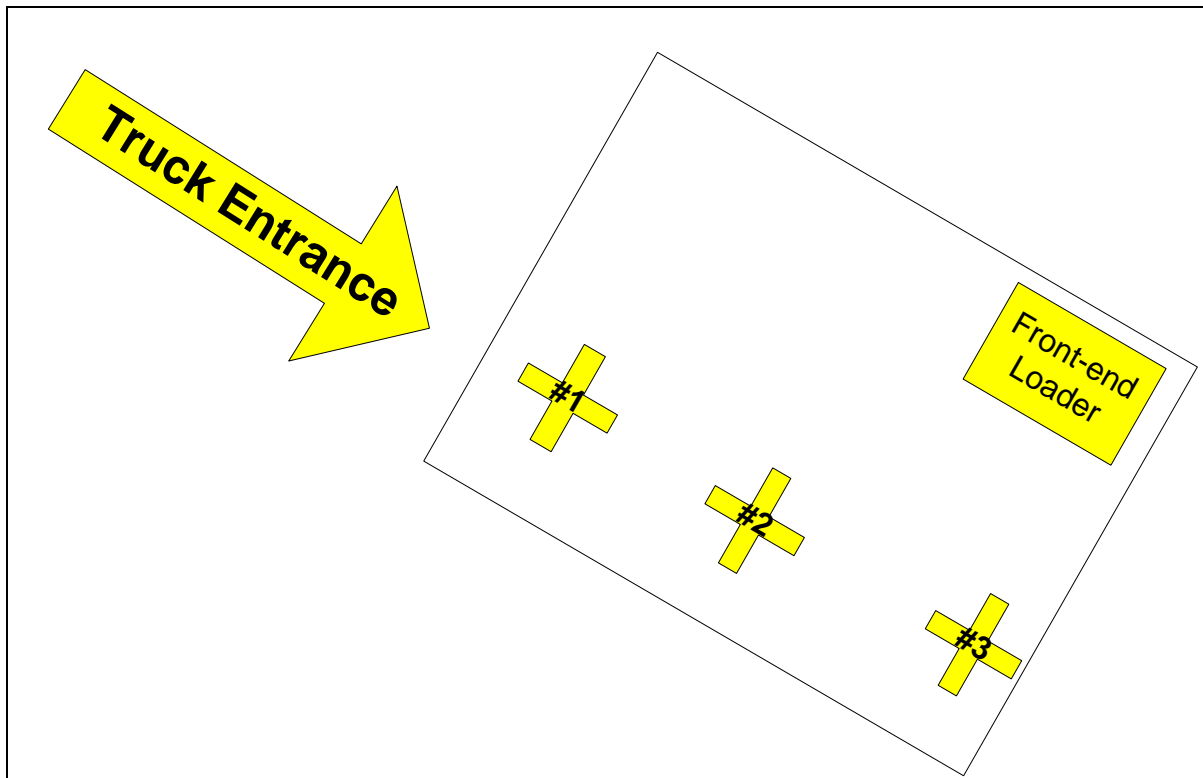
Figure 2.1 - Smoke testing release points within the TTB on 27 November 2019

The smoke released at this point initially rose gradually moving towards the truck entrance before rising to the roof and moving slowly towards the extraction system. Visible smoke extraction at the overhead capture points was evident during the smoke testing at this point. Any smoke that continued towards the truck entrance was promptly blown back into the building.

The smoke released at this point revealed a similar result to smoke testing point #1.

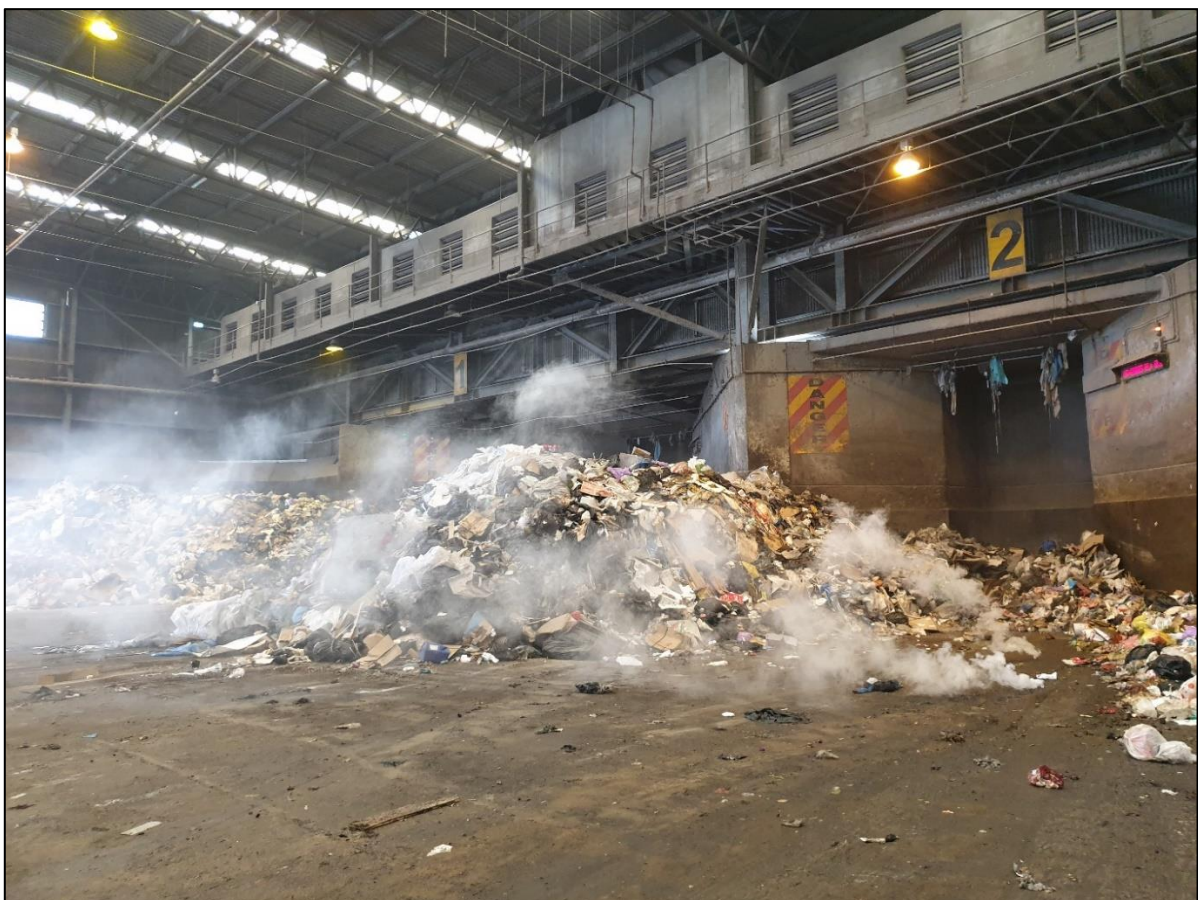
Photo 2.4 – Smoke testing within the TTB on 27 November 2019

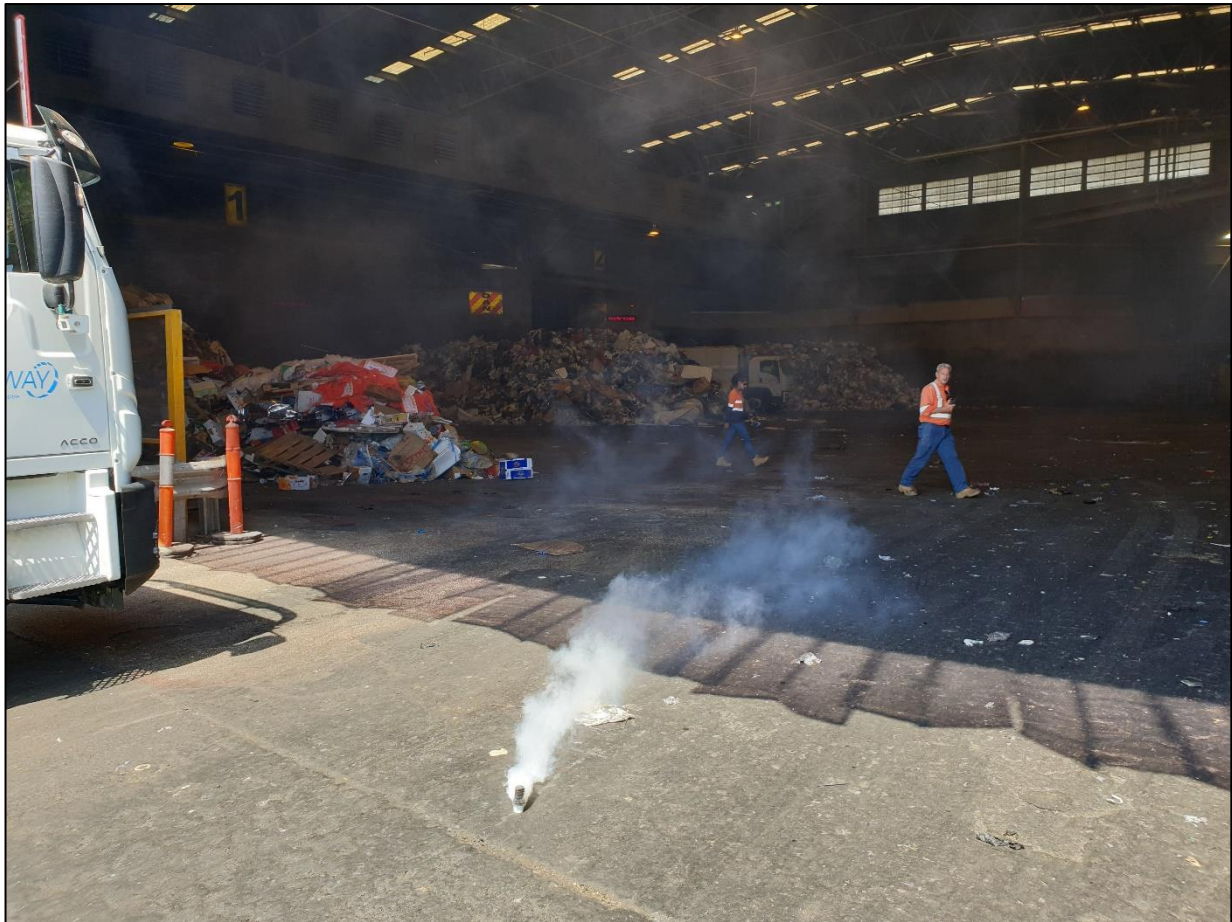
Photo 2.5 – Smoke testing at the truck entrance of the TTB on 27 November 2019

The smoke released at this point indicated that smoke tended to be drawn into the TTB, suggesting that the odour extraction system was performing well during the Odour Audit visit.

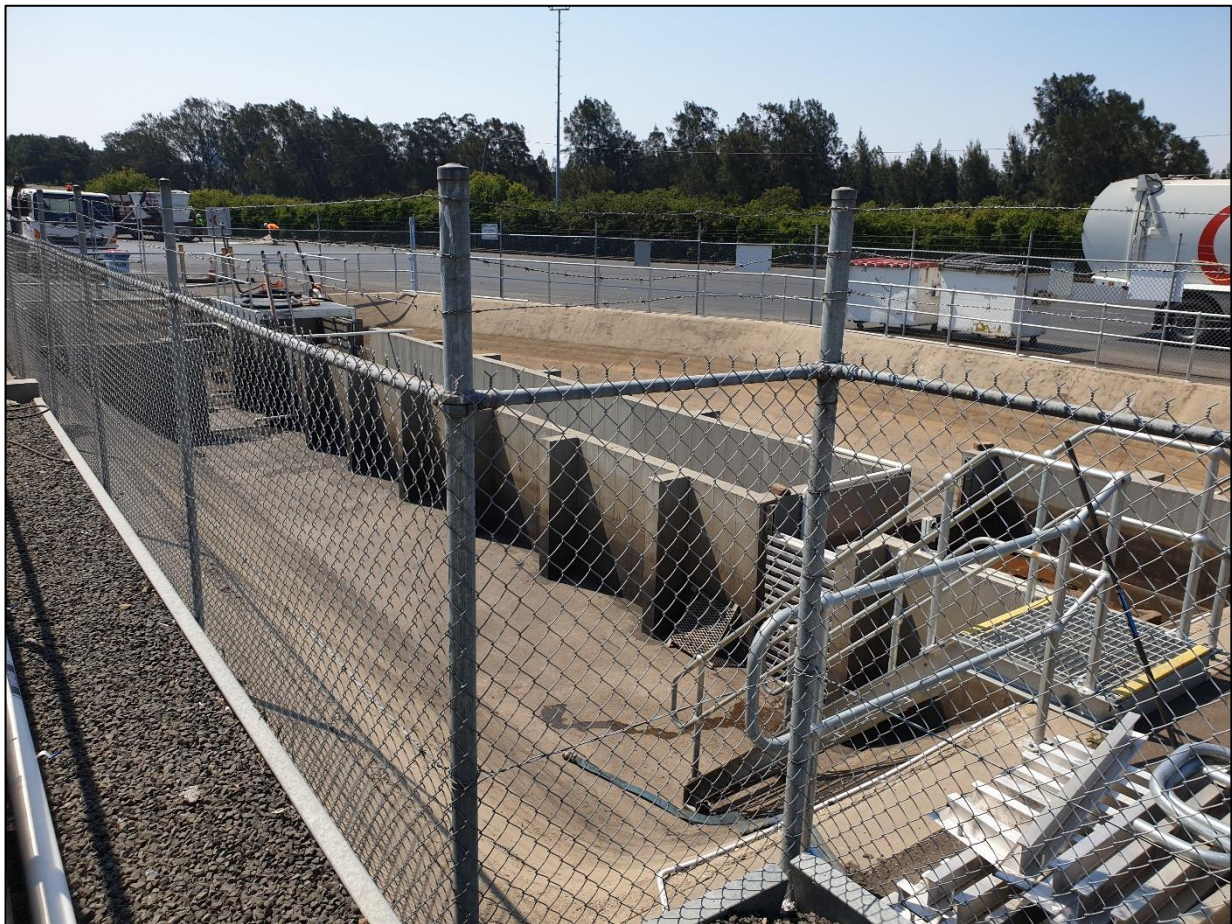
The auditor observed that there was no effluent in this pond at the time of the Odour Audit visit. **Photo 2.6** shows the state of the pond as found on 27 November 2019.

Photo 2.6 – Stormwater retention pond as seen on 27 November 2019

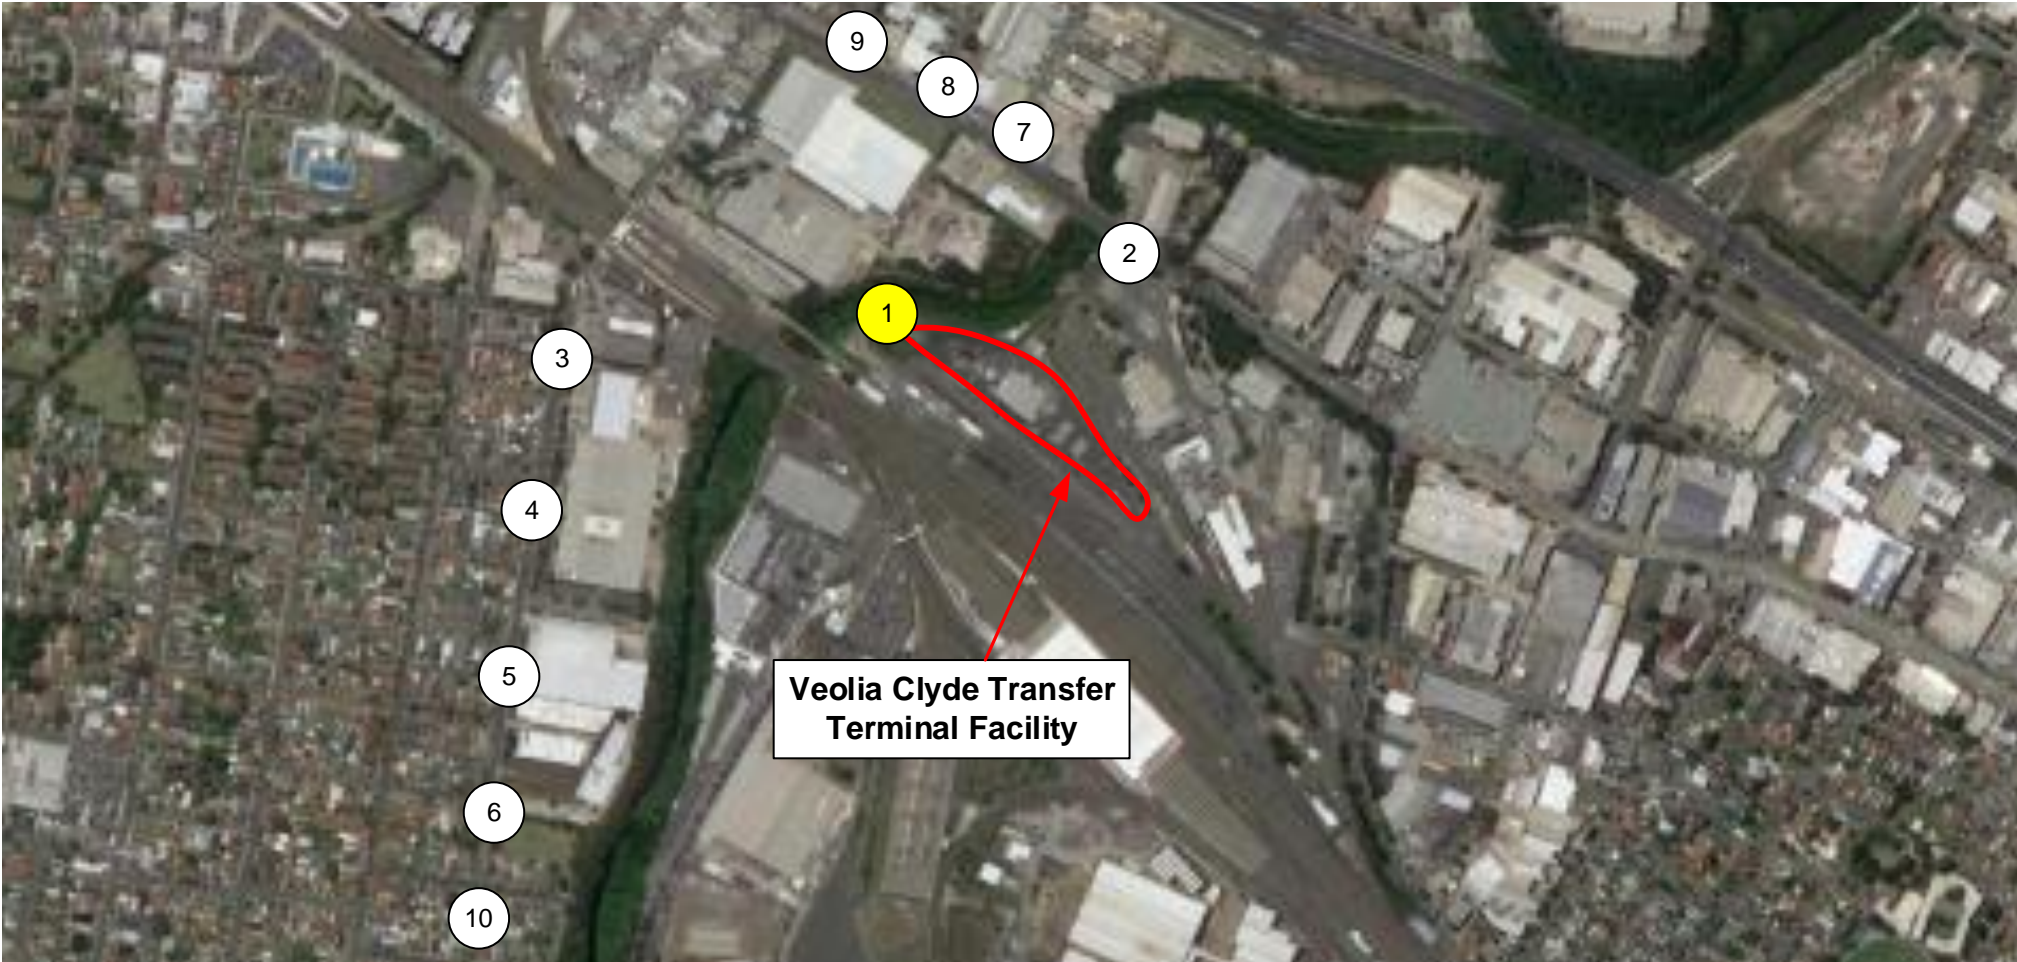
The results of the FAOA survey conducted during the Odour Audit found that whilst intermittent odours were detected onsite, no odours were detectable off-site that could be linked back to the Site and its activities.

Local wind conditions Light to moderate (0.5 m/s – 3 m/s), with winds blowing from the north-east. No rainfall observed. Refer to FAOA Logsheet N1473L-XXXIV for details on recorded odour detections
