# **Clyde Waste Transfer Terminal**

## **Odour Audit II**

Document No. 746244\_TRP\_003579\_02  
8/4/05

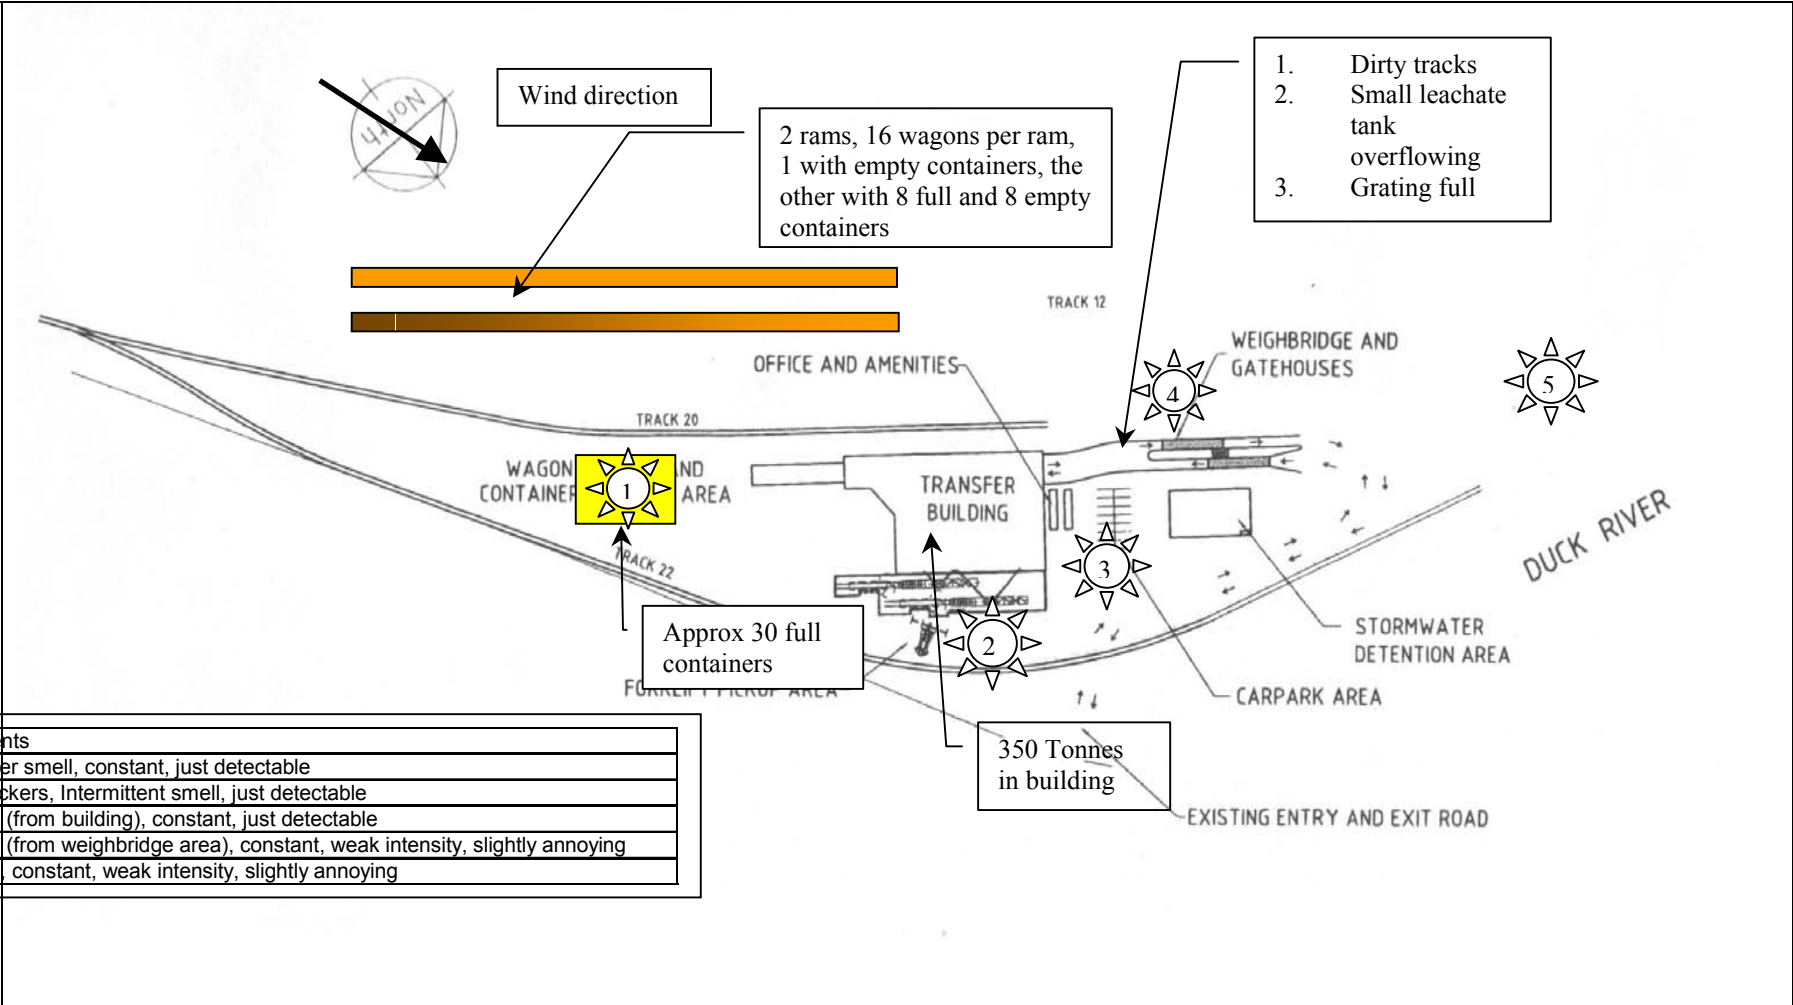
Point #	Comments
1	Container smell, constant, just detectable
2	Slug packers, Intermittent smell, just detectable
3	Fugitive (from building), constant, just detectable
4	Fugitive (from weighbridge area), constant, weak intensity, slightly annoying
5	Fugitive constant, weak intensity, slightly annoying

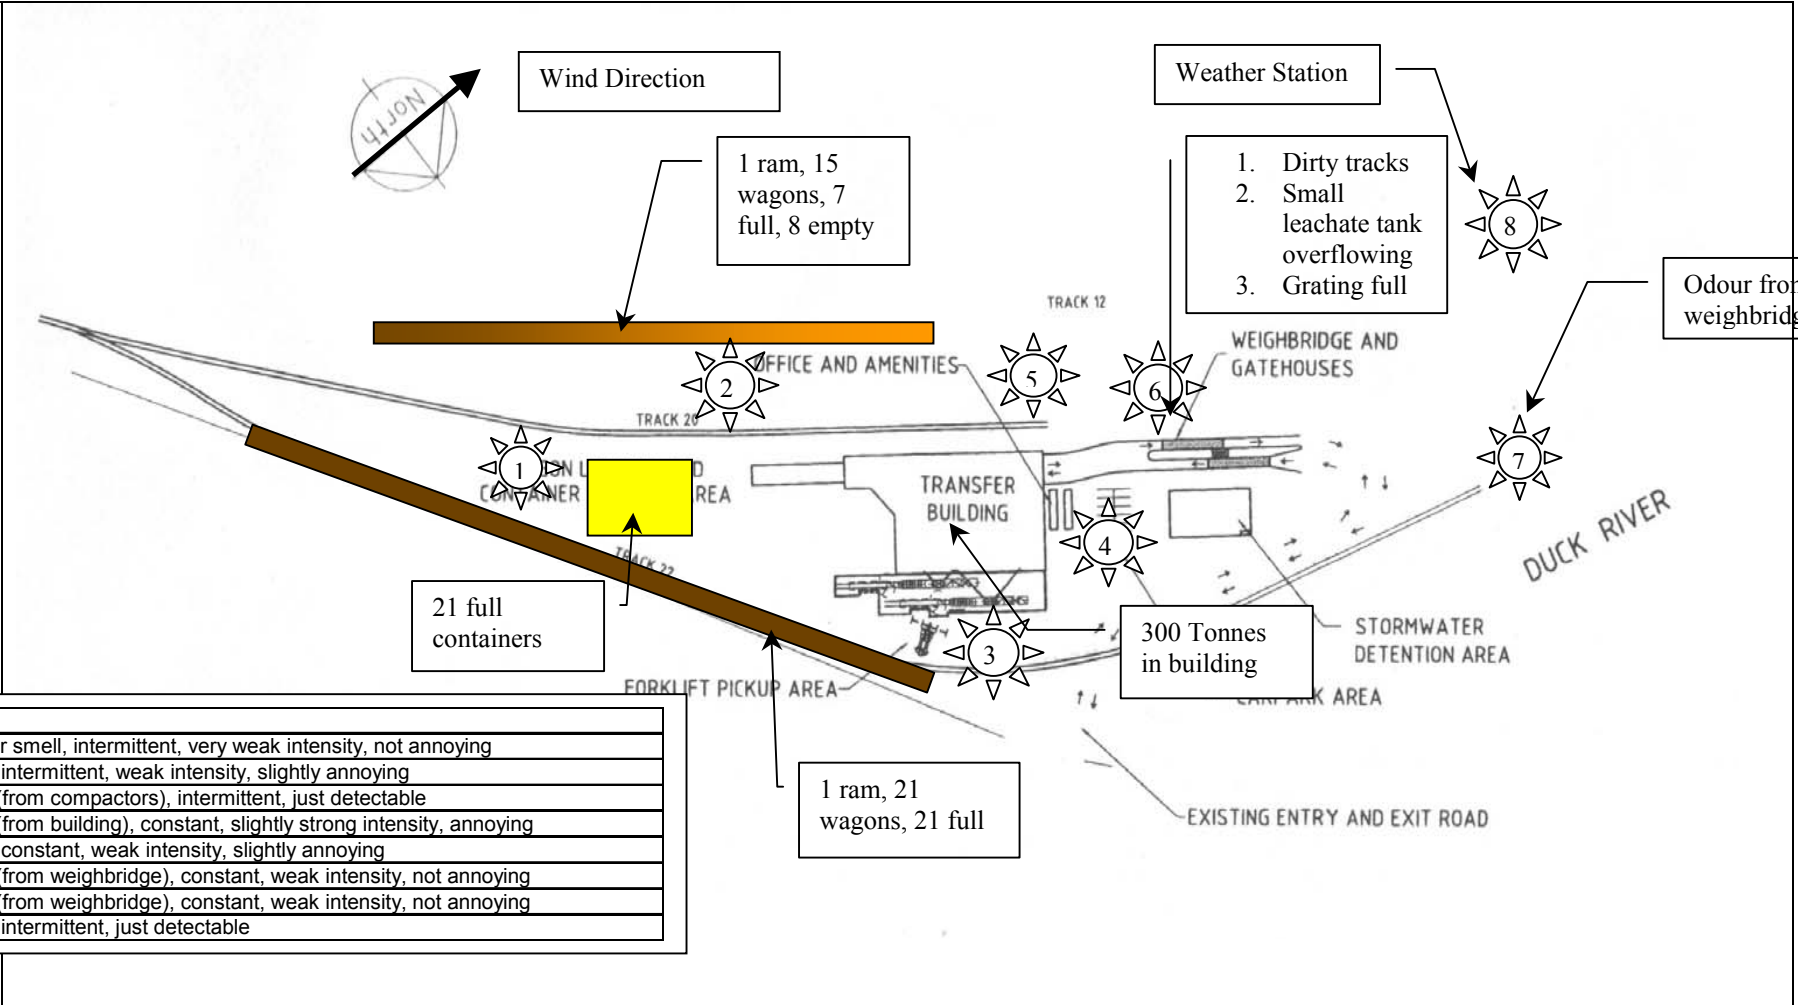
Point #	Comme
1	Container smell, intermittent, very weak intensity, not annoying
2	Fugitive, intermittent, weak intensity, slightly annoying
3	Fugitive (from compactors), intermittent, just detectable
4	Fugitive (from building), constant, slightly strong intensity, annoying
5	Fugitive, constant, weak intensity, slightly annoying
6	Fugitive (from weighbridge), constant, weak intensity, not annoying
7	Fugitive (from weighbridge), constant, weak intensity, not annoying
8	Fugitive, intermittent, just detectable
