Veolia Environmental Services (Australia) Pty Limited

Clyde Waste Transfer Terminal

Odour Audit VII

Final Report

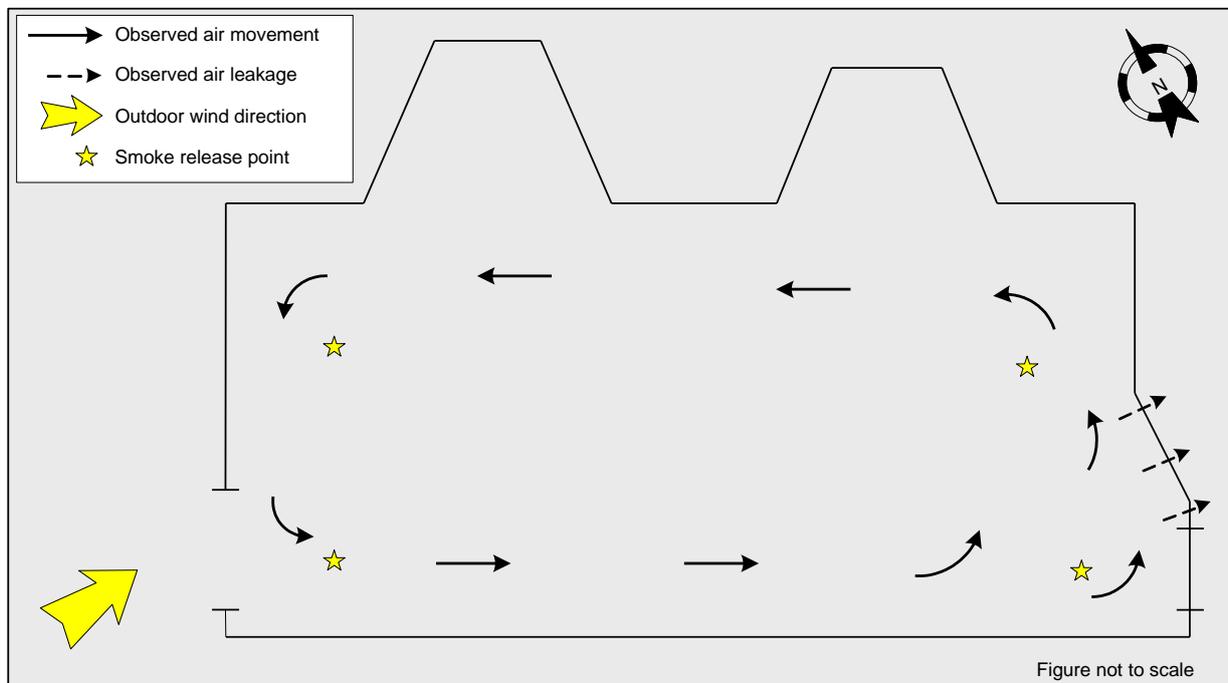
Figure 2.1 – Transfer Building smoke release locations and observed airflow patterns.

The principal finding of the smoke testing re-confirmed what was found in previous odour audits; that there was minimal visible airflow towards the extraction fans. The bulk of the smoke dispersed inside the building as if there was little mechanically induced air movement, with a very slow counter-clockwise circulation. The westerly wind through the doorway was the main influencing factor in this airflow pattern. All extraction fans were operating at the time except for Fan 3, which was found to be offline. VES advised TOU that Fan 3 was brought back online as immediate as possible after the day of the audit. The plastic strip curtain covering the upper-third of the open truck doorway prevented fugitive emissions from exiting back out of the top of the doorway. The airflow was observed to descend from above the doorway, into the westerly flow at the surface and then return back into the circulation within the building.

Smoke released at the southeastern corner showed clearly that air was escaping the building through gaps in the breezeways, in particular the unsealed breezeway directly north of the roller-door. This could be a major source of fugitive emissions and should be sealed as soon as possible.

In the meantime, TOU strongly recommends that the breezeways at the southeastern corner of the building be fully sealed as soon as possible along with any other 'gaps' in the breezeways that may be apparent elsewhere.
