Veolia Environmental Services (Australia) Pty Limited

Clyde Waste Transfer Terminal

Odour Audit XIII

May 2009

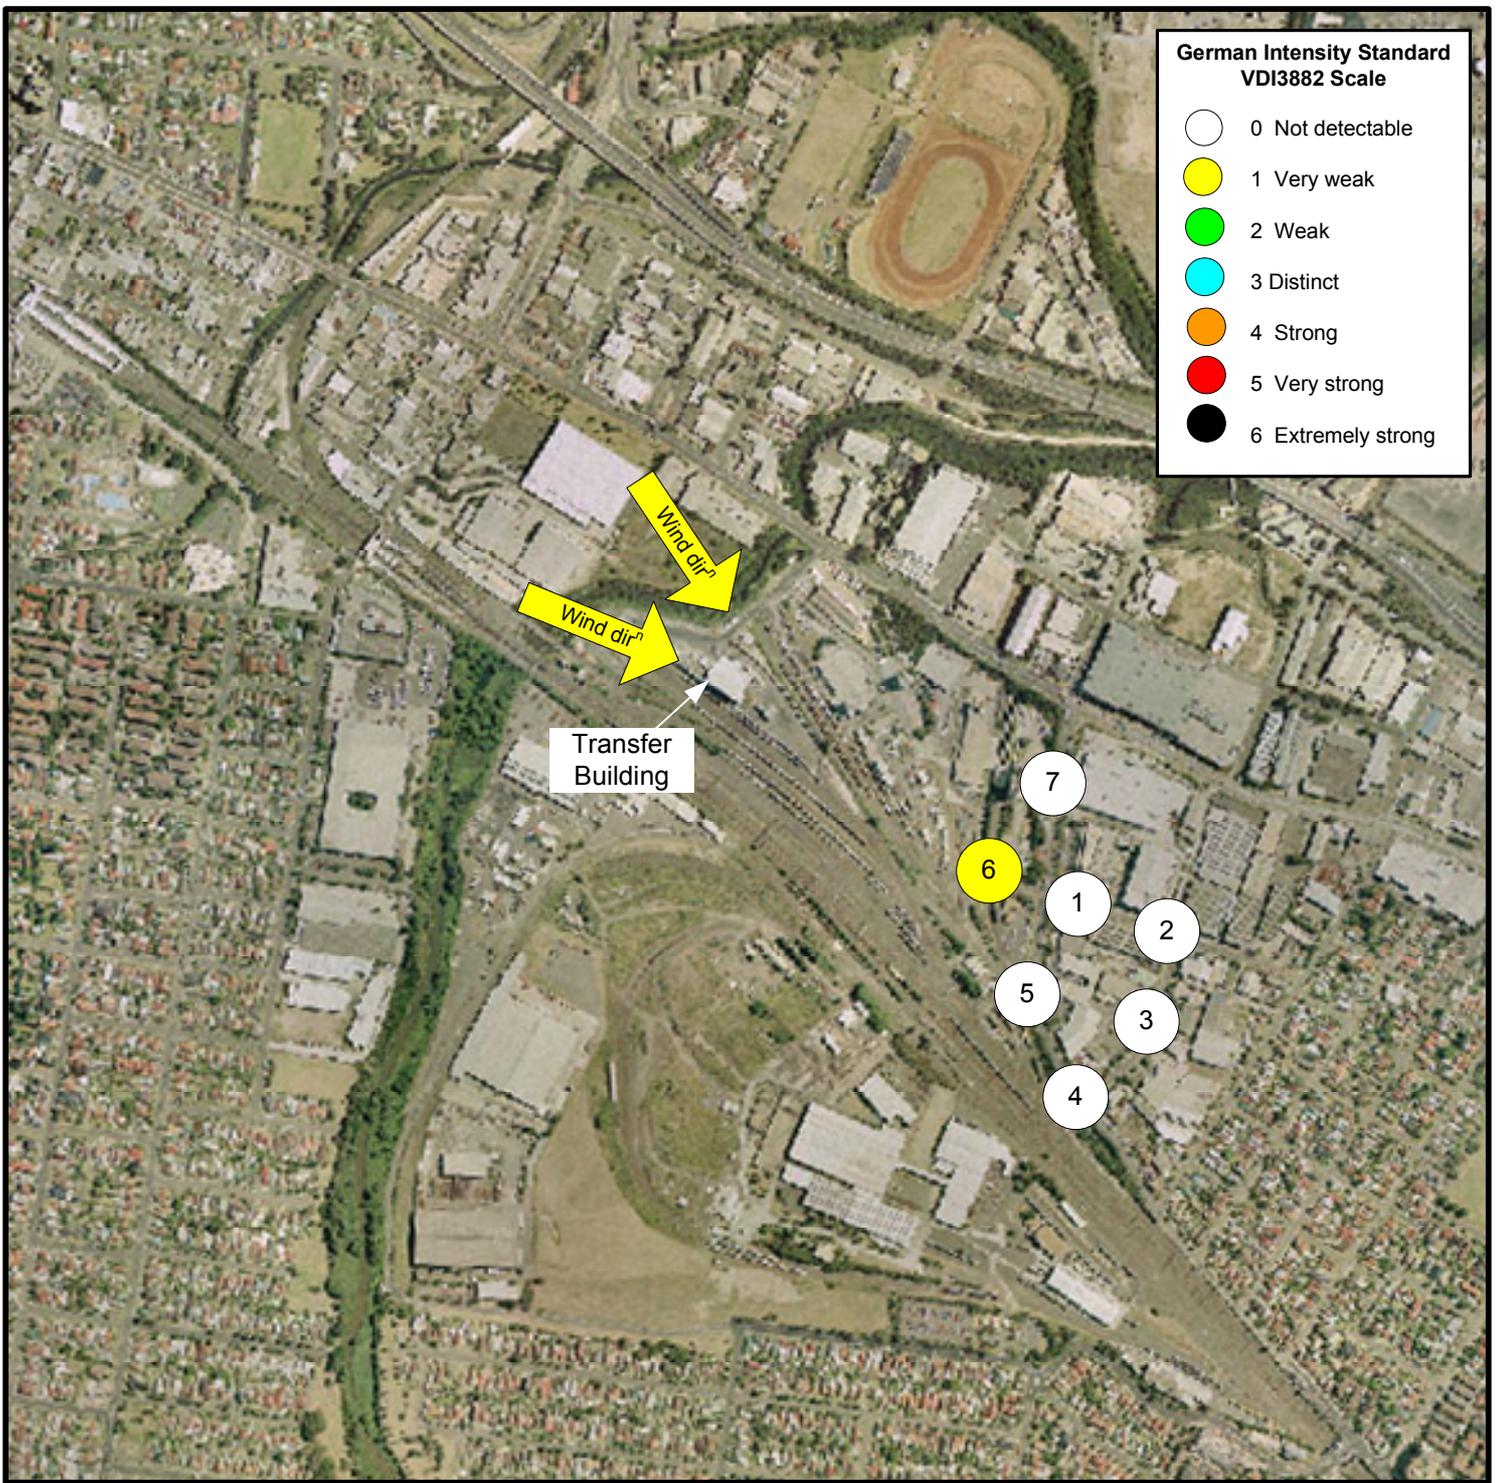
Veolia Environmental Services
 Clyde Transfer Terminal, Clyde NSW
 Field Ambient Odour Assessment Survey

As **Appendix B** illustrates, a very weak garbage smell was detected adjacent to the Cement Australia Entrance.
