# **Veolia Environmental Services (Australia) Pty Limited**

**Clyde Waste Transfer Terminal**

**Odour Audit XVII**

**May 2011**

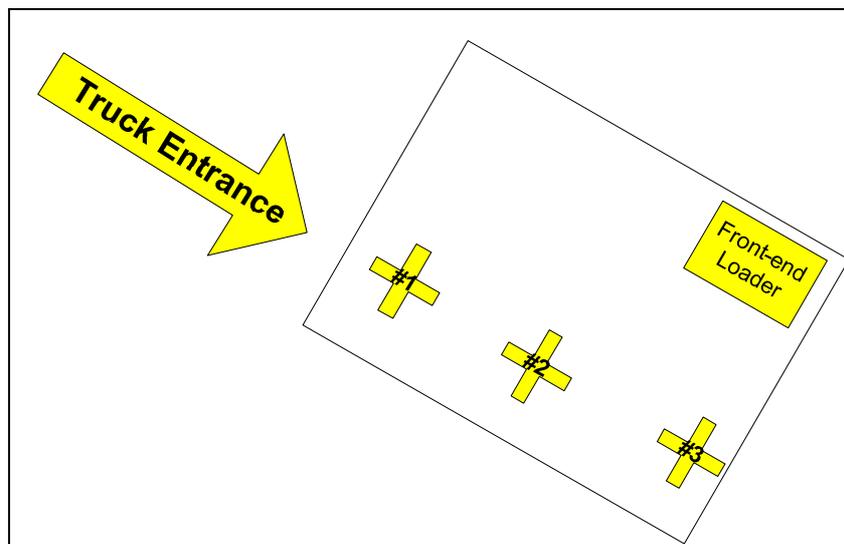
**Figure 1:** Smoke testing release points within the Transfer Building.

Smoke testing was carried out at the truck entrance and the smoke was observed to initially move upwards towards the roof and then towards the extraction fan. There was no observed movement towards the truck entrance

Smoke released from the second point initially moved upwards in eddies and was gradually drawn into the extraction system.

Smoke released at this point initially rose gradually before being drawn upwards to the extraction system.

The overall finding of the smoke testing was that the extraction system was effective in maintaining the stack as the main emission point of air from the building, with no evidence of any fugitive odour releases.

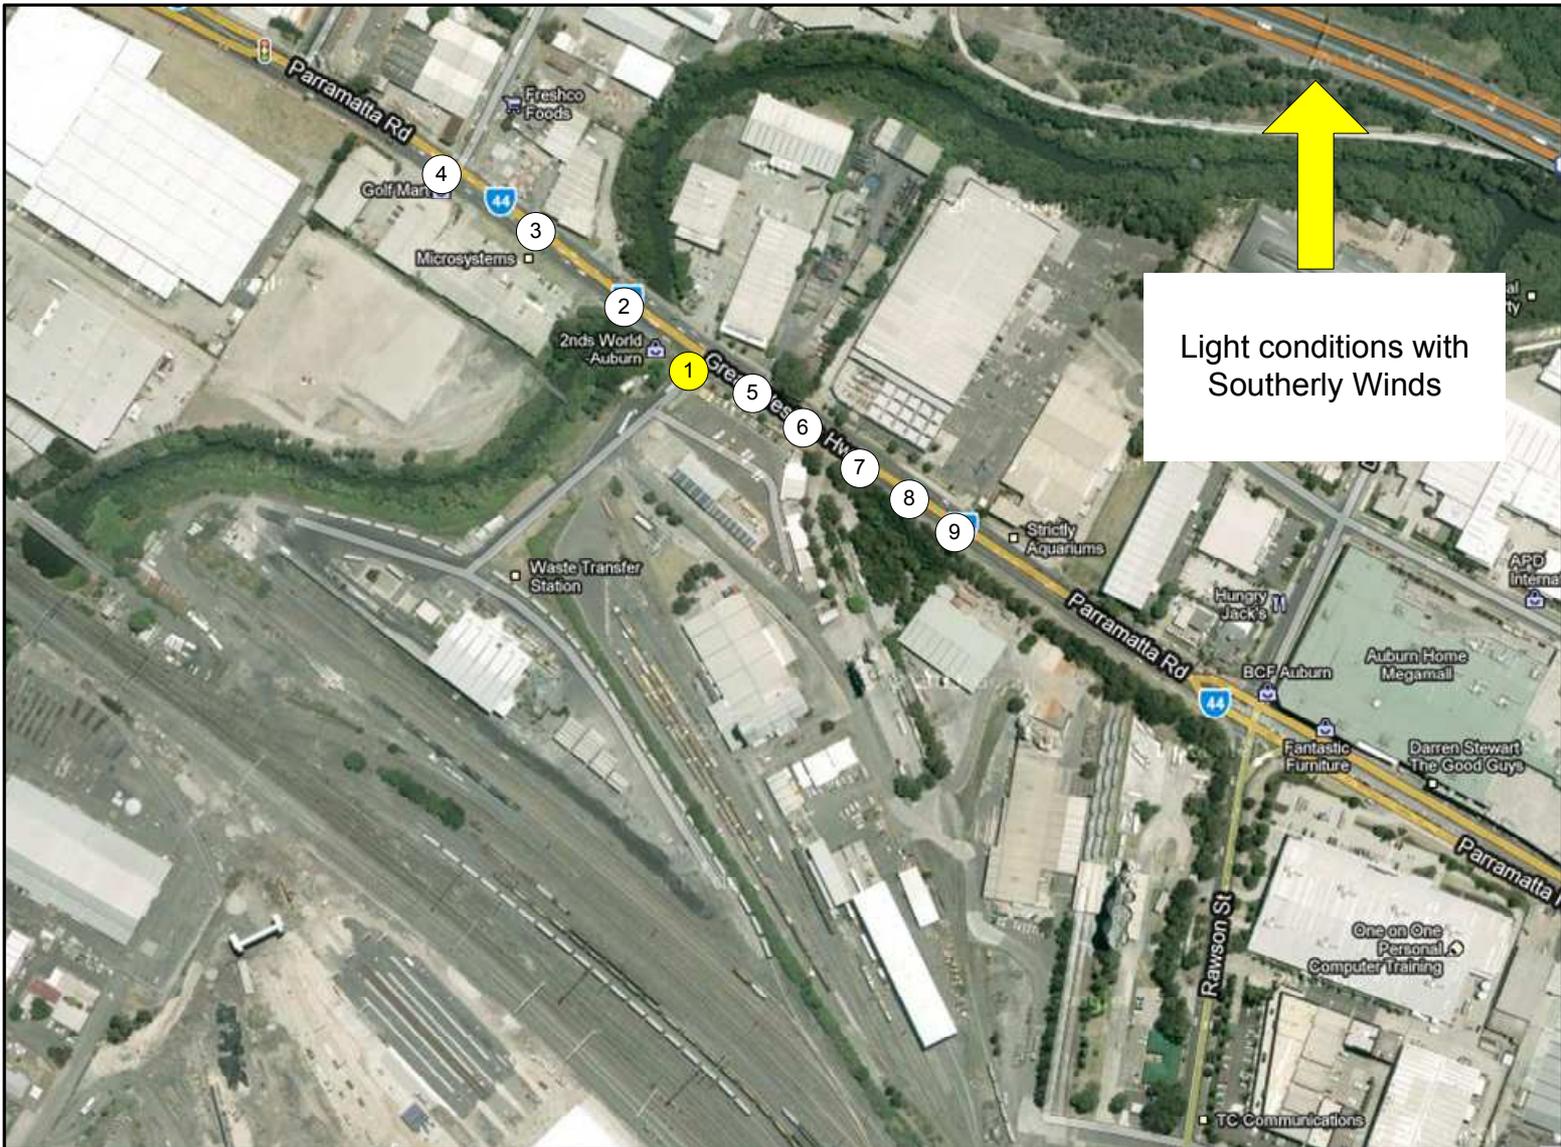
DESCRIPTION  
**Field Ambient Odour Assessment Survey**  
 Modified German Standard VDI 3940

Apart from a very weak intermittent odour being detected by the assessor at the entrance roadway to the plant (1140 hrs) no identifiable plant odour could be detected at other locations. The southerly direction of the wind restricted the survey to the north of the plant, extending to the northern side of Parramatta Road. The field log sheets and odour impact map are attached as **Appendix C**.

GRID REF. POSITION	TIME	WIND DIRECTION	WIND SPEED (m/s)	ODOUR PRESENT Y / N	ODOUR CHARACTER	VDI 3940 INTENSITY SCALE 0-6	COMMENTS
1	1140	S	0.5-2	Y	Municipal Solid Waste	1	Intermittent
2	1145	S	0.5-2	N	-	0	-
3	1149	S	0.5-2	N	-	0	-
4	1153	S	0.5-2	N	-	0	-
5	1201	S	0.5-2	N	-	0	-
6	1205	S	0.5-2	N	-	0	-
7	1209	S	0.5-2	N	-	0	-
