# **Veolia Environmental Services (Australia) Pty Limited**

**Clyde Waste Transfer Terminal**

**Odour Audit XV**

**May 2010**

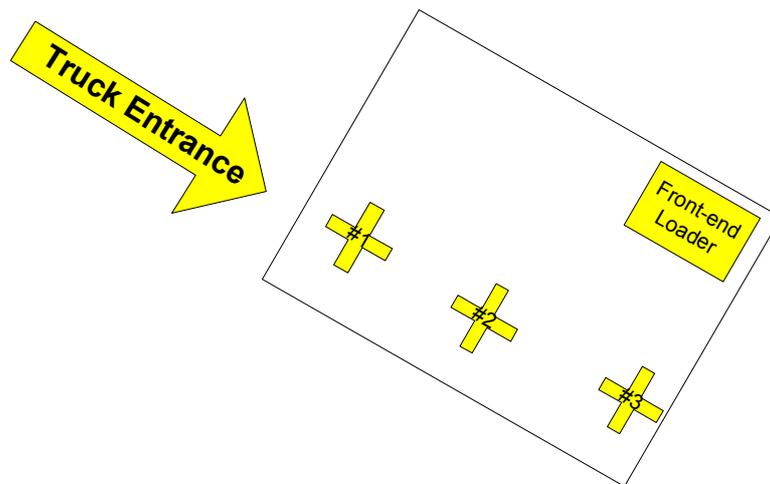
**Figure 1:** Smoke testing release points within the Transfer Building.

The smoke initially was drawn towards the truck entrance and was then pulled back under and into the Transfer Building. The smoke then moved in a swirling motion towards the ceiling and then moved back down again. Smoke testing was carried out at the truck entrance and the smoke was observed to move back into the Transfer Building.

Smoke released from the second point initially moved in eddies near the ground and was gradually drawn up towards the ceiling.

The final point where smoke testing was carried out showed that the air initially lingered near the ground and then was slowly drawn up towards the ceiling.

A front end loader working under the extraction system of the Transfer Building (location shown in **Figure 1**) pushed dust into the air which was in turn drawn quickly up to the extraction system by the fans.

In all instances the smoke was completely contained within the Transfer Building therefore no evidence of any fugitive odour release was observed whilst this odour audit was carried out.
