**Clyde Waste Transfer Terminal**

**Odour Audit XXXIX**

**Final Report**

**June 2022**

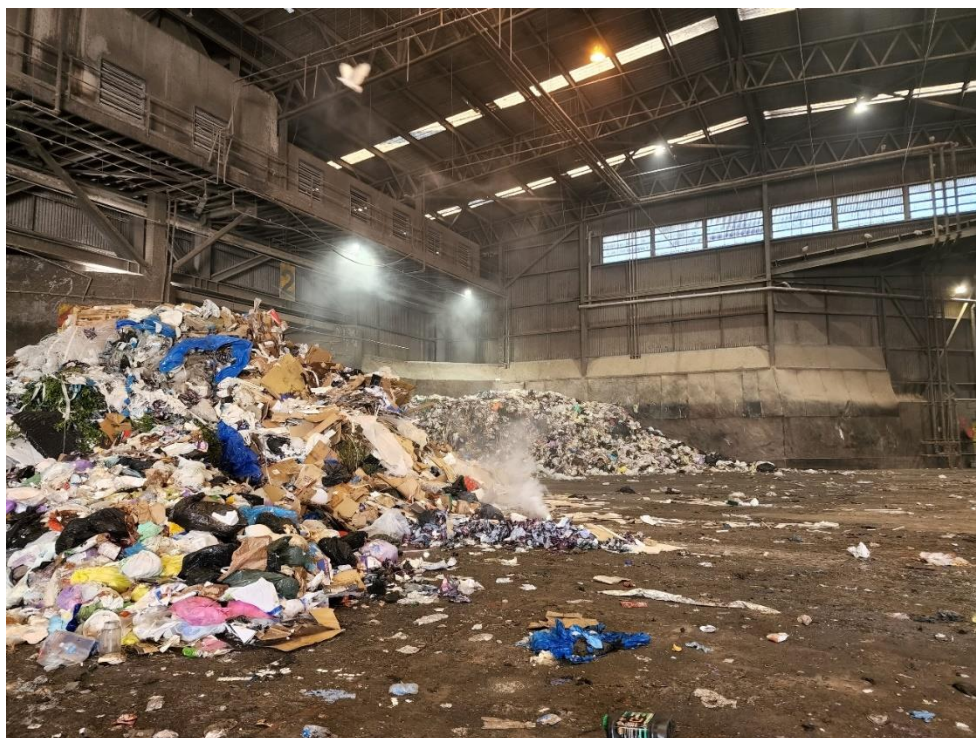
**Photo 2.1** – TTB waste on-floor as found on 8 June 2022 (during a smoke test)

As with previous audits, and consistent with TOU's experience at other waste transfer stations, there was a weak to distinct level of odour observed within the TTB. A photo of the waste on the floor as found during the Odour Audit visit is shown in Photo 2.1.

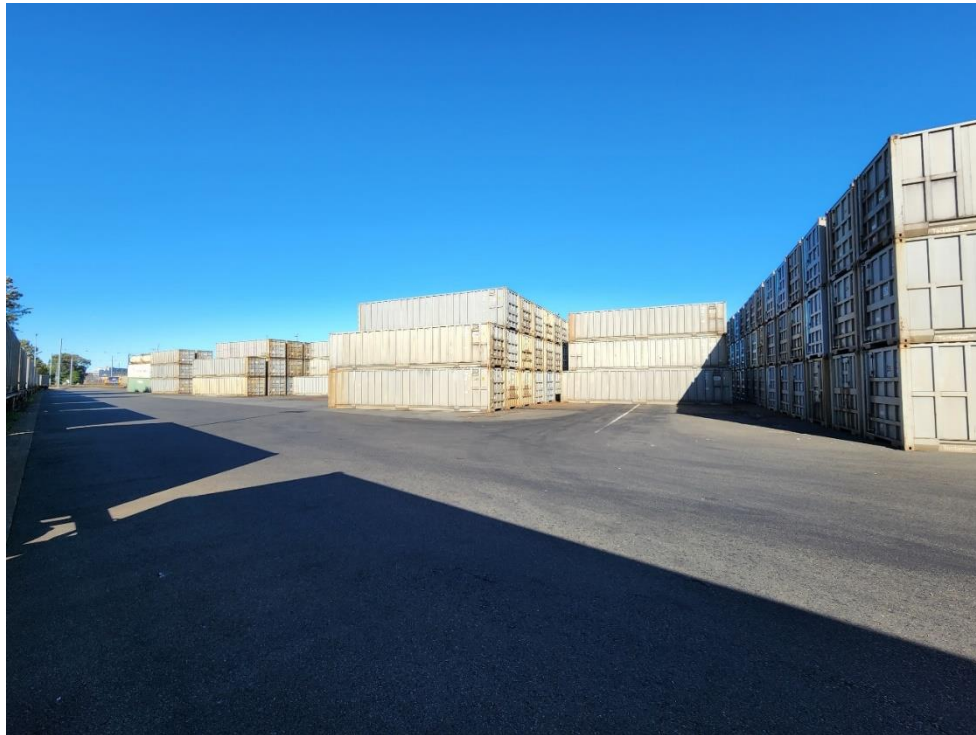
**Photo 2.2** – A view of the container area as found on 8 June 2022

As per the Odour Management Plan dated February 2010 (the **February 2010 OMP**) for the Site, following the compaction of waste, all filled containers are entirely sealed and remain so while at the Site. All containers used are required to be in good condition, and unused/returned containers adequately clean. The Odour Audit finds that this continues to be current practice at the Site. A view of the condition of the container area as found on 8 June 2022 is shown in **Photo 2.2**.

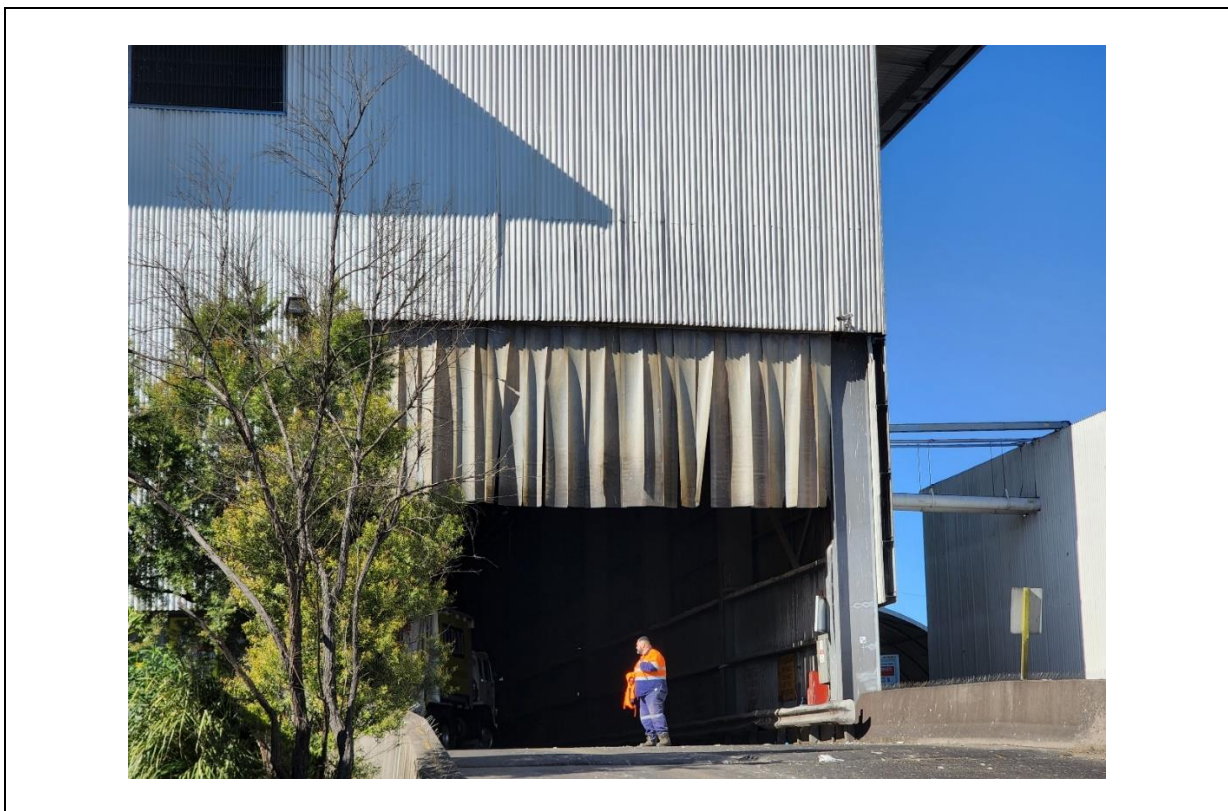
**Photo 2.3** – A view of the truck entrance plastic strips as found on 8 June 2022

The truck entrance plastic strips of the TTB, used to reduce odour escaping through the opening, were found to be intact and in good condition (refer to **Photo 2.3**).

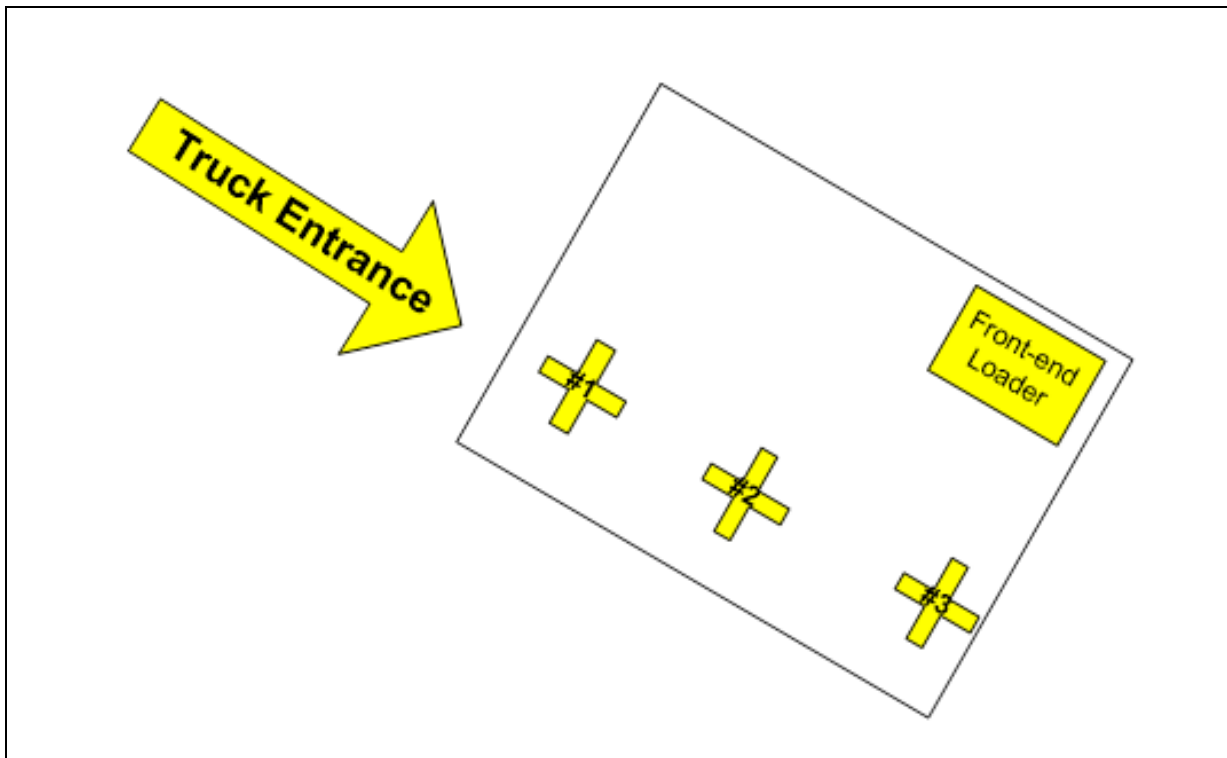
**Figure 2.1** – Smoke testing release points within the TTB on 8 June 2022

The smoke released at this point initially rose gradually, rising to the roof and moving slowly towards the extraction system. Visible smoke extraction at the overhead capture points was evident during the smoke testing at this point.

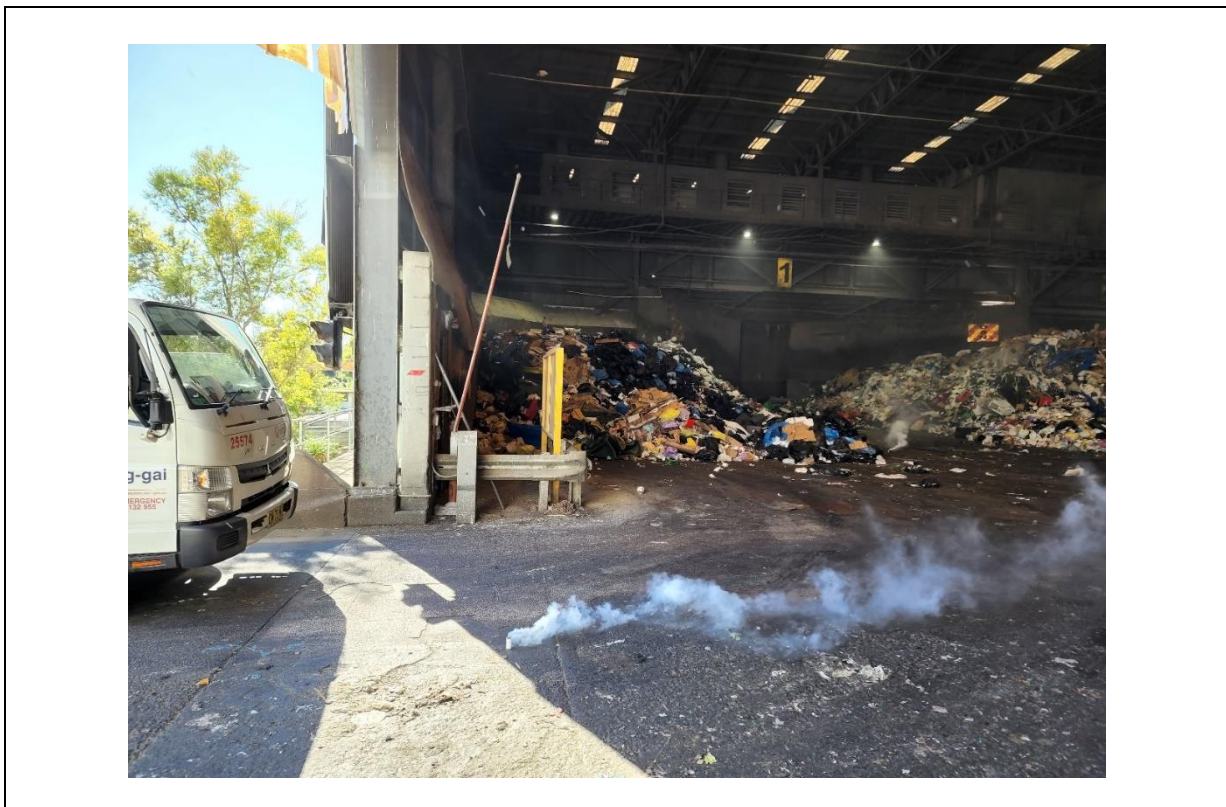
**Photo 2.4** – A view of the truck entrance plastic strips during smoke testing on 8 June 2022

As per previous audits, smoke testing was carried out within the TTB to assist in determining the effectiveness of the forced air extraction system, as well as the extent to which the TTB has been sealed from leaks. As per previous audits, smoke was released from within the TTB at three points within the TTB. **Figure 2.1** shows the three points where the smoke was released within the TTB. **Photo 2.4** shows smoke testing

at the truck entrance of the TTB, which reflects an additional test location to the normal smoke testing release points shown in **Figure 2.1**.
