**Clyde Waste Transfer Terminal**

**Odour Audit XXXVIII**

**Final Report**

**March 2022**

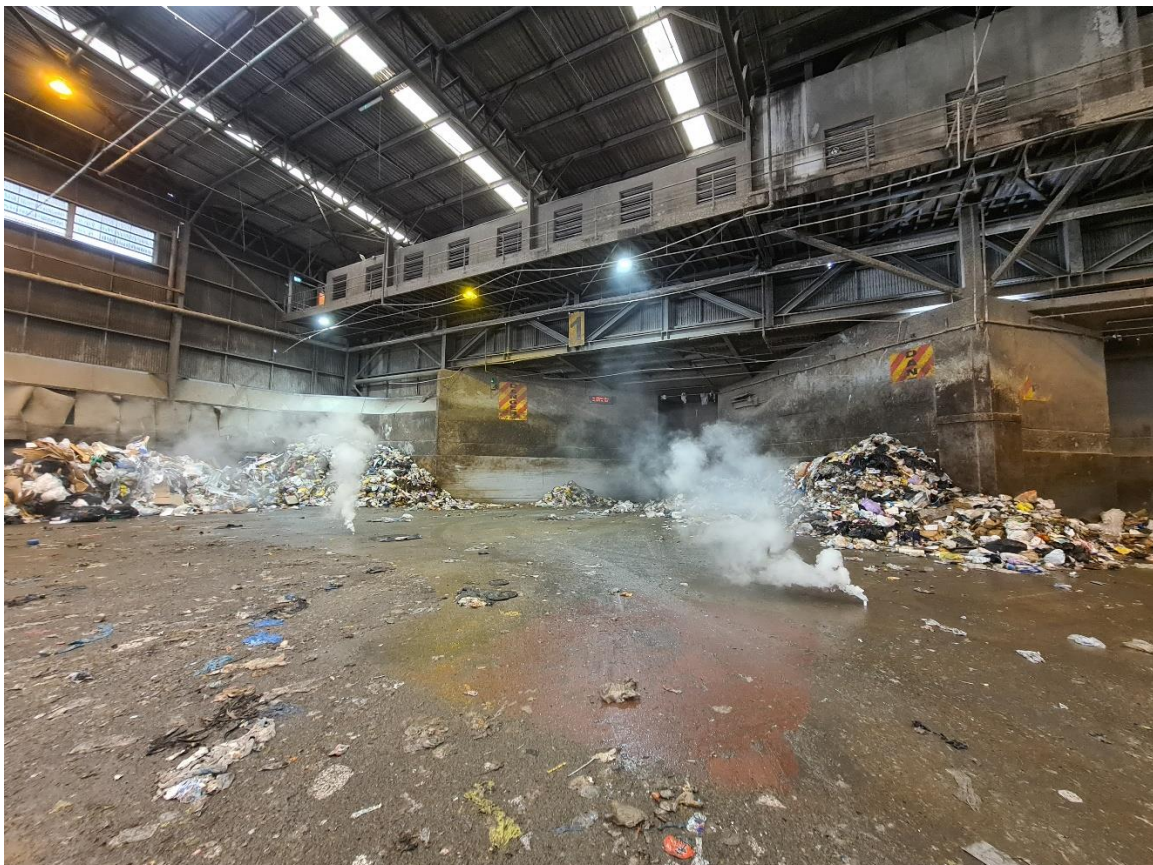
**Photo 2.1** – TTB waste on-floor as found on 25 November 2021 (during a smoke test)

During the Odour Audit visit, there were approximately 120-150 tonnes of waste on the floor. This tonnage is considered to be within the normal operating range of the Transfer Terminal Building (TTB). The TTB floor area not covered by waste material was observed to be reasonably clean, with little evidence of leachate or aged material. General housekeeping procedures of the TTB were good, as found during several truck-unloading sequences. It was also observed that the TTB's front-end loaders cleared the floor area of waste on a regular basis, minimising the exposed area of waste.

As with previous audits, and consistent with TOU's experience at other waste transfer stations, there was a weak to distinct level of odour observed within the TTB. A photo of the waste on the floor as found during the Odour Audit visit is shown in Photo 2.1.

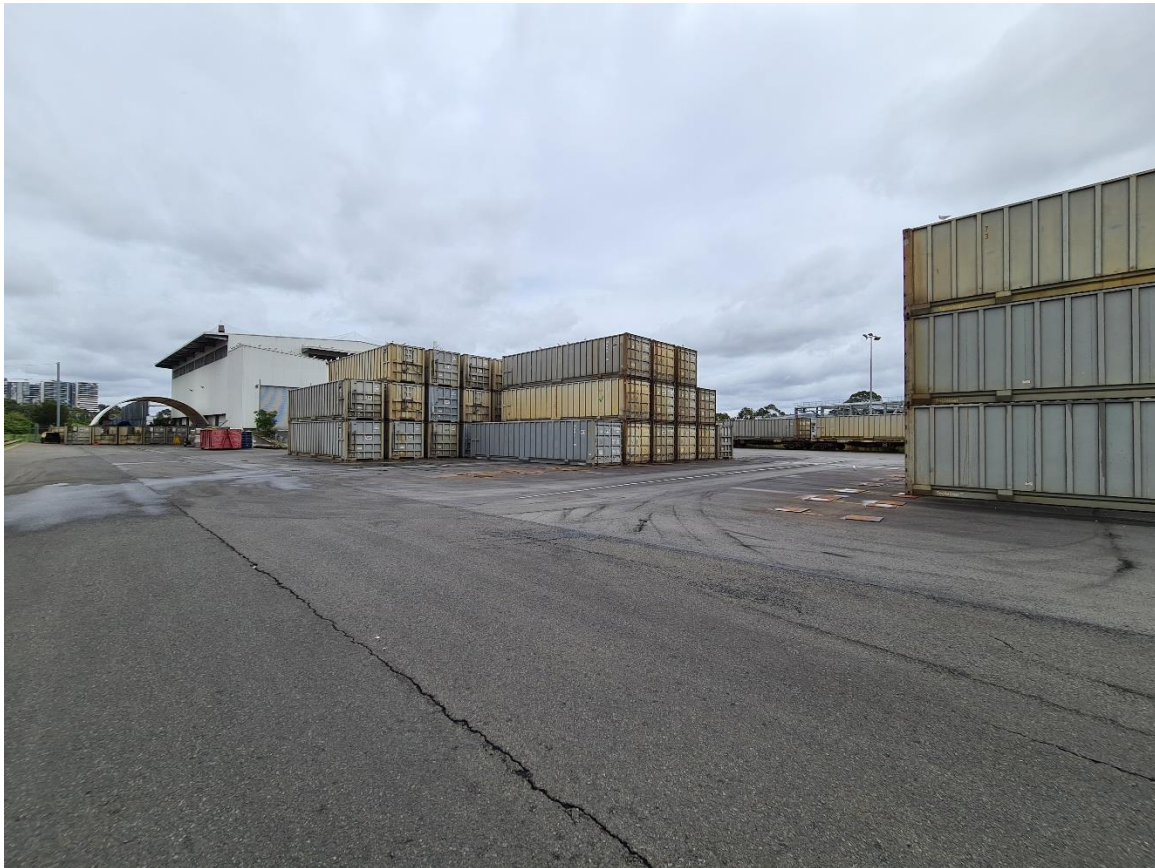
**Photo 2.2** – A view of the container area as found on 25 November 2021

The container packing area and site roadways were found to be clean and well managed with no evidence of waste or exposed leachate. Like previous odour audits, the container compacting/train packing area had a weak to distinct odour that was intermittently detectable but was confined to this area only (see **Appendix B** for Field Ambient Odour Assessment Survey results). TOU was advised by a Veolia personnel that one of the two compactors were in operation at the time of the Odour Audit visit. The general housekeeping around this area was observed to be of high quality, with no evidence to suggest otherwise.

and remain so while at the Site. All containers used are required to be in good condition, and unused/returned containers adequately clean. The Odour Audit finds that this continues to be current practice at the Site. A view of the condition of the container area as found on 25 November 2021 is shown in **Photo 2.2**.

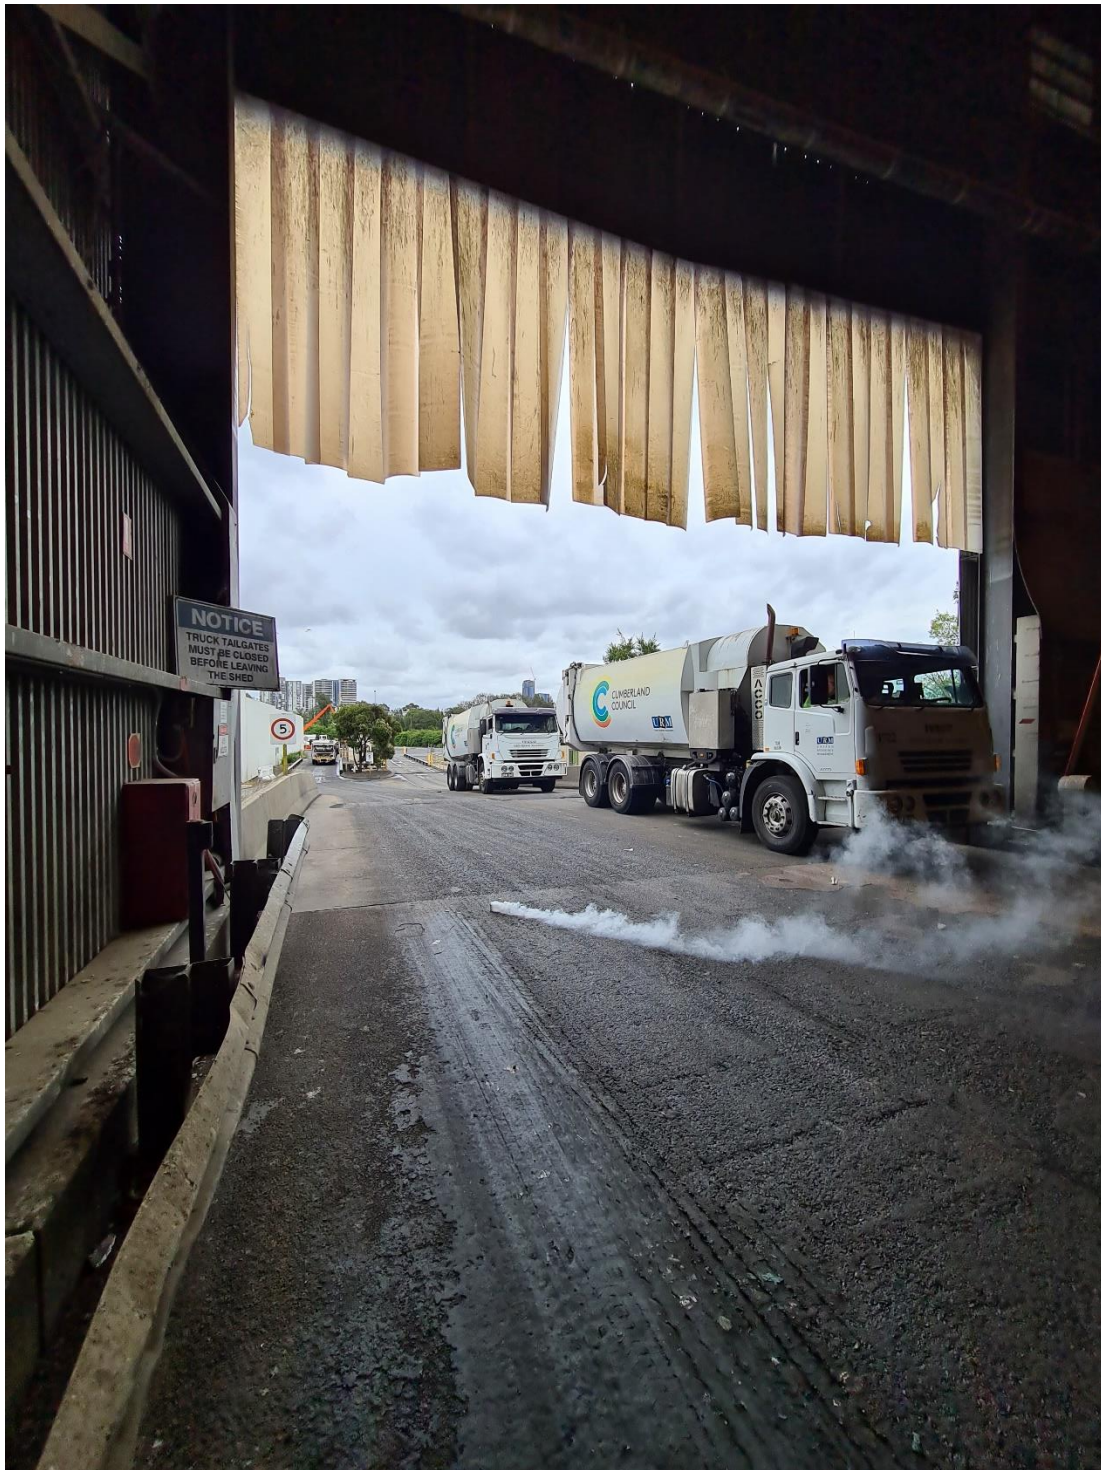
**Photo 2.3** – A view of the truck entrance plastic strips as found on 25 November 2021

The truck entrance plastic strips of the TTB, used to reduce odour escaping through the opening, were found to be intact and in good condition (refer to **Photo 2.3**).

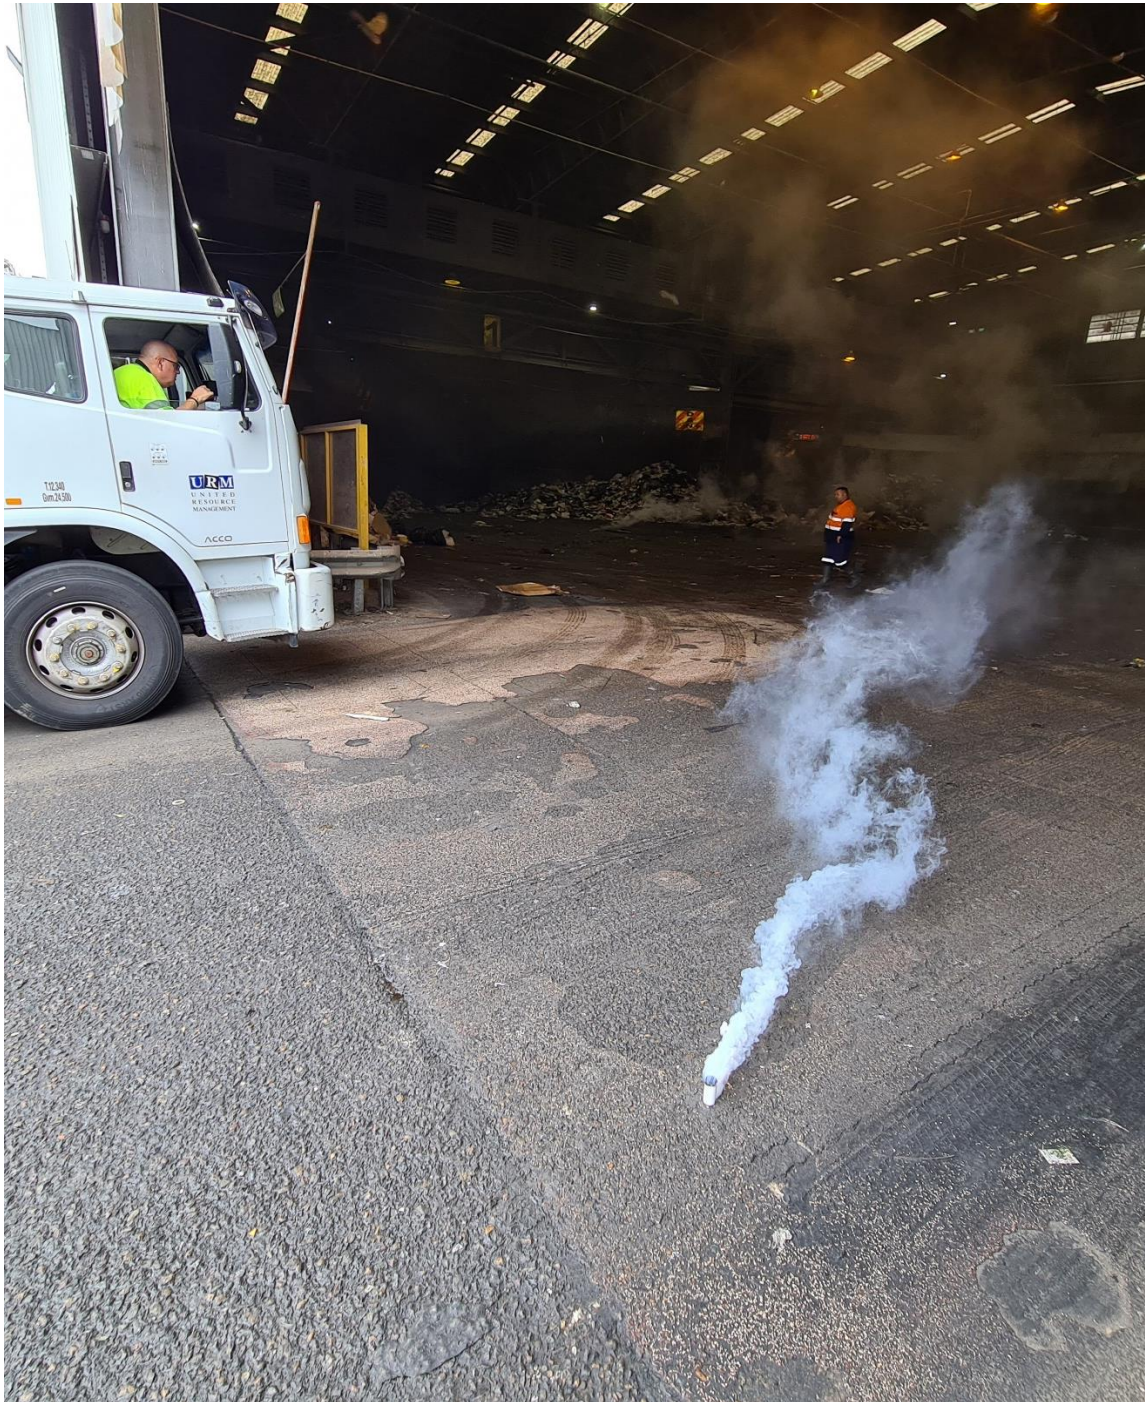
**Photo 2.4** – A view of the truck entrance plastic strips during smoke testing on 25 November 2021

The smoke released at this point initially rose gradually moving towards the truck entrance before rising to the roof and moving slowly towards the extraction system. Visible smoke extraction at the overhead capture points was evident during the smoke testing at this point. Any smoke that continued towards the truck entrance was drawn back into the building (see shown in **Photo 2.4**).

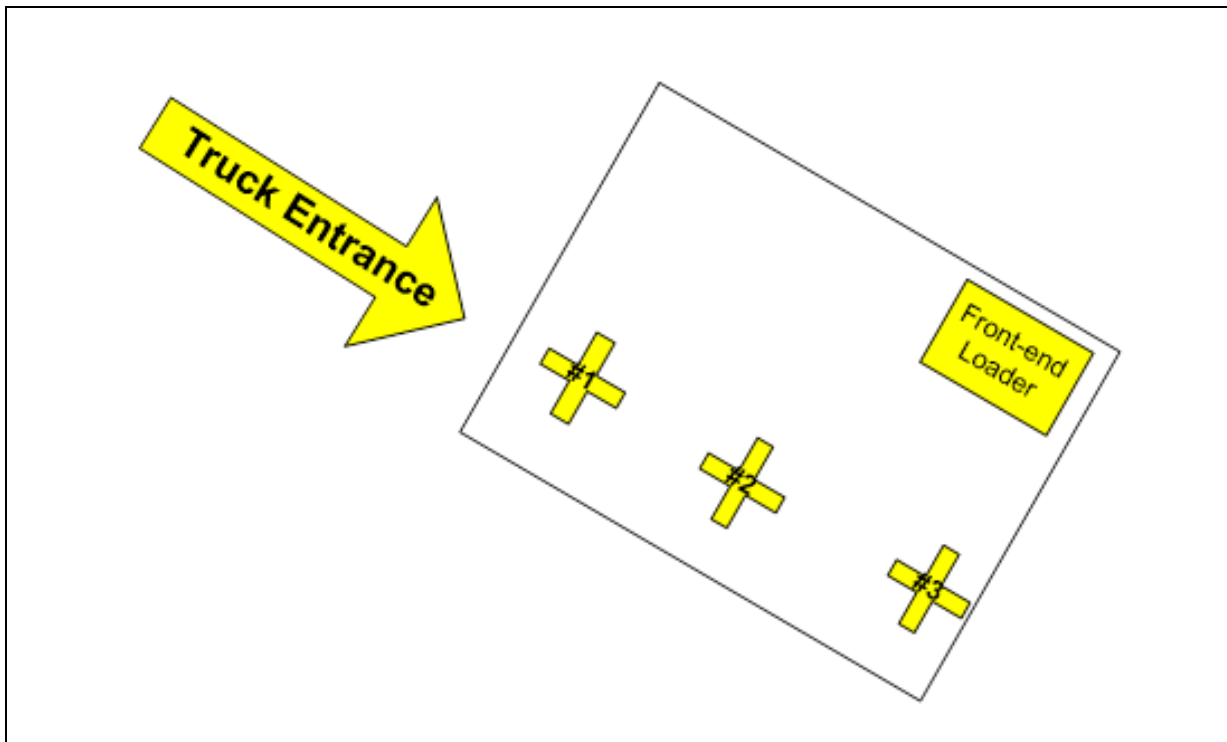
**Figure 2.1 – Smoke testing release points within the TTB on 25 November 2021**

The smoke released at this point revealed a similar result to that documented for smoke testing point #1.

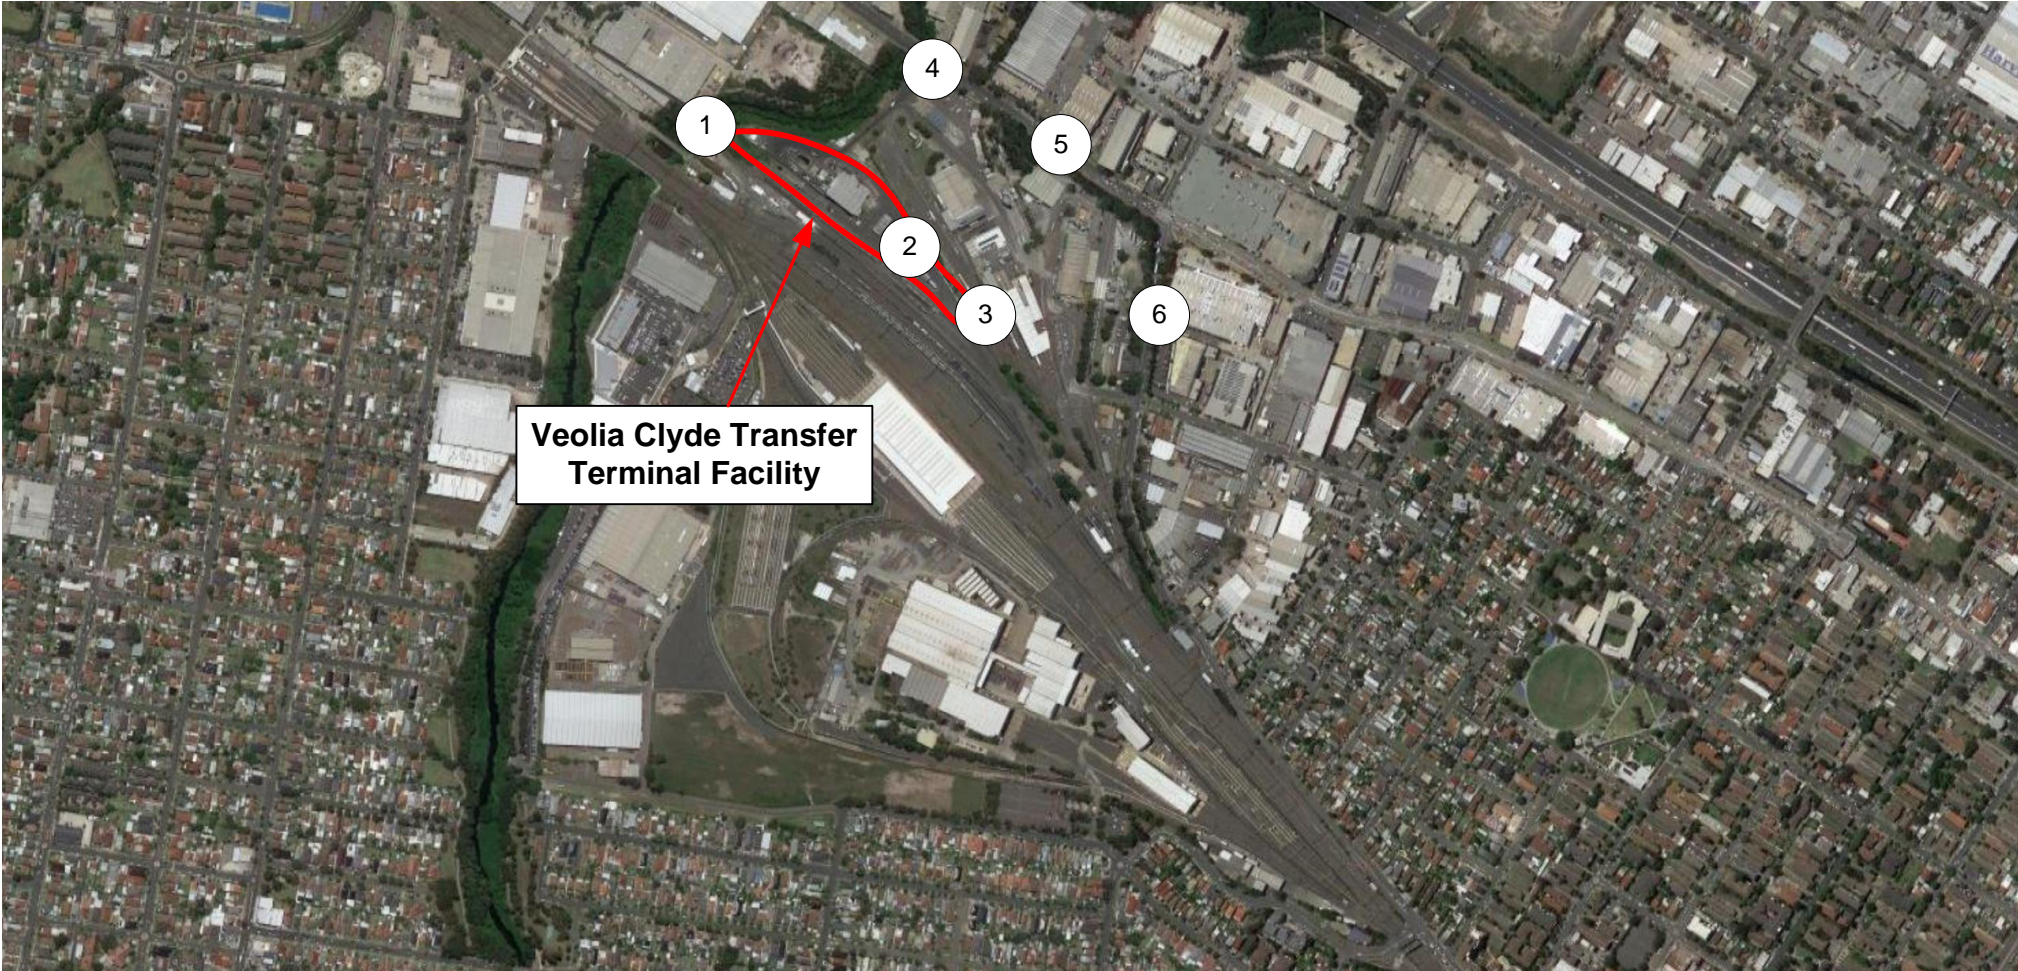
The results of the FAOA survey conducted during the Odour Audit found that whilst intermittent odours were detected on-site, no odours were detectable off-site that could be linked back to the Site and its activities. This is a good outcome and reflects the findings from previous odour audits.

<b>Local wind conditions</b>  Calm to Light, with winds blowing from the north. No rainfall observed.  Refer to <b>FAOA Logsheet N1473L-XXXVIII</b> for details on recorded odour detections
