Annual Environmental Management Report -Clyde Transfer Terminal 2022-2023

Name of operation	Clyde Transfer Terminal
Name of operator	Veolia Environmental Services
Development consent / project approval #	DA 205-08-01
Name of holder of development consent / project approval	Veolia Environmental Services
Mining lease #	NA
Name of holder of mining lease	NA
Water licence #	NA
Name of holder of the water licence	NA
MOP/RMP start date	NA
MOP/RMP end date	NA
Annual Review start date	15th of January 2022
Annual Review end date	14th of January 2023

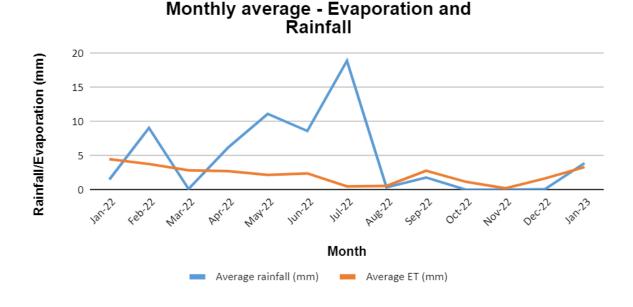
Figure 2.2 - Average Evaporation and Rainfall rates at the Terminal

Note: Some data in October, November and December is missing due to multiple issues affecting the meteorological station during this time period, including failures to the solar regulator, modem and data logger as a result of a suspected lightning strike.

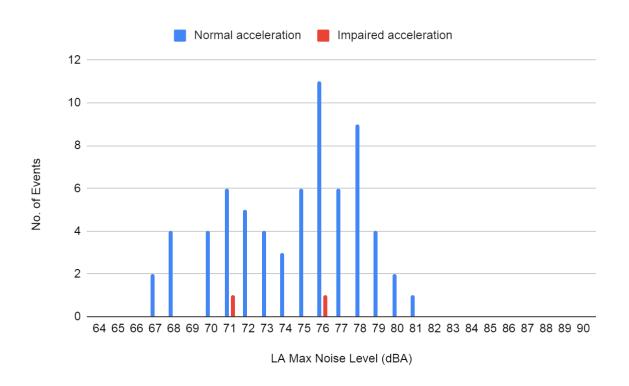
Figure 2.3 -Noise level distribution from Truck Noise Monitoring – 4 October 2022

All trucks monitoring were between 67.2dBA to 81.8dBA, and fell within or below the thresholds of 81dBA to 87dBA for Heavy Goods Vehicles with a GVM > 12 tonne in accordance with the Australian Design Rules (ADR) 28/01.

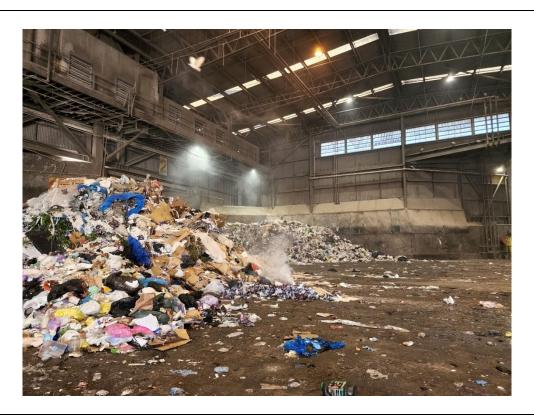
As with previous audits, and consistent with TOU's experience at other waste transfer stations, there was a weak to distinct level of odour observed within the TTB. A photo of the waste on the floor as found during the Odour Audit visit is shown in Photo 2.1.

Photo 2.1 – TTB waste on-floor as found on 8 June 2022 (during a smoke test)

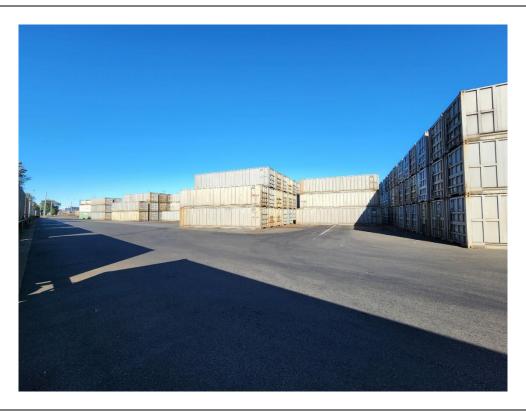
Photo 2.2 – A view of the container area as found on 8 June 2022

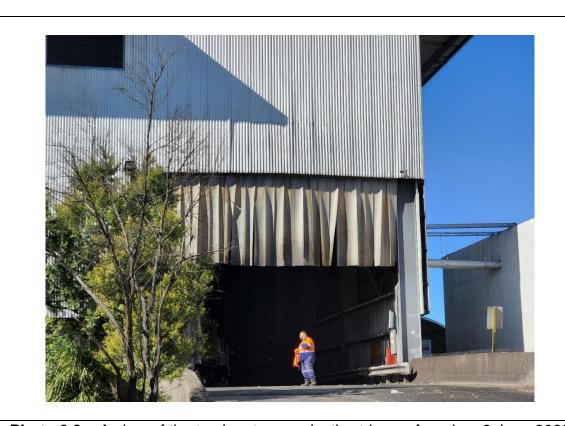
The truck entrance plastic strips of the TTB, used to reduce odour escaping through the opening, were found to be intact and in good condition (refer to **Photo 2.3**).

Photo 2.3 – A view of the truck entrance plastic strips as found on 8 June 2022

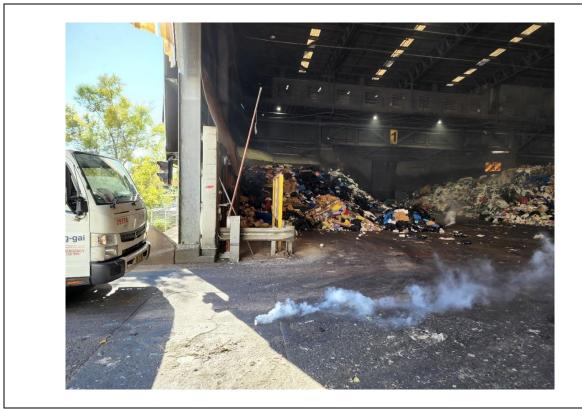
Photo 2.4 – A view of the truck entrance plastic strips during smoke testing on 8 June 2022

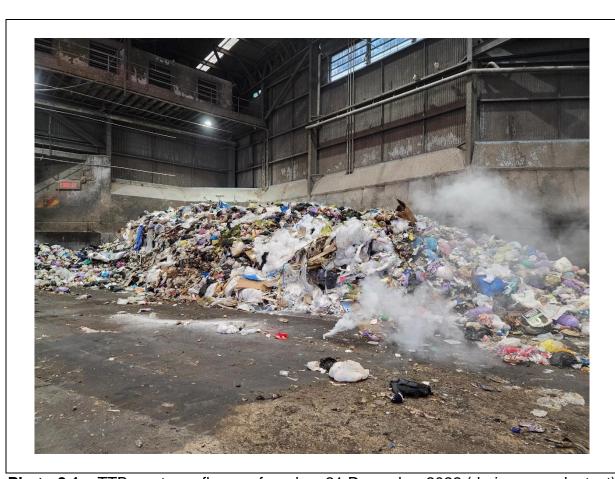
As with previous audits, and consistent with TOU's experience at other waste transfer stations, there was a weak to distinct level of odour observed within the TTB. A photo of the waste on the floor as found during the Odour Audit visit is shown in Photo 2.1.

Photo 2.1 – TTB waste on-floor as found on 21 December 2022 (during a smoke test)

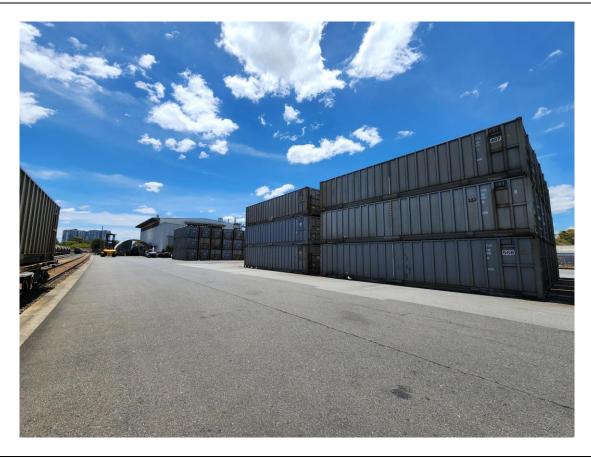
Photo 2.2 – A view of the container area as found on 21 December 2022

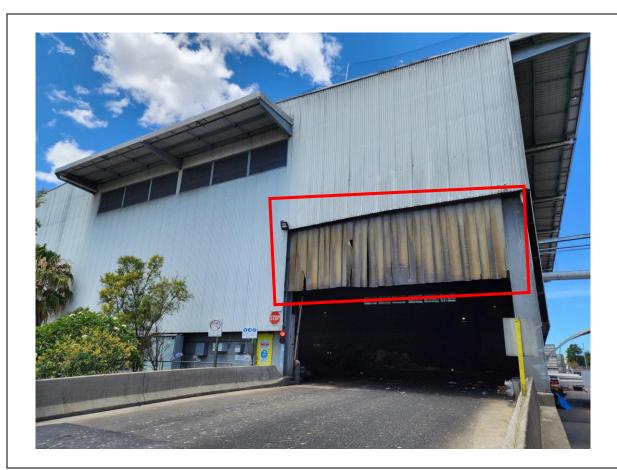
The truck entrance plastic strips of the TTB, used to reduce odour escaping through the opening, were found to be superficially damaged and in a state to function and effectively reduce air movement at the top section of the truck entrance (refer to **Photo 2.3**).

Photo 2.3 – A view of the truck entrance plastic strips as found on 21 December 2022

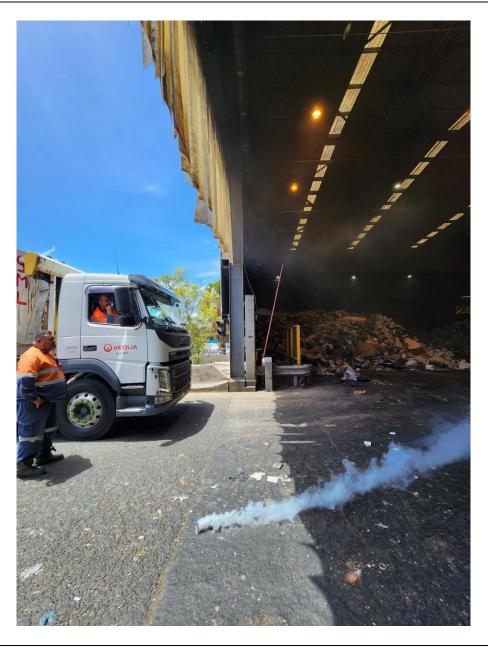
Photo 2.4 – A view of the truck entrance plastic strips during smoke testing on 21 December 2022
