Veolia Environmental Services (Australia) Pty Limited

Clyde Waste Transfer Terminal

Odour Audit XIX

May 2012

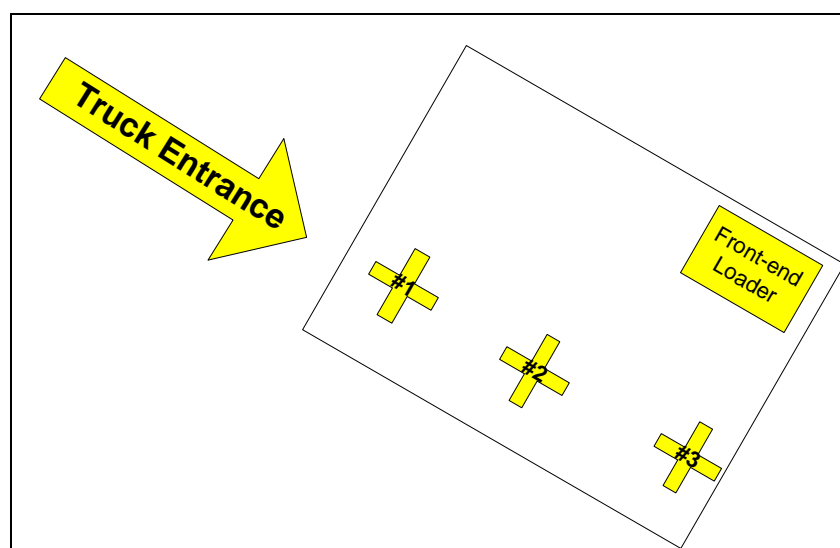
Figure 2.1: Smoke testing release points within the Transfer Building.

Smoke testing was carried out at the truck entrance and the smoke was observed to initially move upwards towards the roof and then towards the extraction fan. There was no observed movement towards the truck entrance.

Smoke released from the second point initially moved upwards in eddies and was gradually drawn into the extraction system.

Smoke released at this point initially rose gradually before being drawn upwards to the extraction system.

The overall finding of the smoke testing was that the extraction system was effective in maintaining the stack as the main emission point of air from the building, with no evidence of any fugitive odour releases.

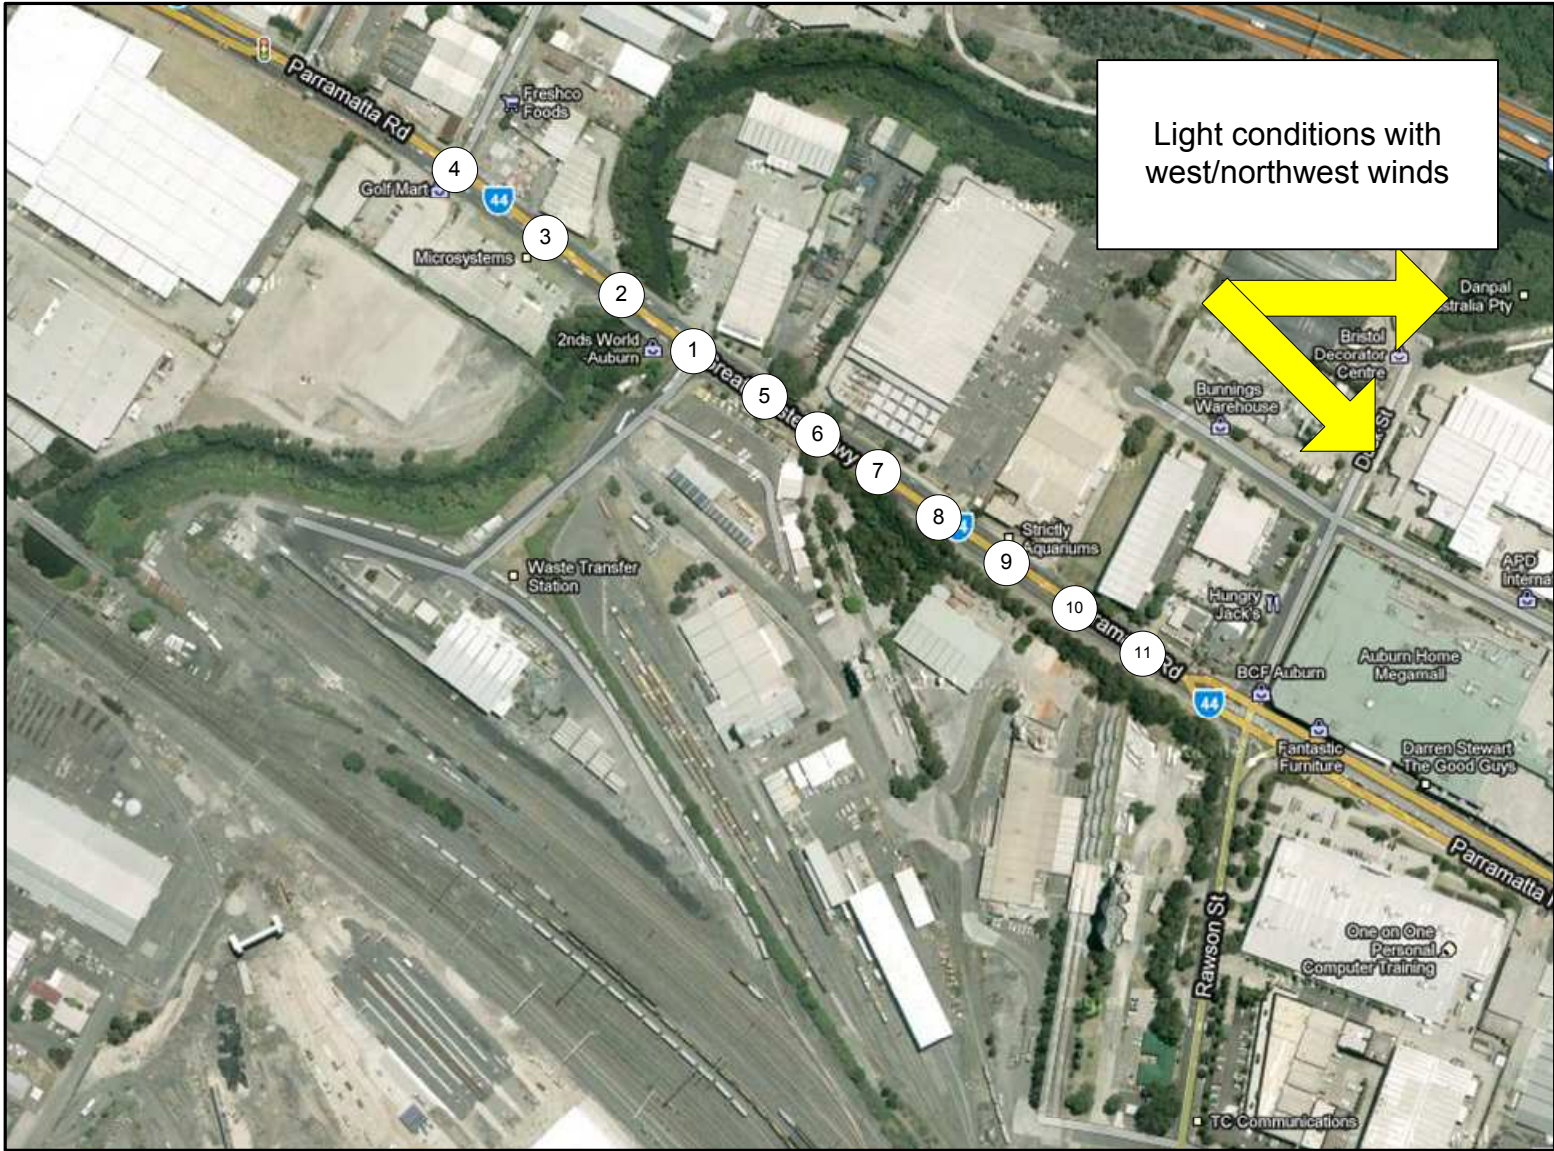
Veolia Environmental Services Clyde Transfer Terminal, Clyde NSW Field Ambient Odour Assessment Survey Date: 09/05/2012 Time: 1122-1154

The results from the FAOA survey conducted during this Audit found that no odours were detected offsite that could be linked back to the Transfer Station. The field log sheets and odour impact map are attached as **Appendix C**.
