VEOLIA (AUSTRALIA) PTY LTD

Clyde Waste Transfer Terminal

Odour Audit XXXVII

June 2021

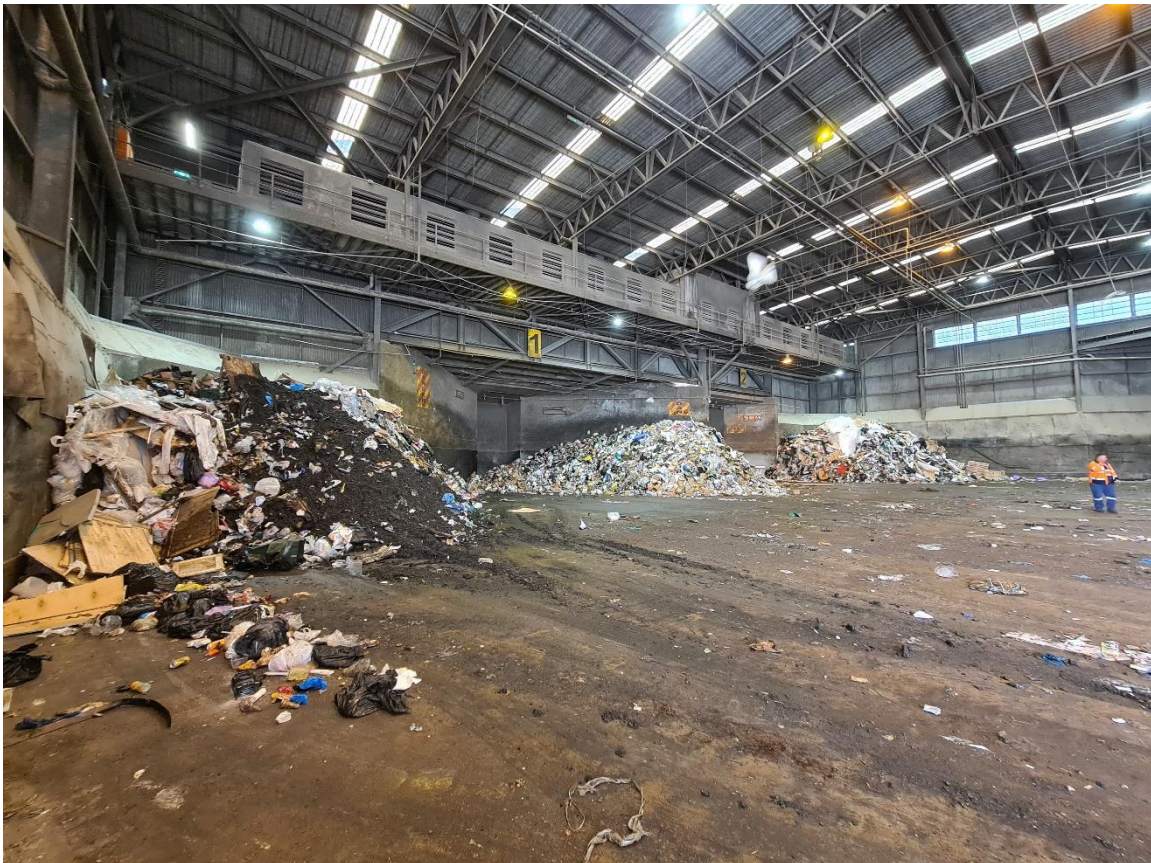
During the Odour Audit visit, there were approximately 120-150 tonnes of waste on the floor. This tonnage is considered to be within the normal operating range of the Transfer Terminal Building (TTB). The TTB floor area not covered by waste material was observed to be reasonably clean, with little evidence of leachate or aged material. General housekeeping procedures of the TTB were good, as found during several truck-unloading sequences. It was also observed that the TTB's front-end loaders cleared the floor area of waste on a regular basis, minimising the exposed area of waste.

As with previous audits, and consistent with TOU's experience at other waste transfer stations, there was a weak to distinct level of odour observed within the TTB. A photo of the waste on the floor as found during the Odour Audit visit is shown in Photo 2.1.

Photo 2.1 – TTB waste on-floor as found on 13 May 2021

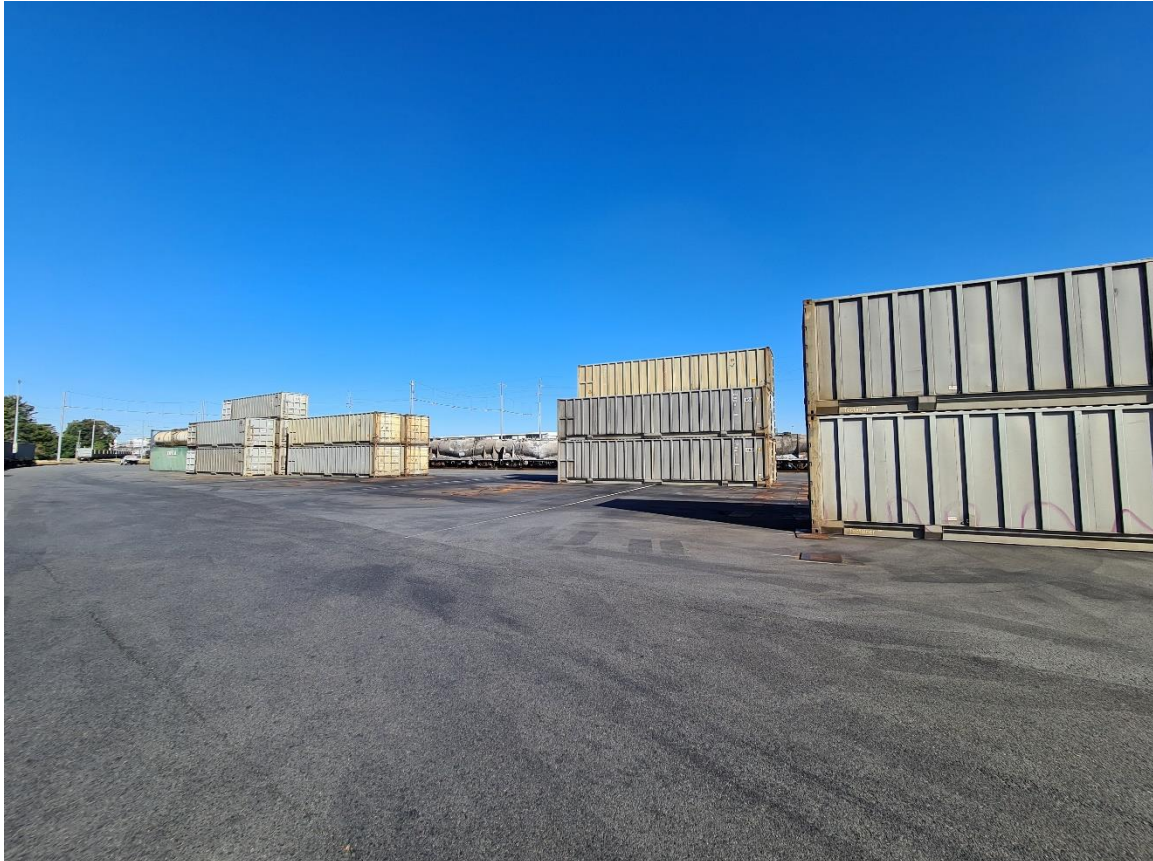
The container packing area and site roadways were found to be clean and well managed with no evidence of waste or exposed leachate. Like previous odour audits, the container compacting/train packing area had a weak to distinct odour that was intermittently detectable but was confined to this area only (see **Appendix B** for Field Ambient Odour Assessment Survey results). TOU was advised by a Veolia personnel that one of the two compactors were in operation at the time of the Odour Audit visit. The general housekeeping around this area was observed to be of high quality, with no evidence to suggest otherwise.

Photo 2.2 – A view of the container area as found on 13 May 2021

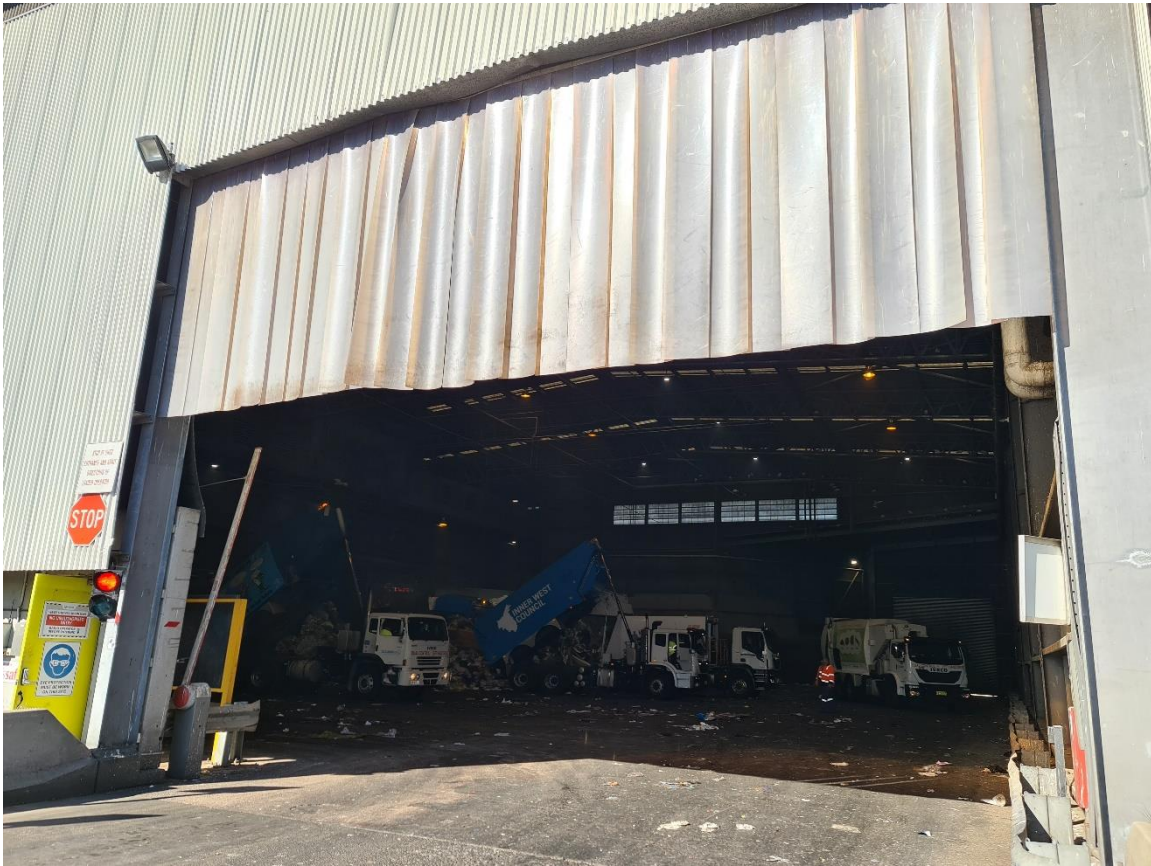
The truck entrance plastic strips of the TTB, used to reduce odour escaping through the opening, were found to be intact and in good condition (refer to **Photo 2.3**).

Photo 2.3 – A view of the truck entrance plastic strips as found on 13 May 2021

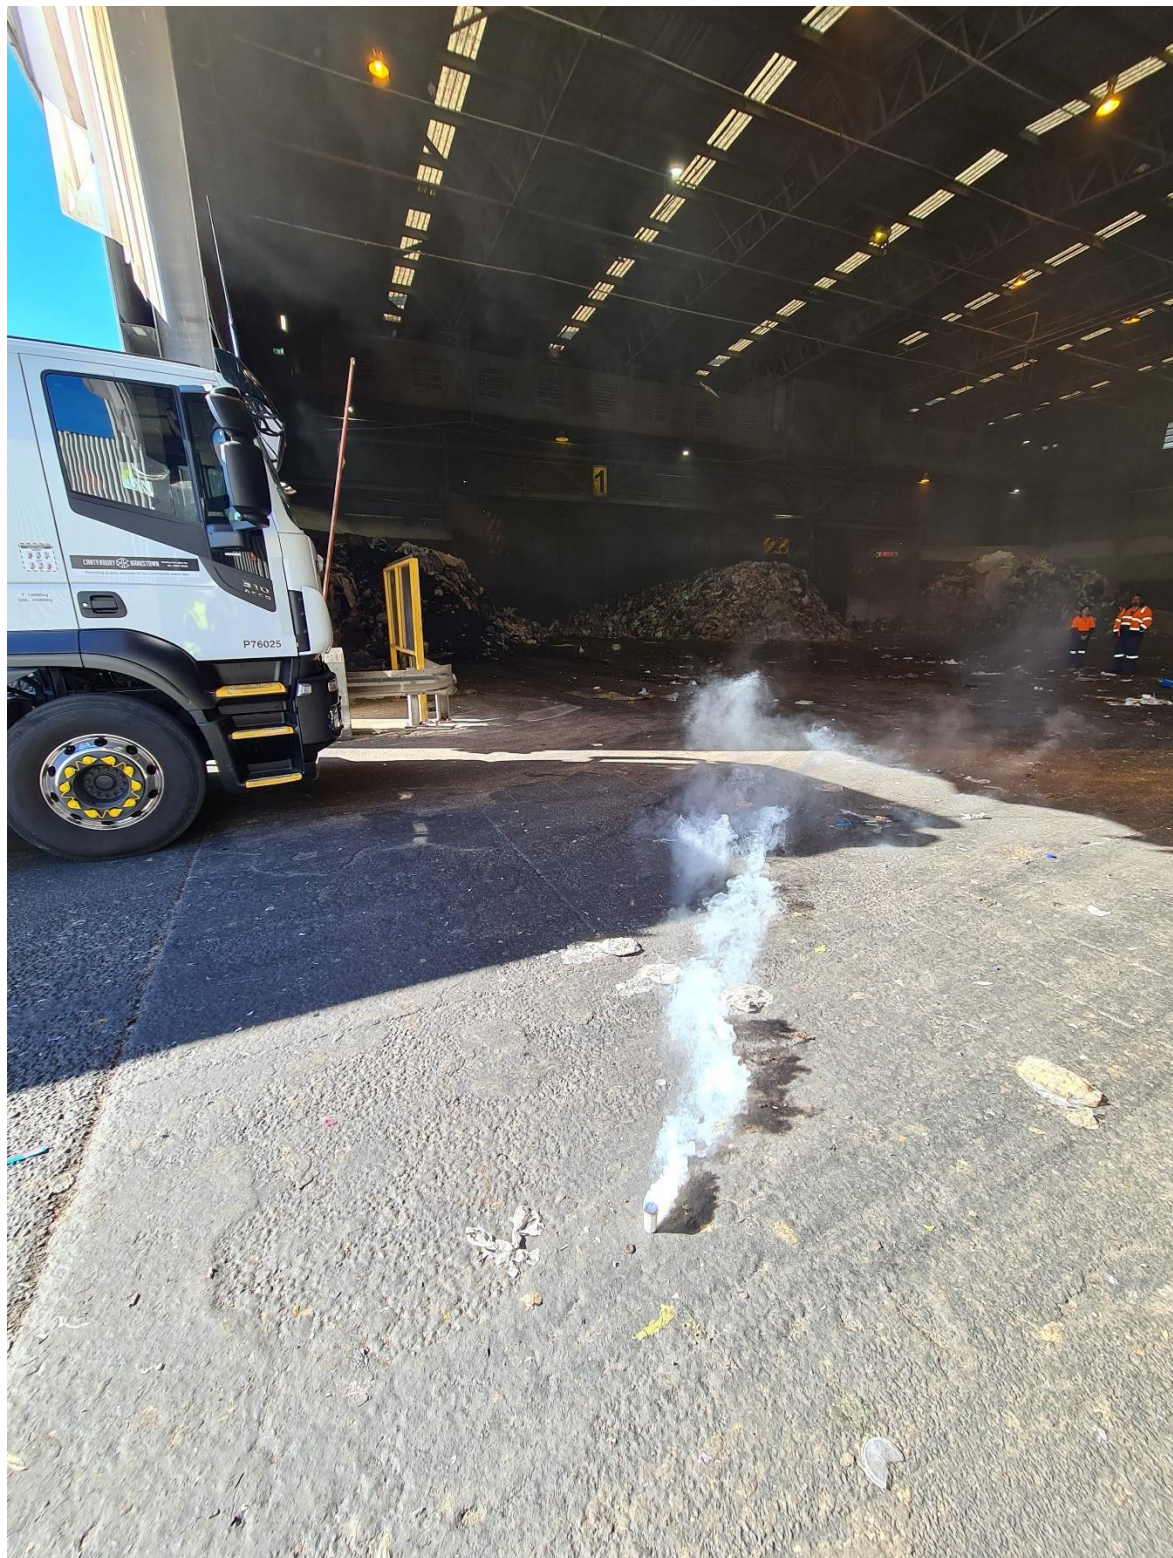
Photo 2.4 – A view of the truck entrance plastic strips during smoke testing on 13 May 2021

The smoke released at this point initially rose gradually moving towards the truck entrance before rising to the roof and moving slowly towards the extraction system. Visible smoke extraction at the overhead capture points was evident during the smoke testing at this point. Any smoke that continued towards the truck entrance was drawn back into the building (see shown in **Photo 2.4**).

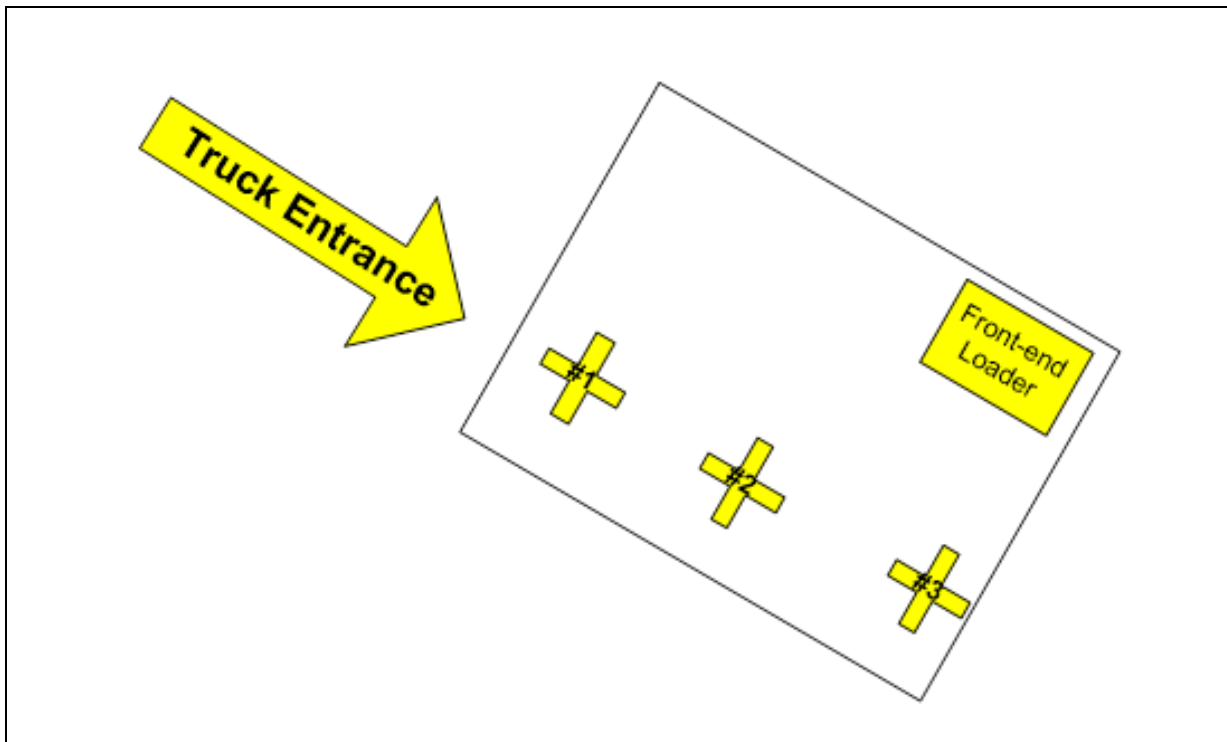
Figure 2.1 – Smoke testing release points within the TTB on 13 May 2021

The smoke released at this point revealed a similar result to that documented for smoke testing point #1.

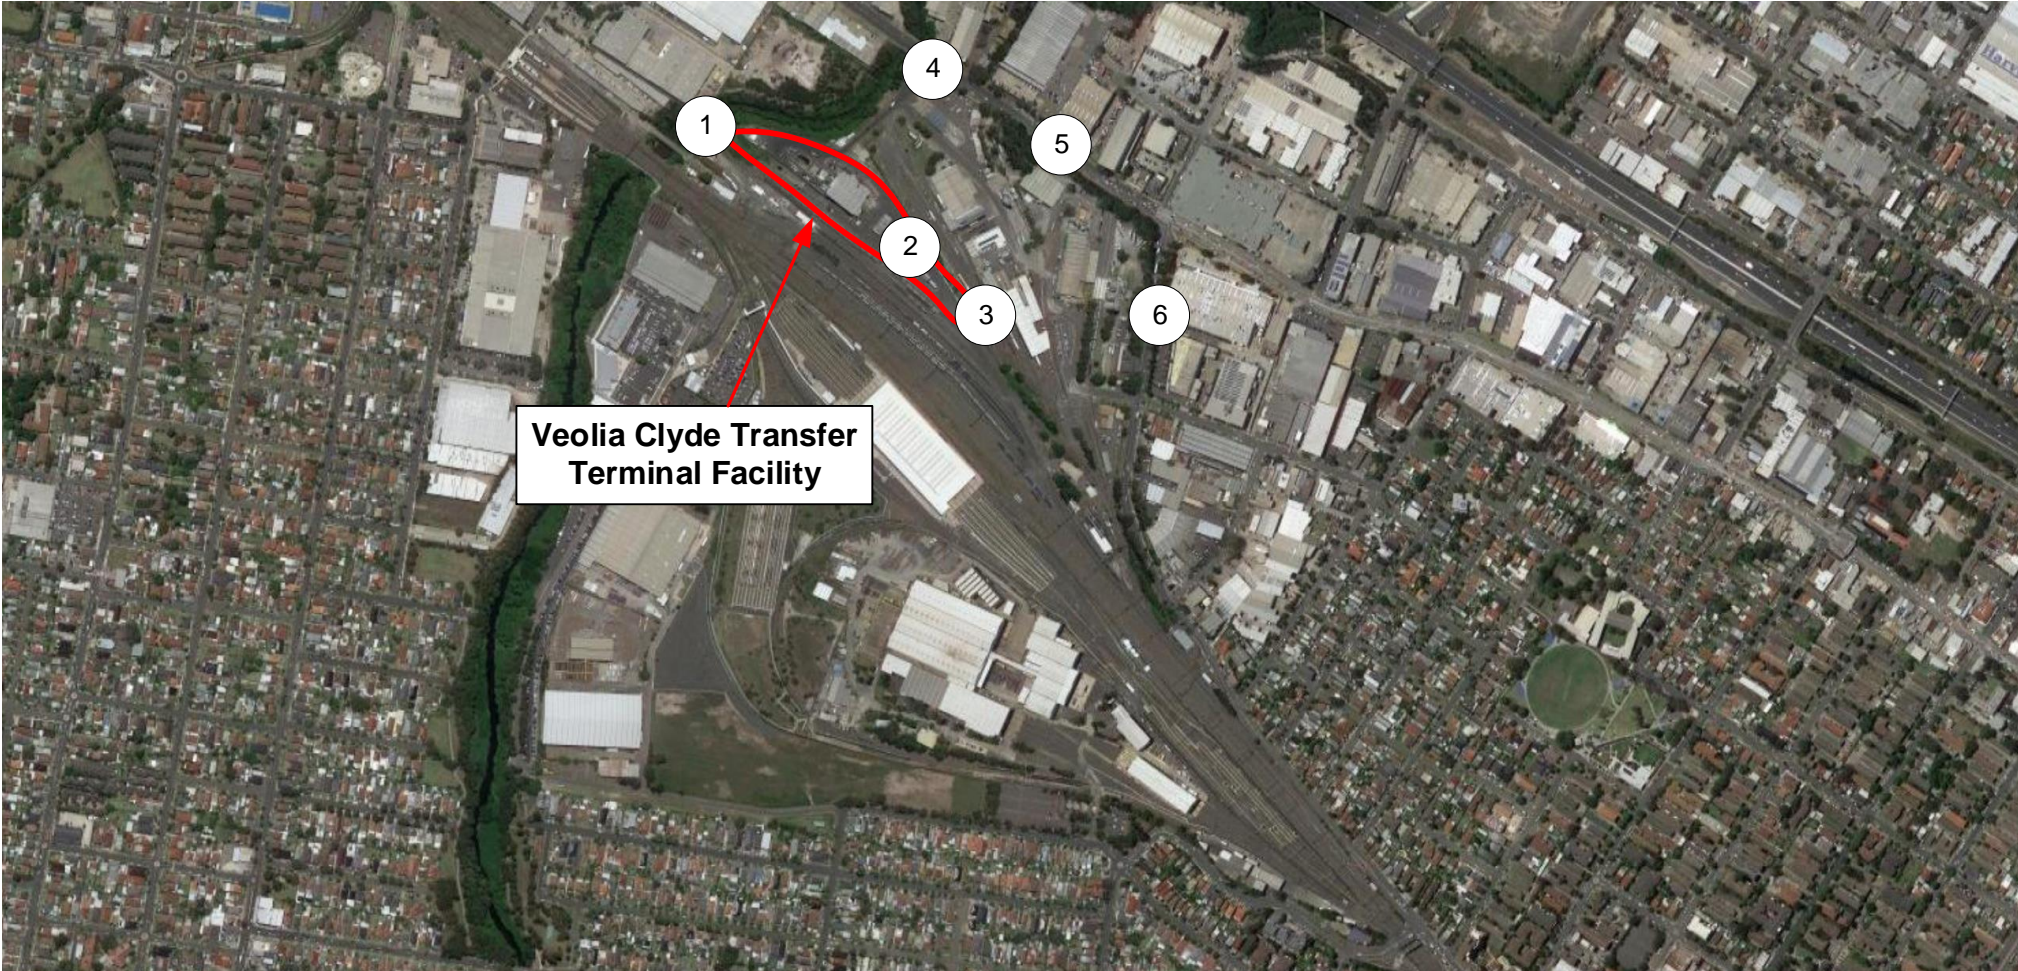
The results of the FAOA survey conducted during the Odour Audit found that whilst intermittent odours were detected on-site, no odours were detectable off-site that could be linked back to the Site and its activities. This is a good outcome and reflects the findings from previous odour audits.

Local wind conditions Calm to light (0 – 0.5 m/s), with winds blowing from the north. No rainfall observed. Refer to FAOA Logsheet N1473L-XXXVII for details on recorded odour detections
