HEGGIES

REPORT 10-6815-R2

**Clyde Waste Transfer Facility
Second Quarterly Truck Noise Monitoring
Truck Noise Measurement Report**

**Veolia Environmental Services
Cnr Unwin & Shirley Street
ROSEHILL NSW 2142**

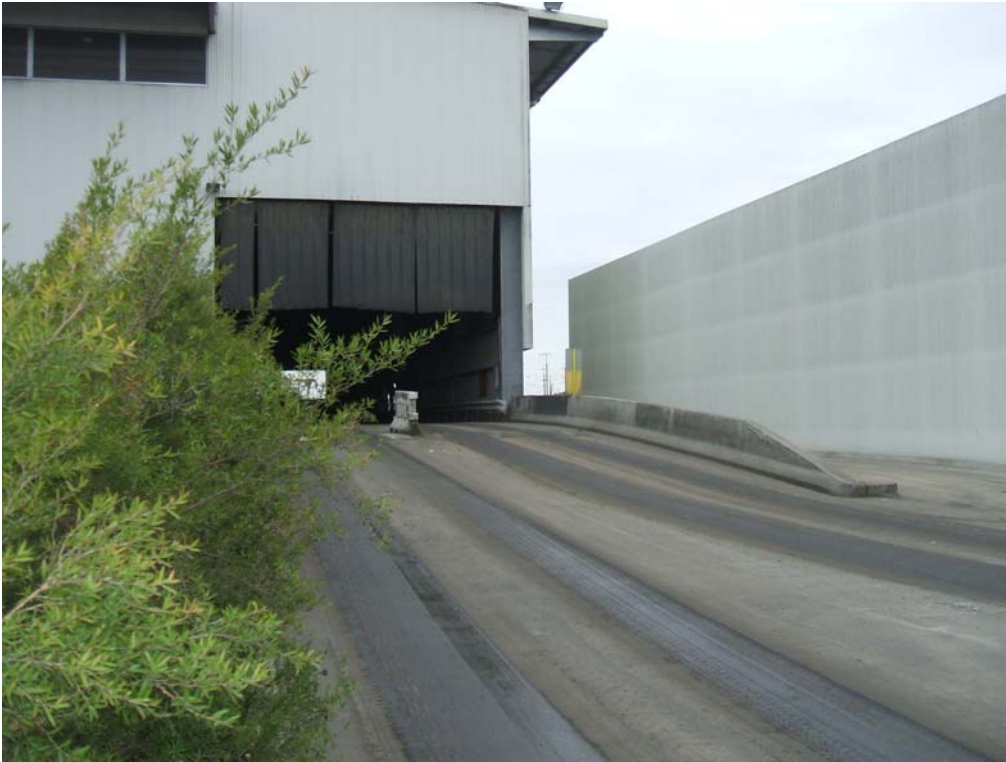
Figure 3 Uphill Incline to Transfer Building

Vehicles were observed to be accelerating up the incline at the measurement location to enable them to enter the transfer building. Only the measurement results from vehicles that had reasonably high throttle levels during the passby were considered to be acceptable.

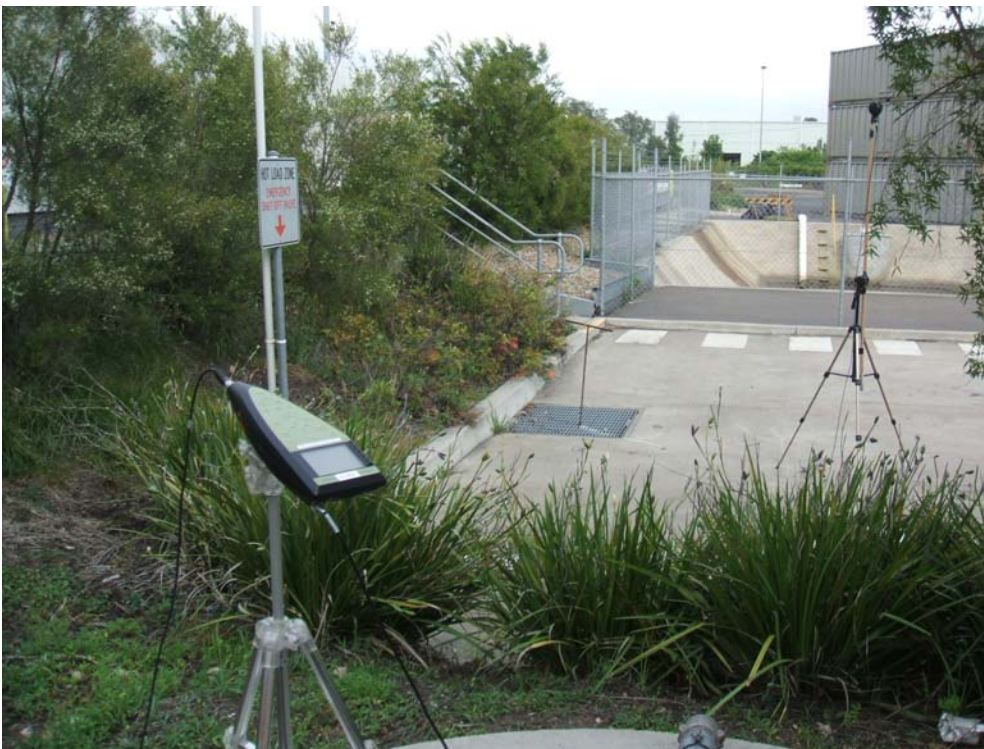
Figure 4 Operating Position away from Plane View

- A 10 m microphone extension lead was used to enable the sound level meter to be operated from a hidden location surrounded by high growing plants to ensure that normal driving behaviour was not influenced by someone standing in full view (see **Figure 4**).

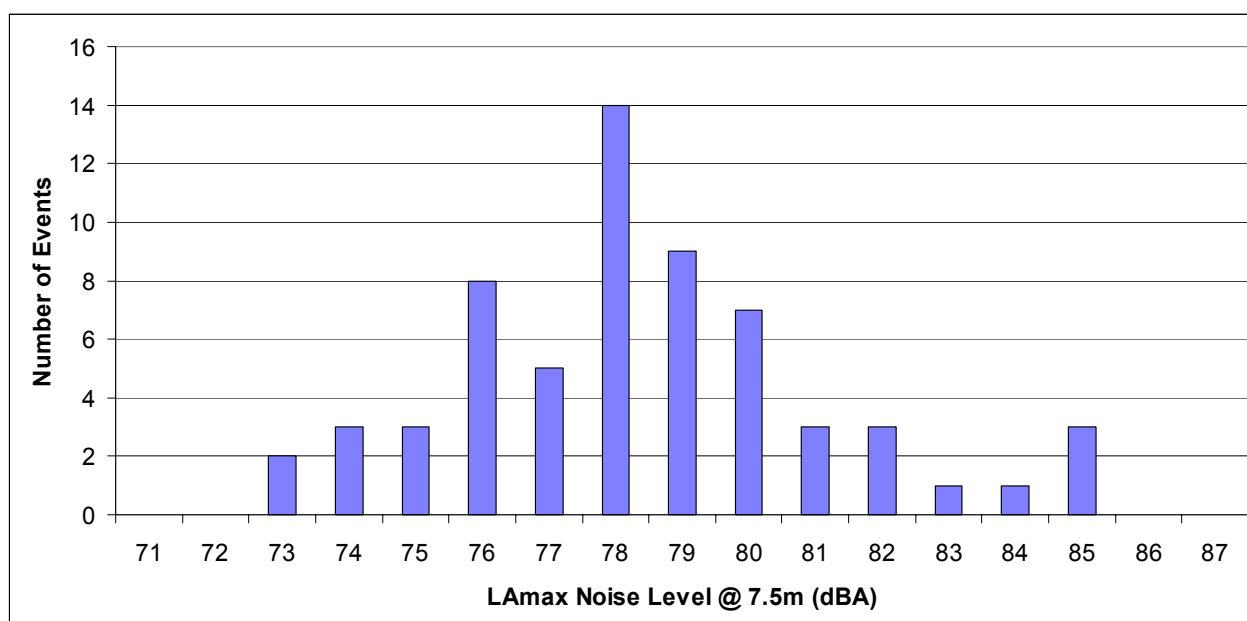
Figure 5 Noise Measurements on 13 January 2009 for Trucks Entering the Waste Transfer Facility

Figure 5 presents a plot of the acceptable monitoring results on a noise level distribution chart. The chart illustrates that the highest L_{Amax} noise levels recorded for the day was 85 dBA with three occurrences. The majority of the vehicles had L_{Amax} noise levels between 76 dBA and 80 dBA.

The results of the days' measurements indicated that the vehicles monitored were within the noise limits outlined in ADR 28/01. However, attention should be paid to the vehicles with a measured L_{Amax} above 84 dBA to ensure that a maintenance plan is in place in order to avoid future exceedances.

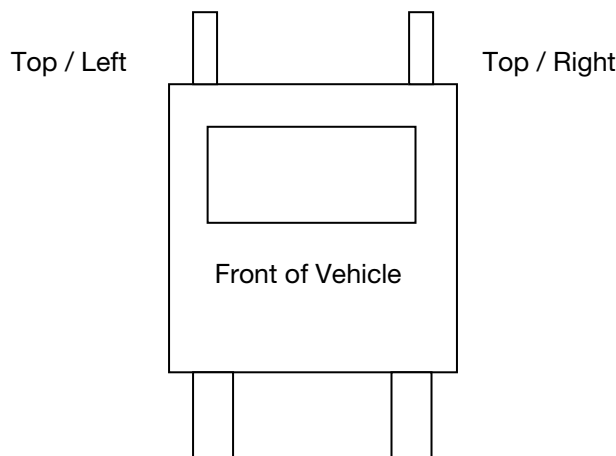
Diagram of Exhaust Location

It was observed on the day of measurement that, for the majority of vehicles, the exhausts were situated at heights above 1,500 mm.
