# Annual Report

Assessment of Environmental Performance - Woodlawn Bioreactor and Crisps Creek Intermodal Facility

November 2018

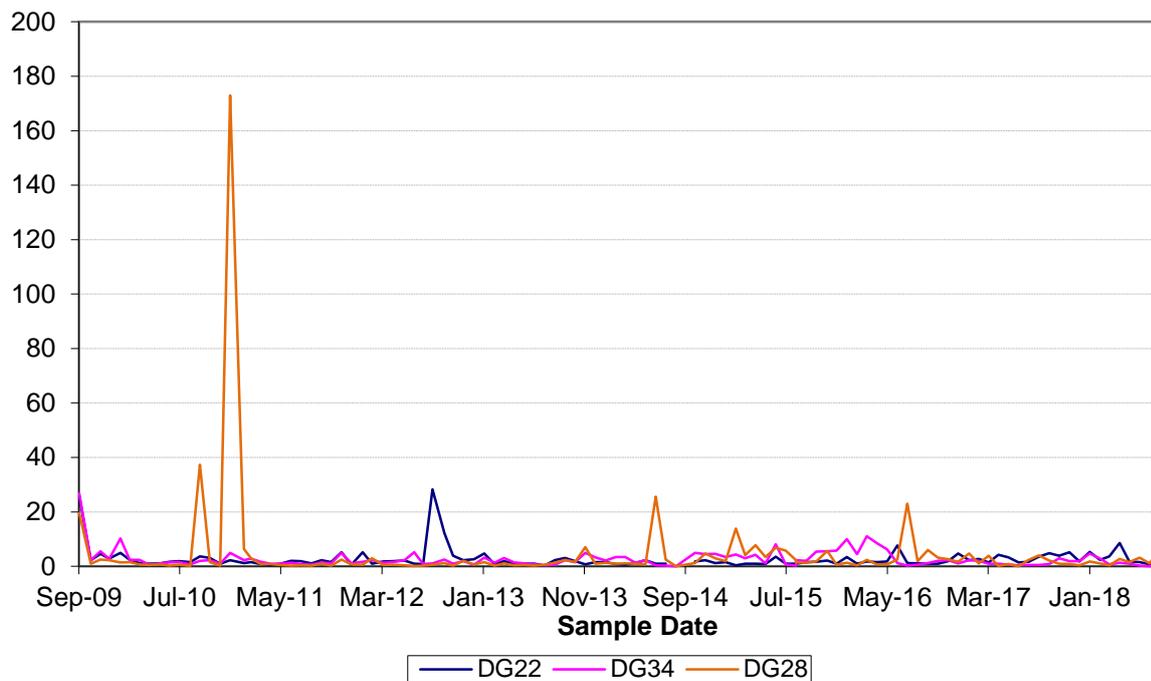
**Figure 3.2.2.1 – Bioreactor Depositional Dust Levels (g/m<sup>2</sup>/month)**

The maximum dust level recorded in this reporting period was 8.6 g/m2/month at DG22 in April 2018 which is located on the East side of the Bioreactor. Given that for the corresponding month there were no similar levels recorded at the dust gauges located within the proximity of the landfill void, it can be inferred that this dust emission was not as a result of the Bioreactor activities and can be treated as an outlier. Veolia infer that this result is due to Heron Resources' construction activities directly next to DG22.

Parameter	Results/Discussion
<b>Particulates/Dust Monitoring</b>	Monitoring of 3 depositional dust gauges (DG) was completed on a monthly basis as required under the EPL, the results of which are generally consistent with previously reporting periods as depicted in <b>Figure 3.2.2.1</b> .

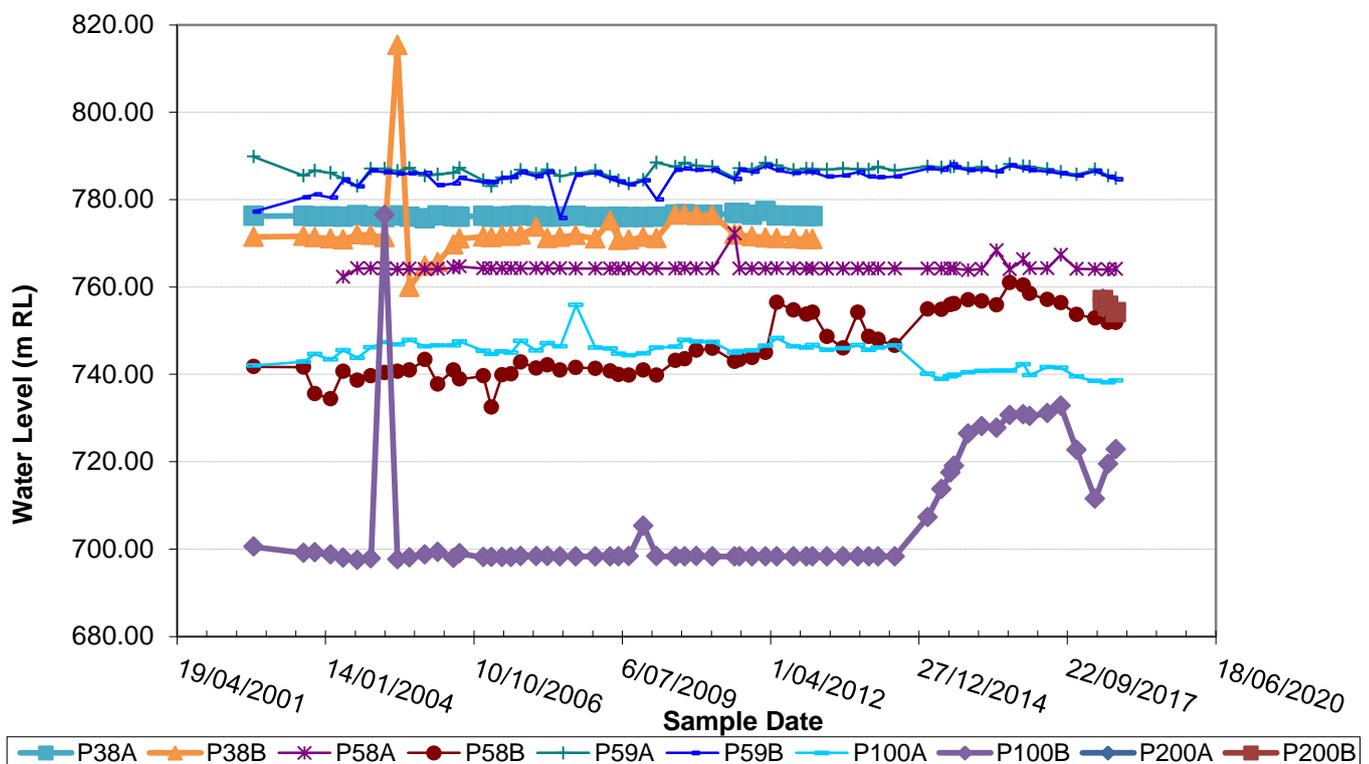
Figure 3.2.6.1 – Piezometer Standing Water Levels – P38 to P200

Parameter	Results/Discussion
	SWL in P59B (deep) ranged between 784.58 m RL and 786.48 m RL, consistent with previous reporting period.
<b>P100A &amp; P100B</b>	<p>P100 is located northeast of the void. Standing water levels are presented in <b>Table 8.5</b> (refer <b>Appendix 4</b>).</p> <p>SWL in P100A (shallow) is consistent with the previous reporting period averaging between 738.10 m RL to 739.46 m RL.</p> <p>P100B (deep) averaged between 711.49 m RL and 722.84 m RL which indicates water above the base level of 698.29 m RL which has been recorded in previous periods.</p> <p>This increase is likely due to the compaction of landfill waste at higher levels within the void preventing water ingress.</p>

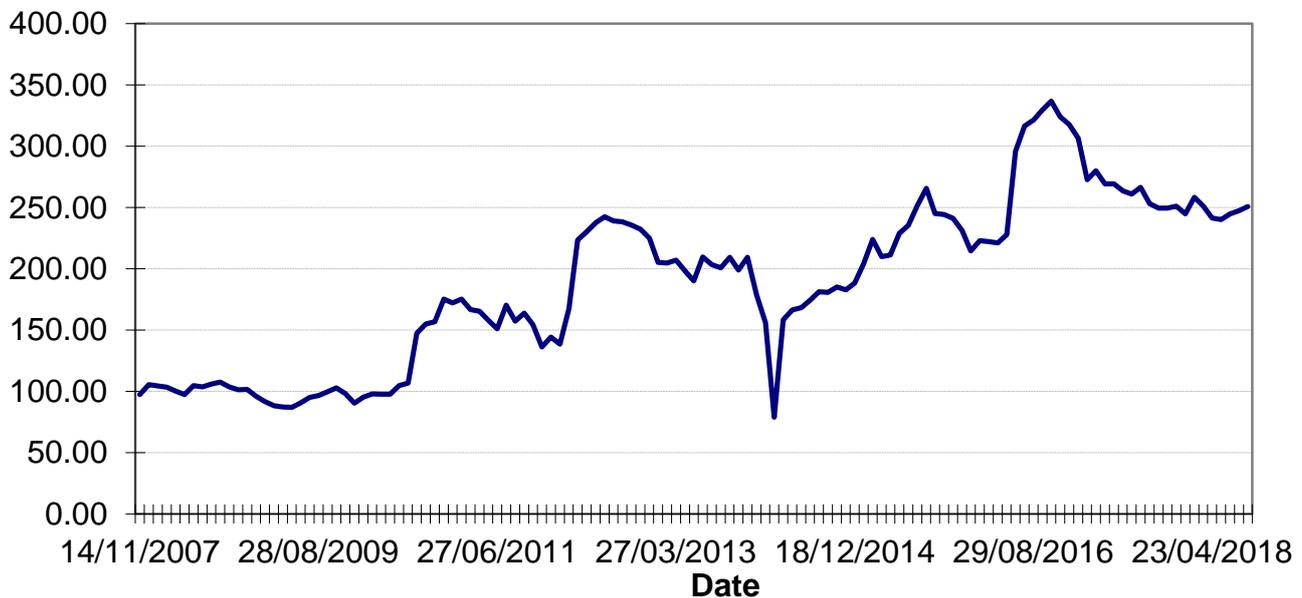
**Figure 3.2.7.1 - Evaporation Dam 3 Volume (Megalitres)**

The Evaporation Dam 3 (ED3) system comprises extracted (and treated) leachate from the landfill void and captured stormwater. The water volume has to be maintained in all Evaporation Dam 3 (Lagoon systems) below the freeboard level as all times.

Water levels are taken monthly as detailed in **Table 3.2.7**, which shows that the dam levels

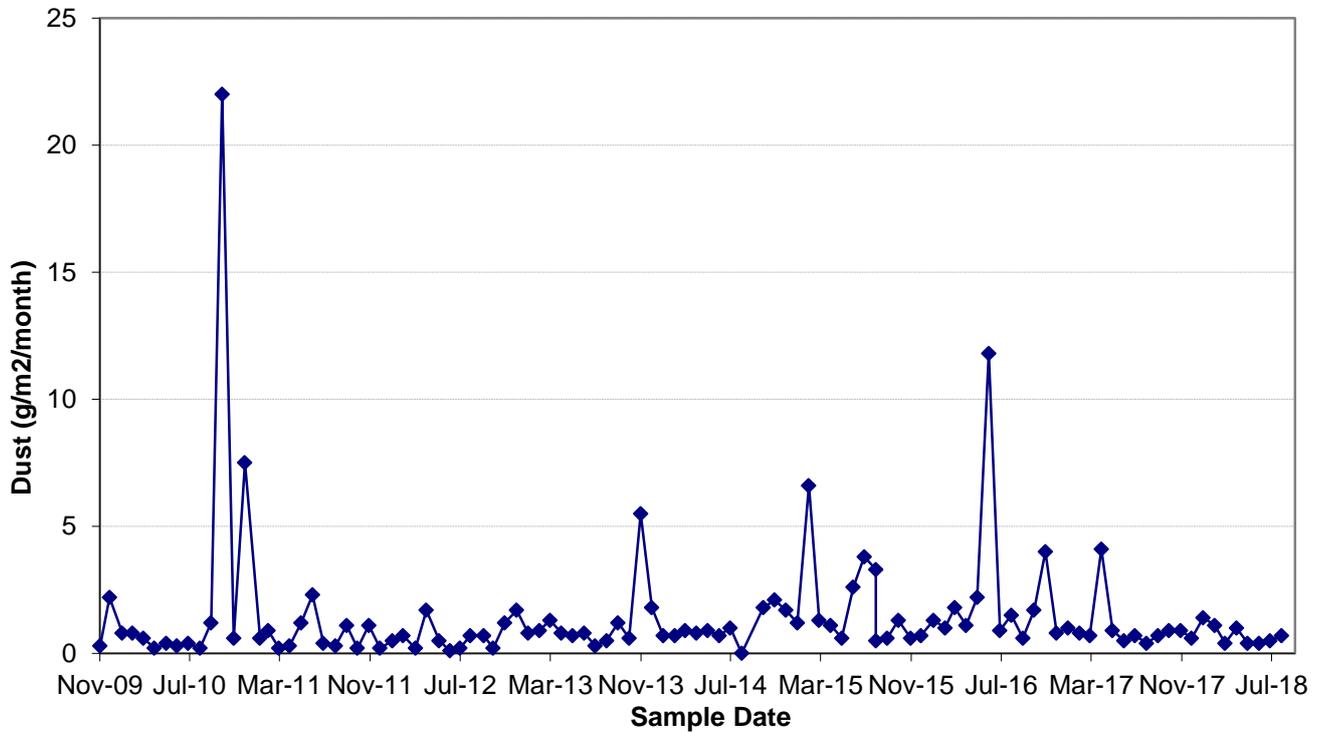
Figure 5.2.2.1 – IMF Depositional Dust Levels – DG18

Dust Gauge	Summary Total Insoluble Solids (g/m <sup>2</sup> /month)		
	Minimum	Maximum	Average
DG18	0.4	1.4	0.75
