Annual Environmental Management Report - Clyde Transfer Terminal 2019

**NSW Resource Recovery Annual Environmental
Management Report - Clyde Transfer Terminal**

Issue Date 13/03/2020

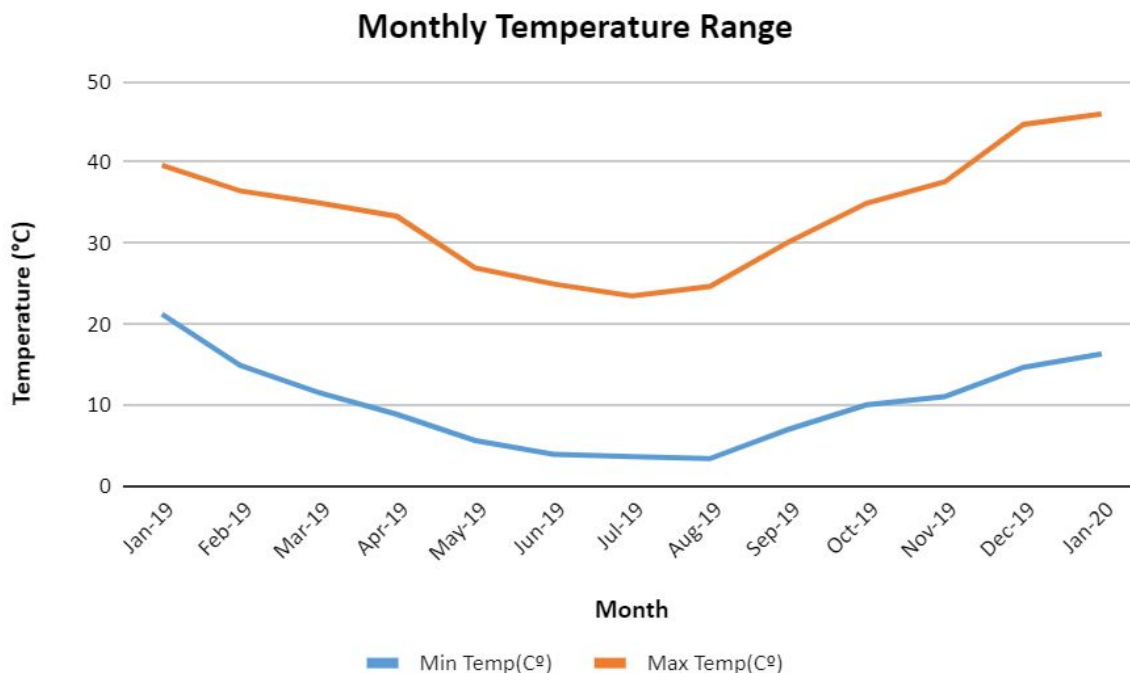
Figure 2.1 - Average Monthly Temperature rates at the Terminal

A summary of monthly rainfall and evaporation rates, as well as minimum and maximum monthly temperatures at the Terminal during this reporting period is presented below in **Figures 2.1** and **2.2** respectively.

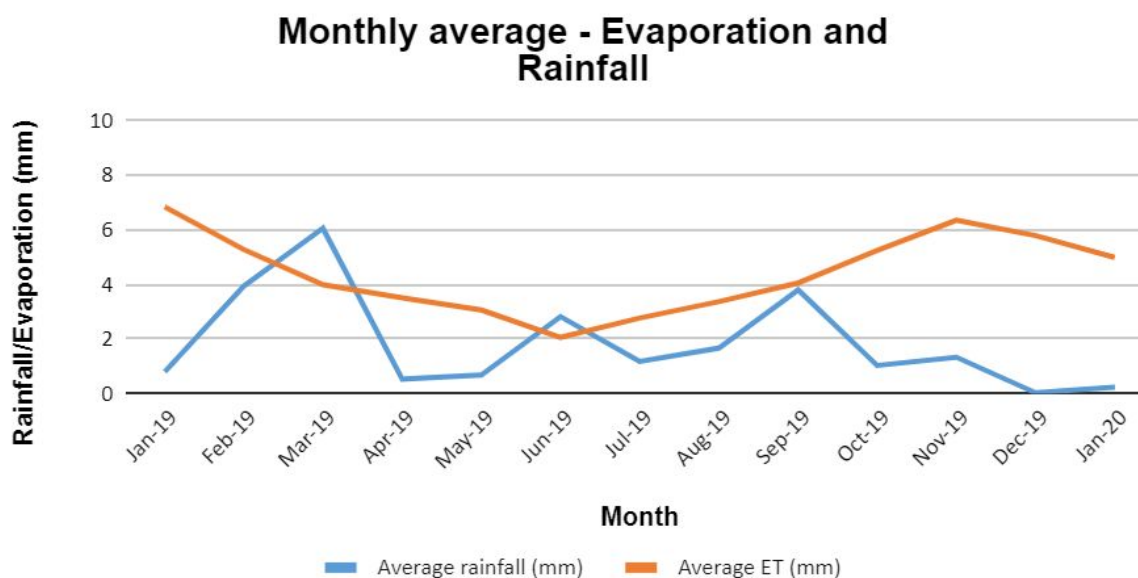
Figure 2.2 - Average Evaporation and Rainfall rates at the Terminal

Overall, the average rainfall for the Terminal during this reporting period was recorded at 54.58mm per month.

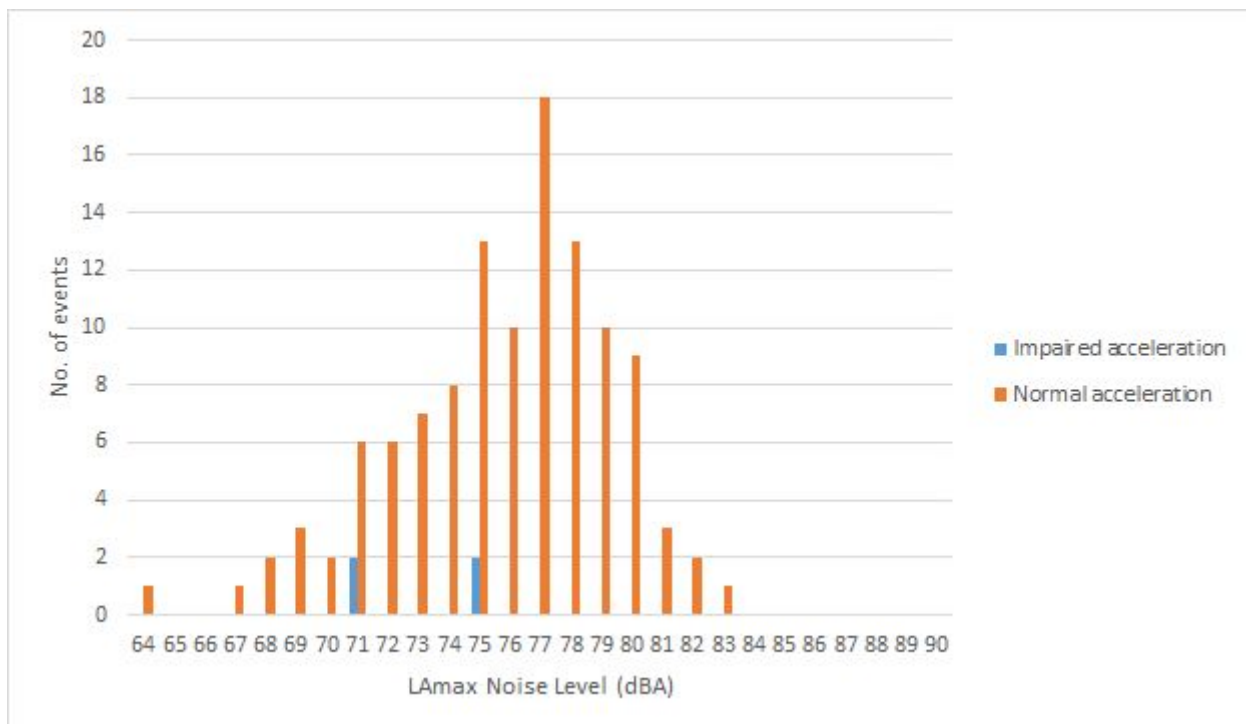
Figure 2.3 -Noise level distribution from Truck Noise Monitoring – 22 October 2019

One round of truck noise monitoring was undertaken on the 22nd of October 2019 in accordance with Consent Condition 112 for this reporting period. Noise levels of 119 truck movements out of a daily total of 307 truck movements were measured, equivalent to 38.76% of truck movements. A summary of the results is illustrated in **Figure 2.3**. Further details regarding truck movements at the site is discussed in **Section 2.4.1**.

All trucks monitoring were between 64dBA to 83dBA, and fell within or below the thresholds of 81dBA to 87dBA for Heavy Goods Vehicles with a GVM > 12 tonne in accordance with the Australian Design Rules (ADR) 28/01

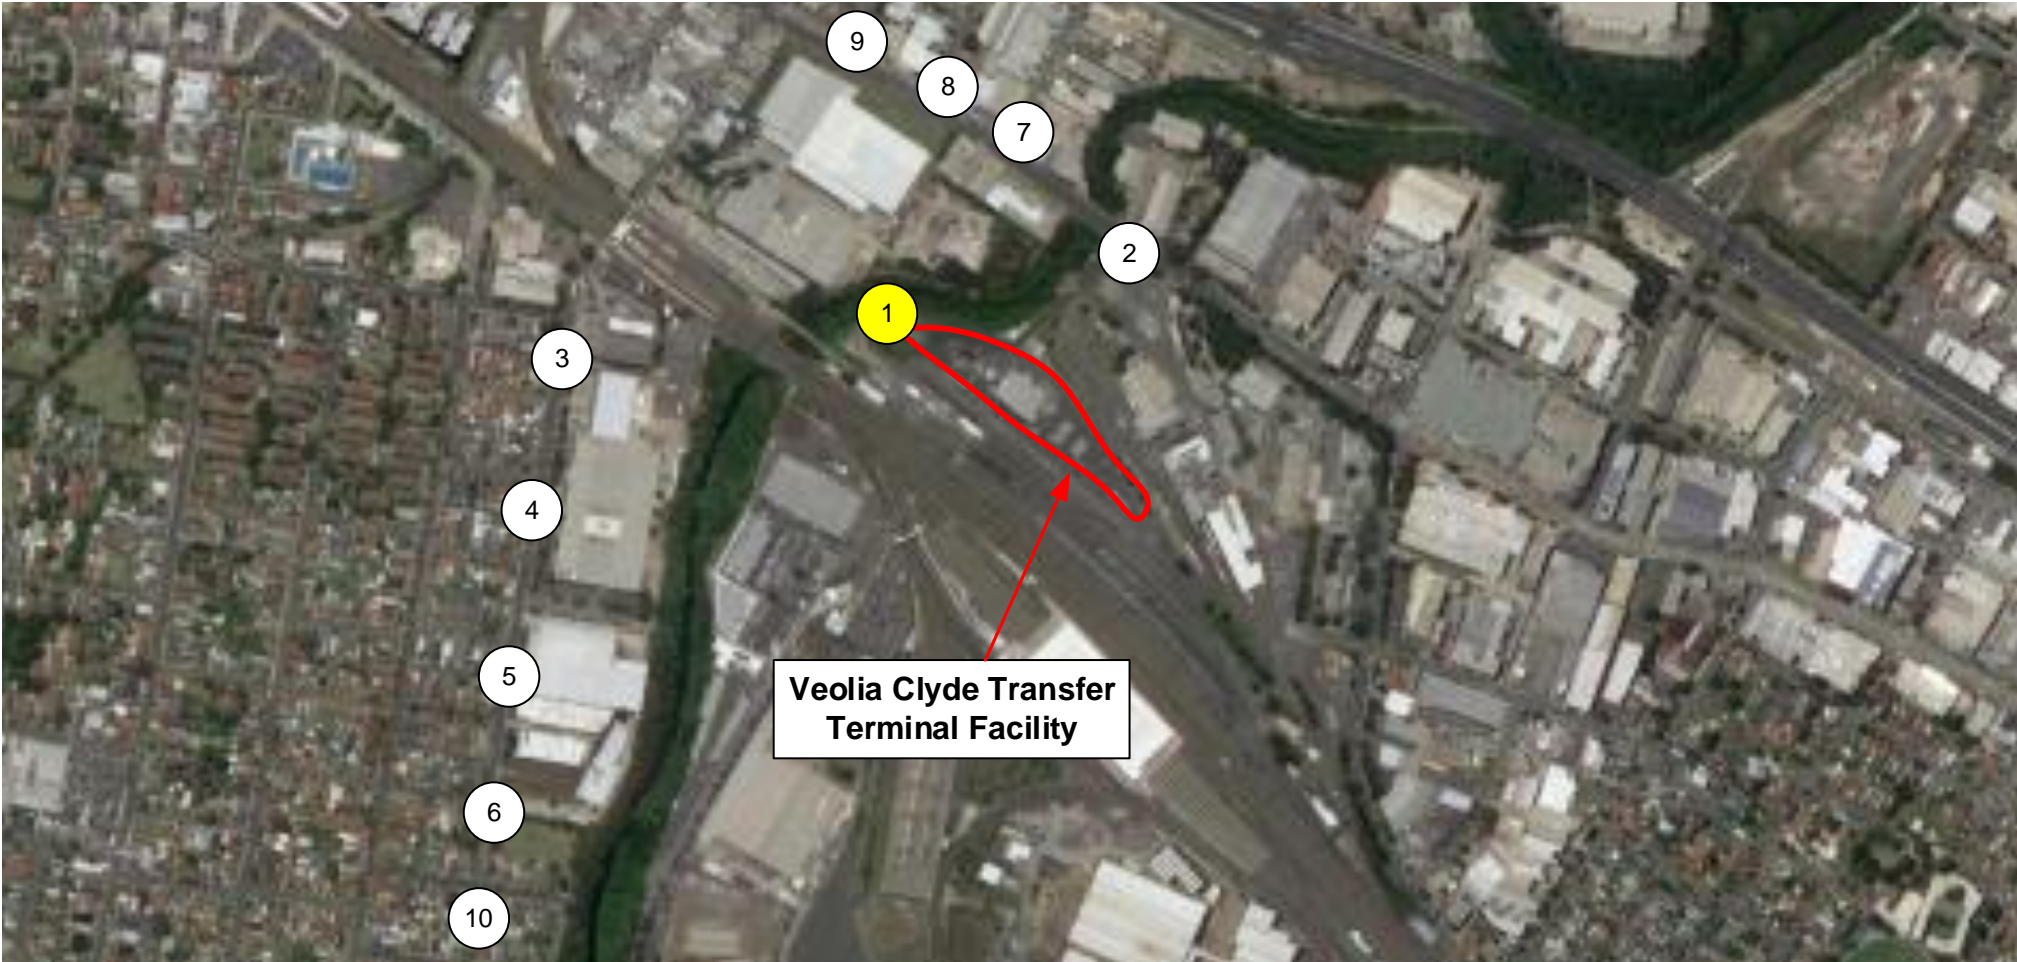
APPENDIX C –
FIELD AMBIENT ODOUR ASSESSMENT PLOT
AND FIELD LOG SHEETS
(27 NOVEMBER 2019)

DESCRIPTION Field Ambient Odour Assessment Survey Modified German Standard VDI 3940		LEGEND German Intensity Scale VDI3882 ○ 0 Not detectable ● 1 Very weak ● 2 Weak ● 3 Distinct ● 4 Strong ● 5 Very strong ● 6 Extremely strong

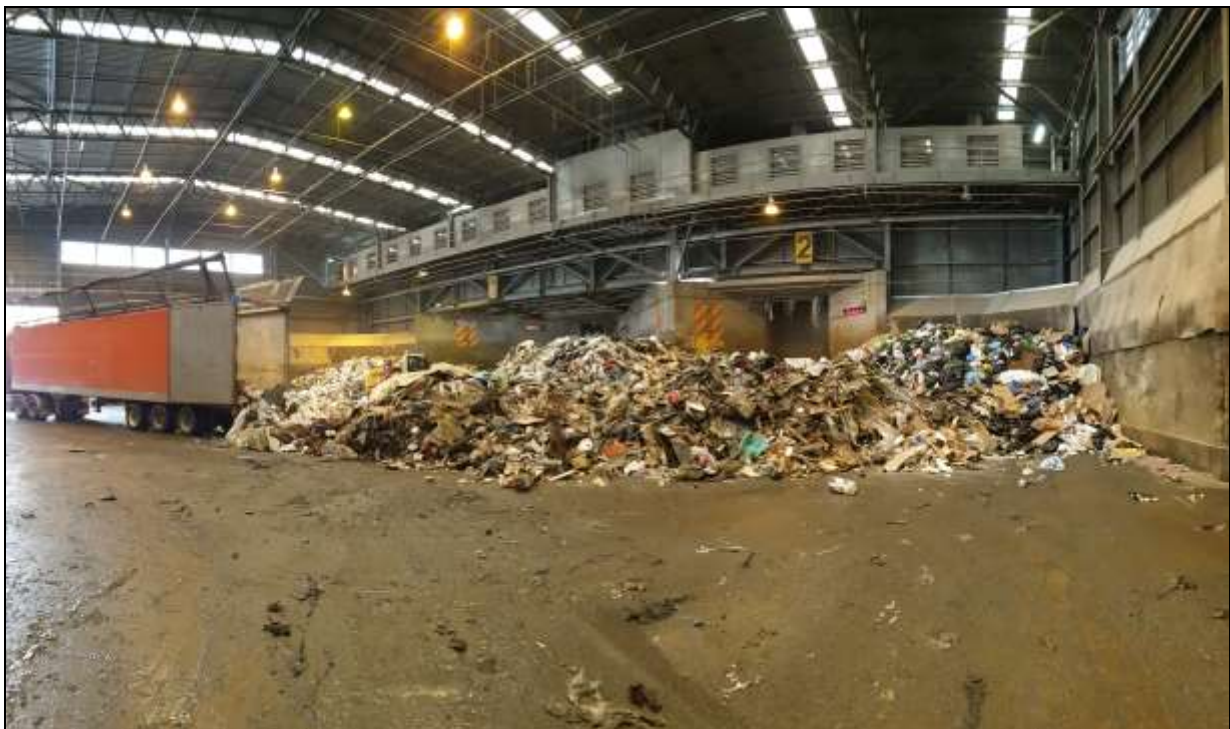
Photo 2.1 – Waste on-floor as seen on 23 May 2019

During the Odour Audit visit, there were approximately 350 to 450 tonnes of waste on the floor. This tonnage is considered to be within the normal operating range of the Transfer Terminal Building (TTB). The TTB floor area not covered by waste material was observed to be reasonably clean, with little evidence of leachate or aged material. General housekeeping procedures of the TTB were good, as found during several truck-unloading sequences. It was also observed that the TTB's front-end loaders cleared the floor area of waste on a regular basis, minimising the exposed area of waste.

As with previous audits, and consistent with TOU's experience at other waste transfer stations, there was a weak to distinct level of odour observed within the TTB. A photo of the waste on the floor as found during the Odour Audit visit is shown in **Photo 2.1**.

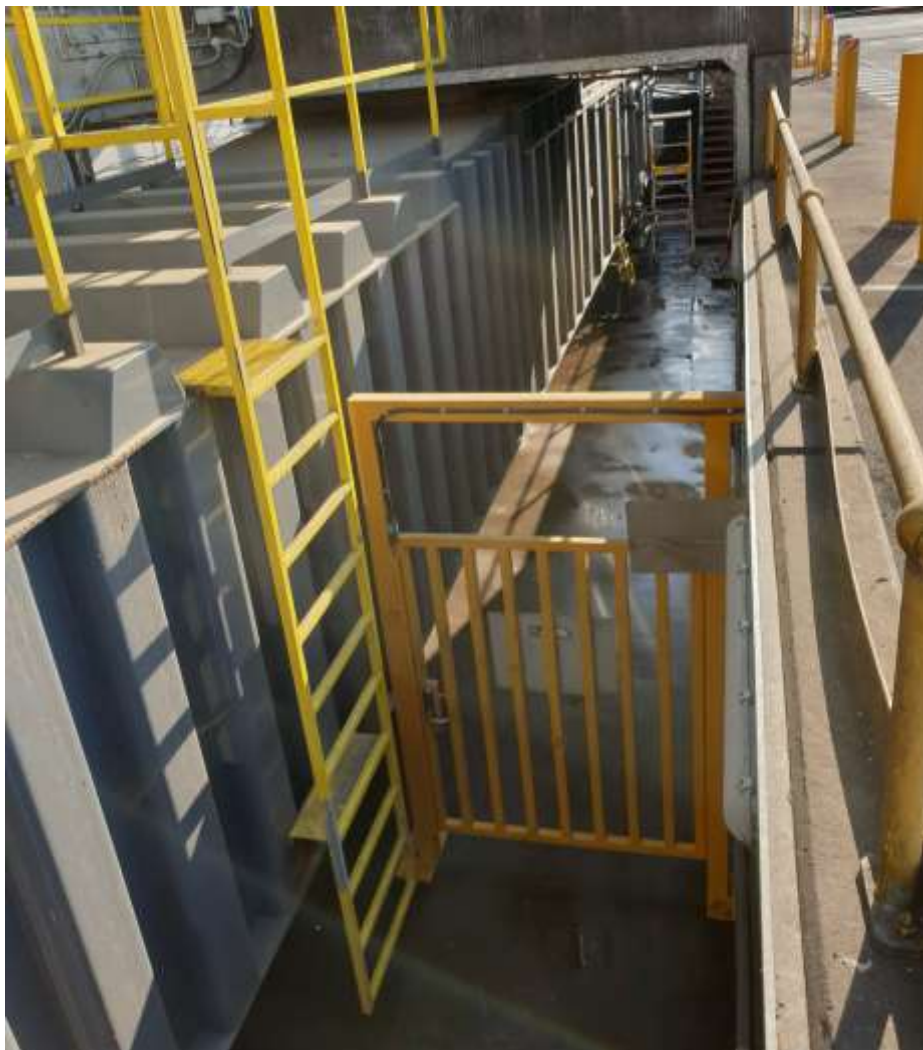
Photo 2.2 – Compactor area as seen on 23 May 2019 (1 of 2)

was intermittently detectable but was confined to this area only (see **Appendix C** for Field Ambient Odour Assessment Survey results). It appeared during the Odour Audit visit that both compactors were in operation. The general housekeeping around this area was observed to be of high quality, with no evidence to suggest otherwise. The condition of the compactor area as found on 23 May 2019 is shown in **Photo 2.2** and **Photo 2.3**.

As with previous Odour Audits, the containers are cleaned off-site at Veolia's Woodlawn Bioreactor Facility before being returned to the Site. The weight of each container is monitored to determine if there is any waste that has not been removed completely from each container, which in turn reduces the likelihood of the containers contributing to the Site's odour levels.

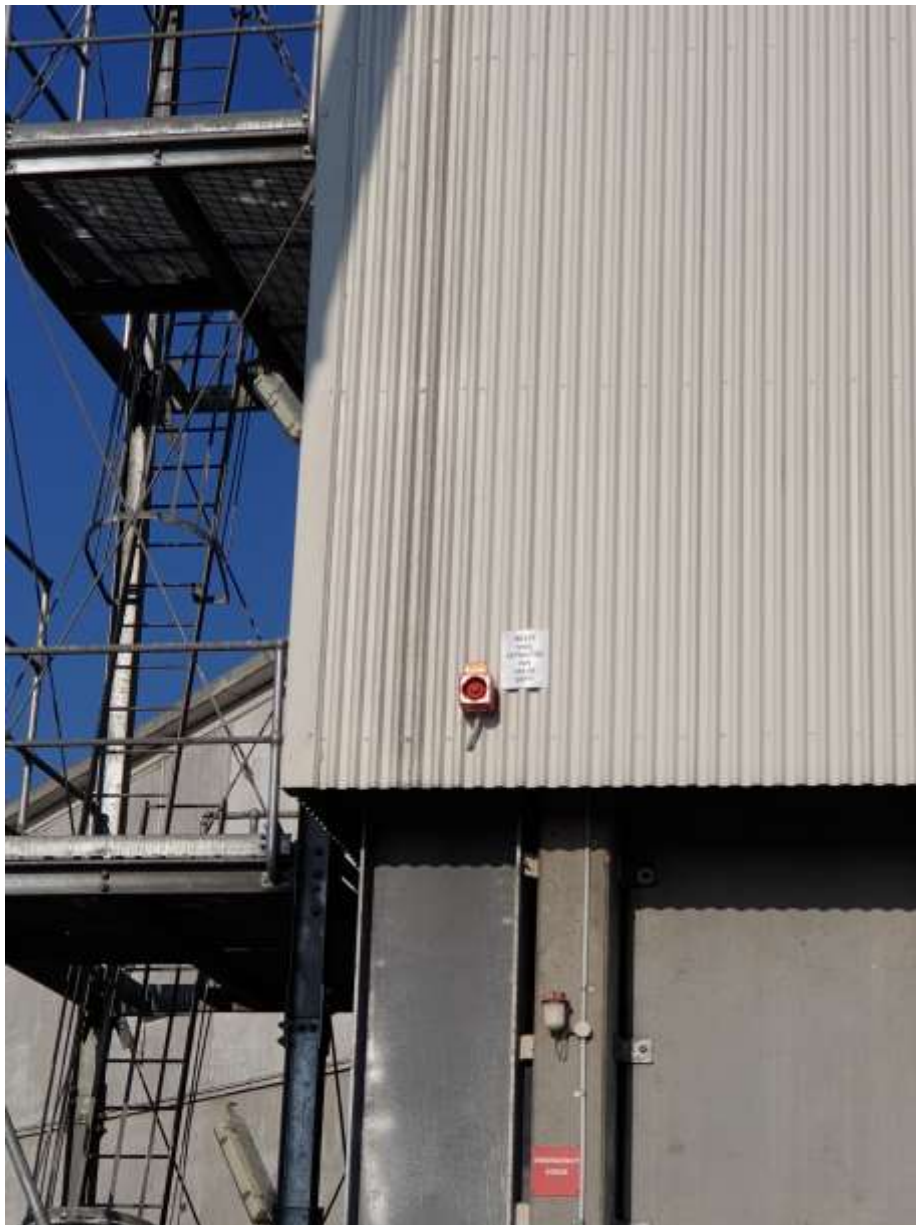
Photo 2.4 – The location of the odour extraction system fan alarm at the Site as seen on 23 May 2019

The subsequent service log visit conducted on 20 May 2019 indicated that Item 5 was completed. However, it is unclear from the service logs if Items 1 to 4, as listed above, were completed in a previous or subsequent visit.

Despite the above findings and identified operating and maintenance related works, based on the positive results obtained for the smoke testing, odour complaints register, and the FAOA survey conducted as part of the Odour Audit visit, it appears that the current operation of the odour extraction system is satisfactory. However, it is highly recommended that Items 1 to 4 as listed above are rectified as a **priority** to ensure that odour risks are sustainably managed and minimised. Upon completion of these rectification works, the discharge stack velocity should be reassessed.

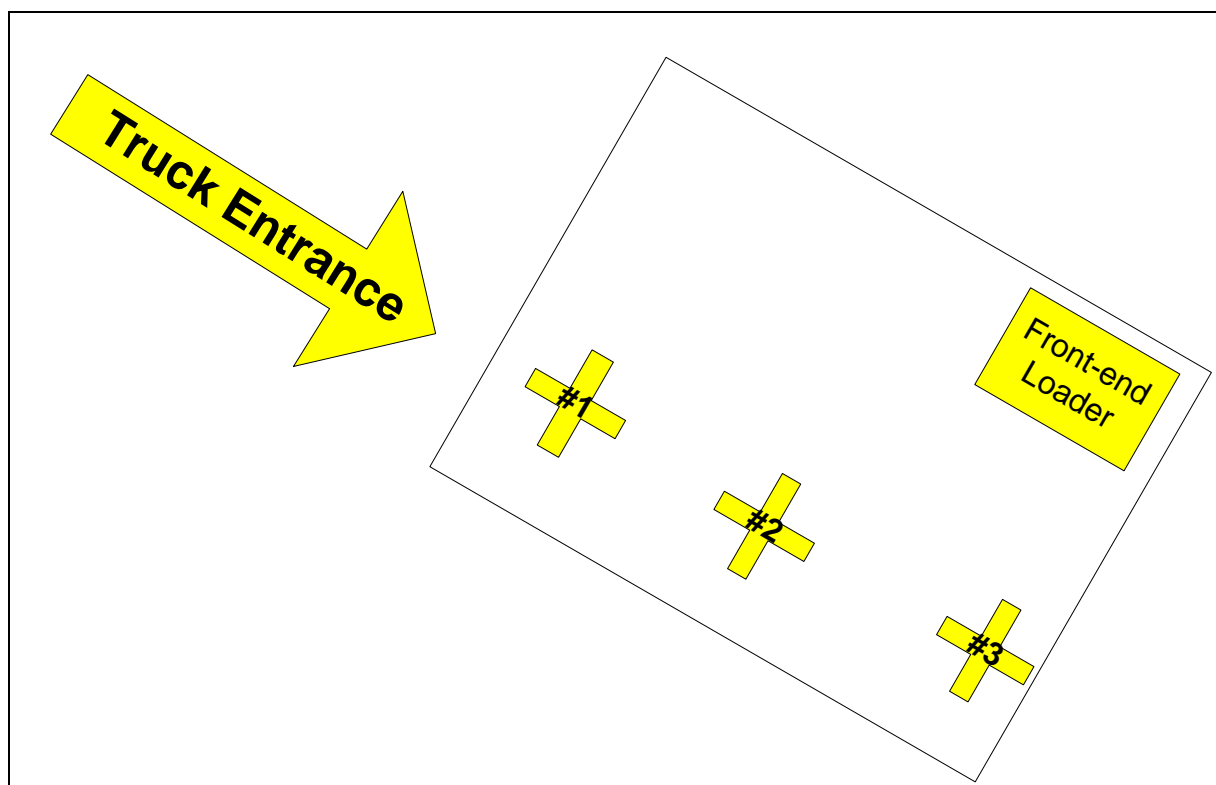
Figure 2.1 - Smoke testing release points within the TTB on 23 May 2019

As per previous audits, smoke testing was carried out within the TTB to assist in determining the effectiveness of the forced air extraction system, as well as the extent to which the TTB has been sealed from leaks. As per previous audits, smoke was released from within the TTB at three points within the TTB. **Figure 2.1** shows the three points where the smoke was released within the TTB. **Photo 2.5** shows smoke testing at one of the test locations (Smoke Testing Point #1) as occurred on 23 May 2019.

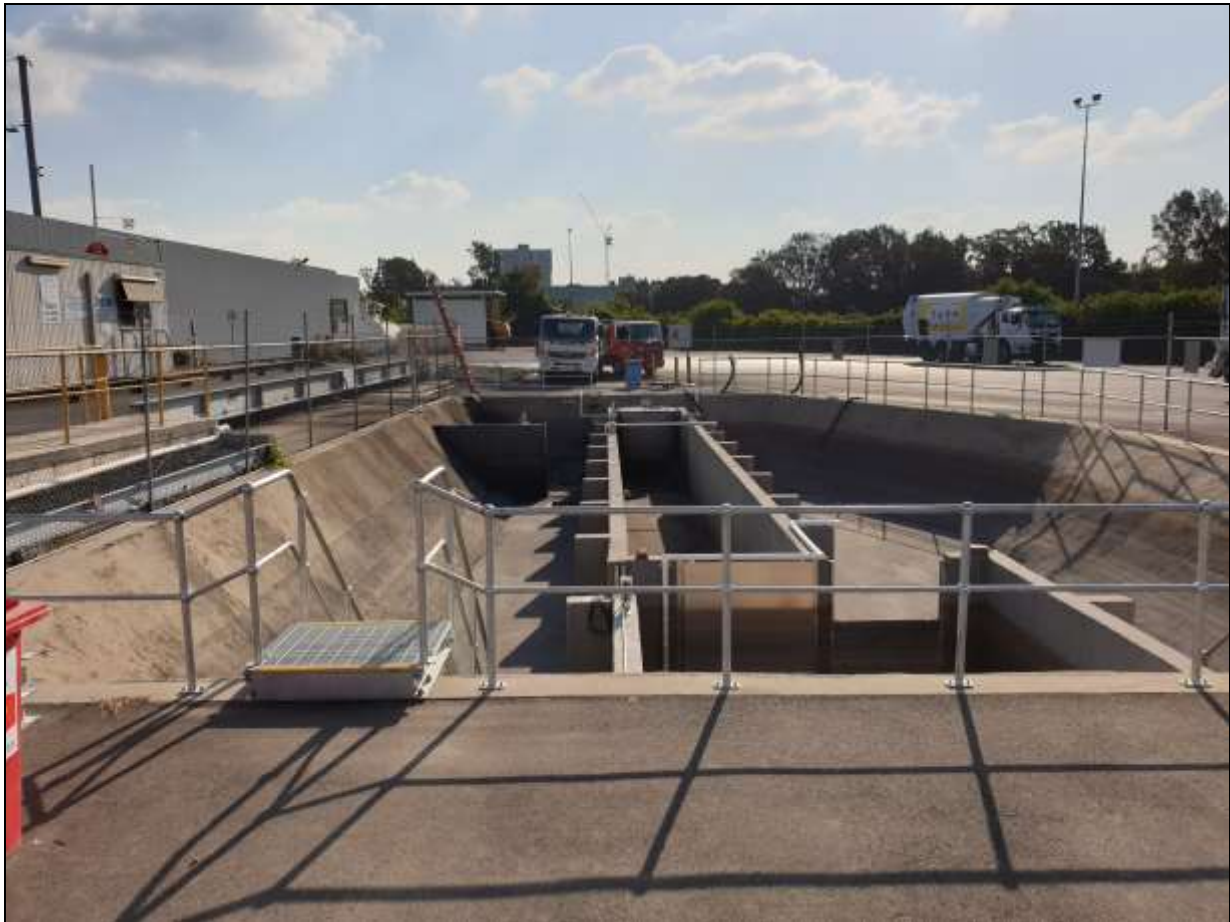
Photo 2.6 – Stormwater retention pond as seen on 23 May 2019

The auditor observed that there was no effluent in this pond at the time of the Odour Audit visit. **Photo 2.6** shows the state of the pond as found on 23 May 2019.

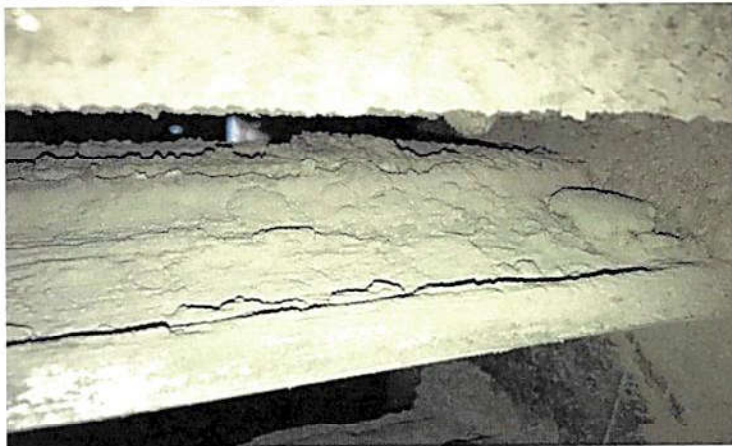
Internal shot of exhaust plenum
Exhaust VCD suffering heavy debris build-up
Build-up restricting airflow
Comprehensive clean required

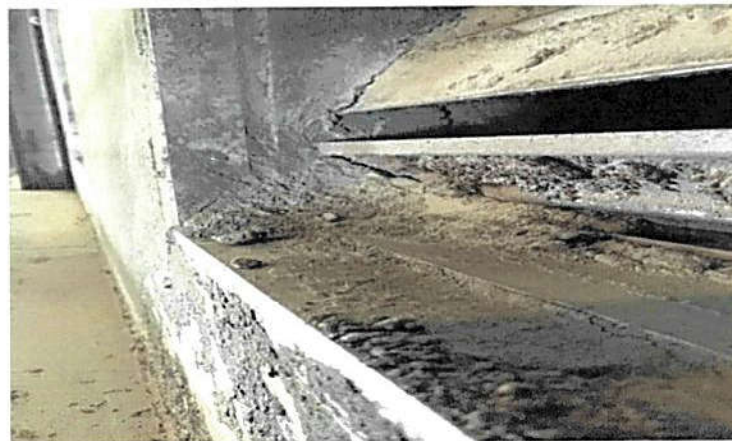
External shot of exhaust plenum
Exhaust VCD suffering heavy debris build-up
Build-up restricting airflow
Comprehensive clean required

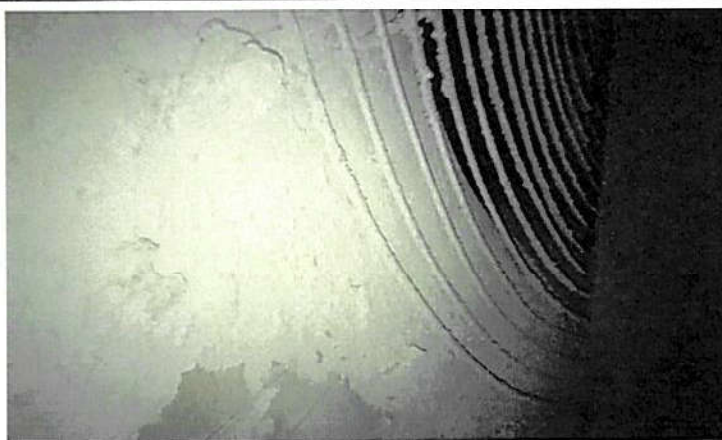
Extraction Fan 1 hub intake
Large amount of debris accumulated on intake mesh.
Debris restricting airflow.
Comprehensive clean required

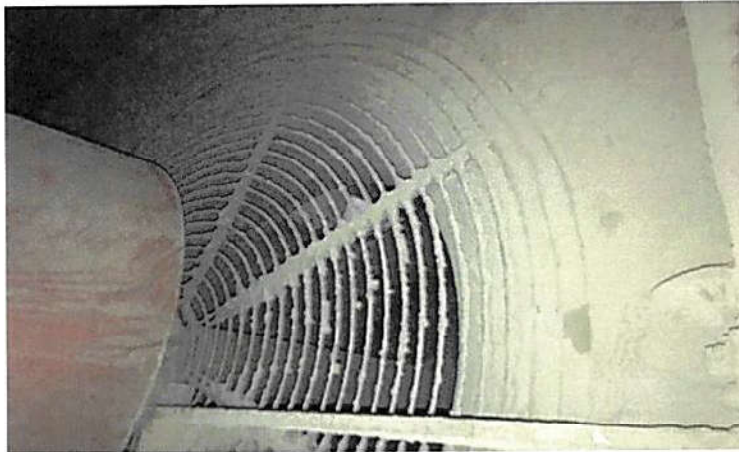
Extraction Fan 2 hub intake
 Large amount of debris accumulated on intake mesh.
 Debris restricting airflow.
 Comprehensive clean required

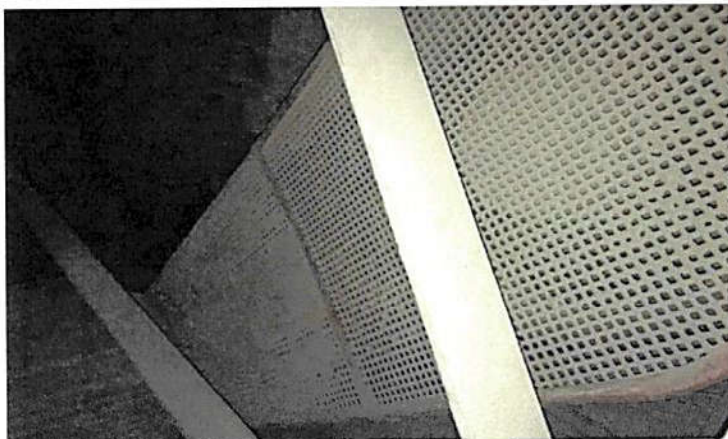
Extraction Fan 1 pulley drive guard
 Build up of dust & debris causing excessive wear on belts & pulleys.
 Comprehensive clean required

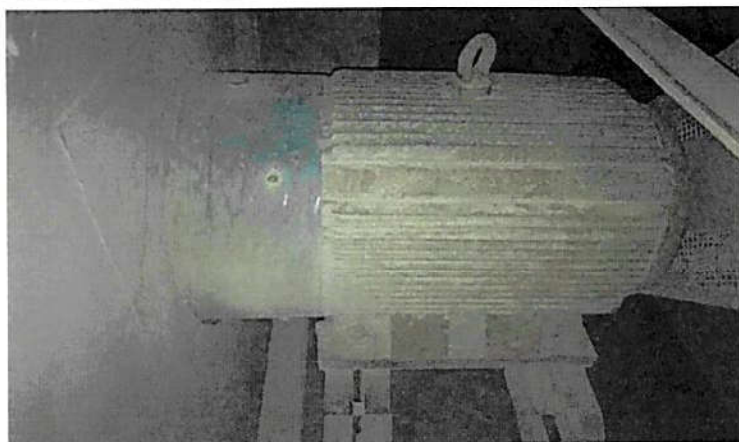
Extraction Fan 1 drive motor
 Dust / debris build up may be causing motor to overheat
 Comprehensive clean required

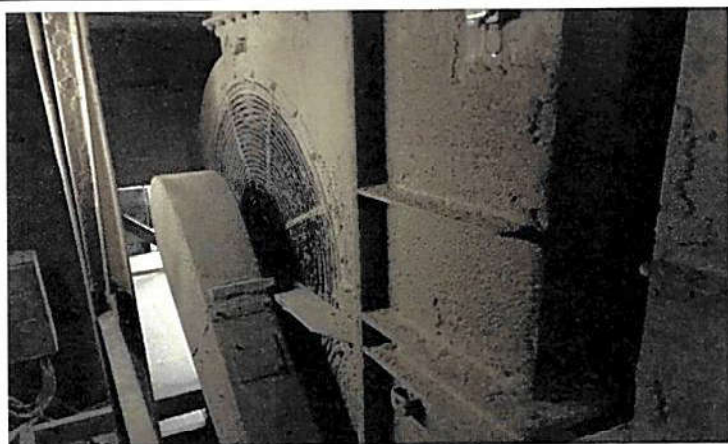
Side view of Extraction Fan 2

Large amount of debris accumulated on intake mesh & discharge duct work.

Comprehensive clean required

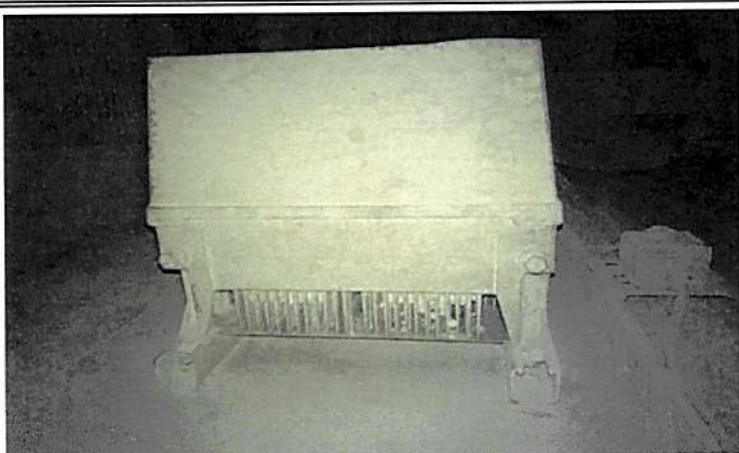
Top view of Extraction Fan 2 VSD showing

build up of dust / debris on VSD cooling vanes.

Possible fire hazard due build up restricting VSD internal ventilation.

Recommend moving BOTH VSDs to a new location, OUTSIDE the exhaust intake chamber. Preferably external to the shed, near the main electrical cabinet.

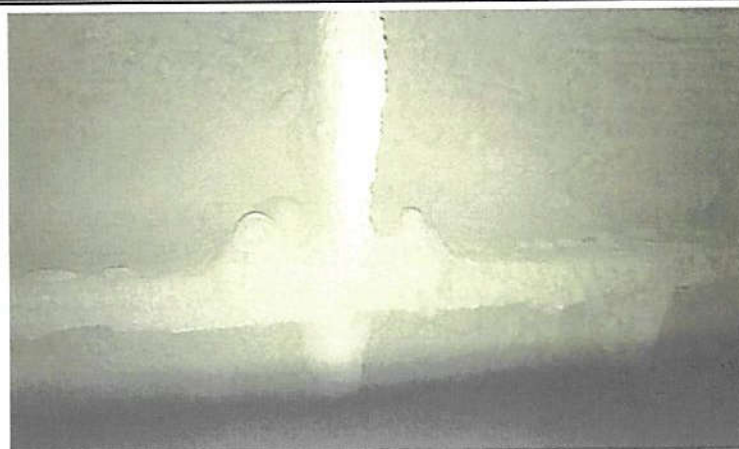
Fan housing for Extraction Fan 1.

Comprehensive clean required.

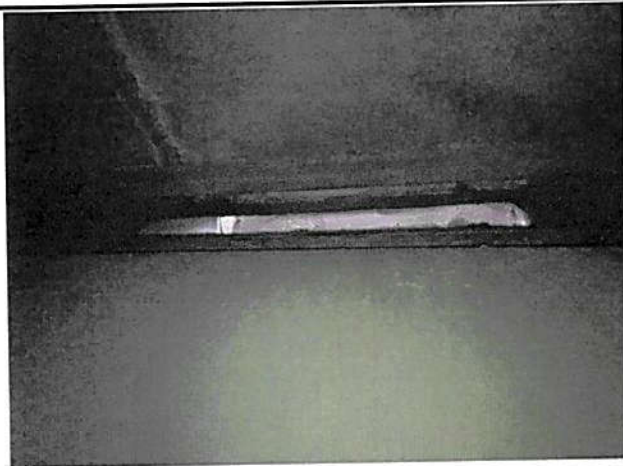
Canvass connection at fan discharge for
Extraction Fan 1 torn.

Large gap between fan scroll and discharge
duct. Fan short-cycling as a result.

Canvass connection to be replaced.

*Recommend replacing canvass connections for both fans as connection for Extraction Fan 2 appears to be worn and also on the verge of tearing.

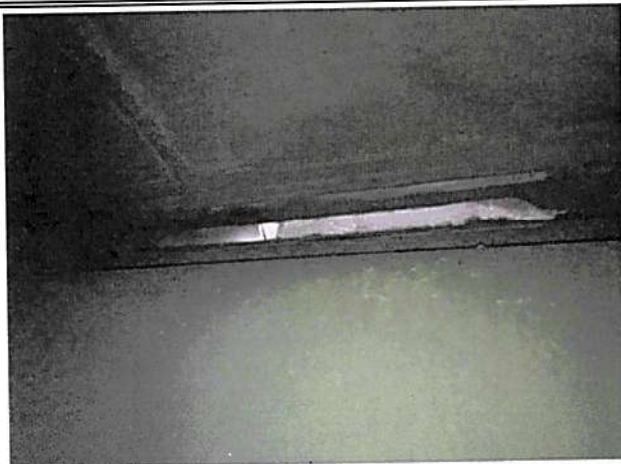
Dimensions of duct work at canvass connection:
2170mm x 2030mm

2030mm is the length of the torn connection
side.

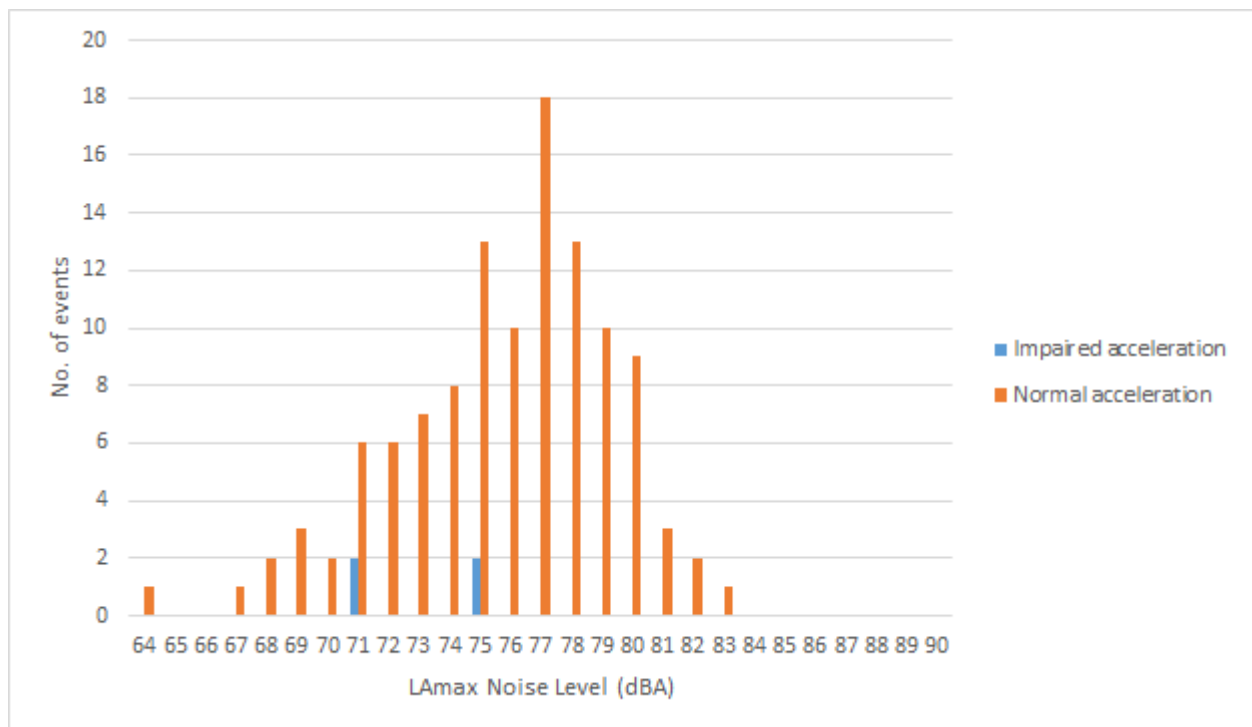
Figure 1: Noise level distribution from Truck Noise Monitoring – 22 October 2019

Measurements of 'normal' truck acceleration ranged from 64dBA to 83dBA with the highest frequency occurring between 75dBA to 80dBA. Impaired acceleration readings due to the impeded traffic conditions ranged from 71dBA to 75dBA, with the highest frequency occurring 75dBA. Impaired acceleration readings were plotted separately from the normal accelerating vehicles on Figure 1.
