WOODLAWN BIOREACTOR

Independent Audit
Leachate and Water Management System

SLR Ref: 630.13050-R01
Version No: FINAL
August 2020

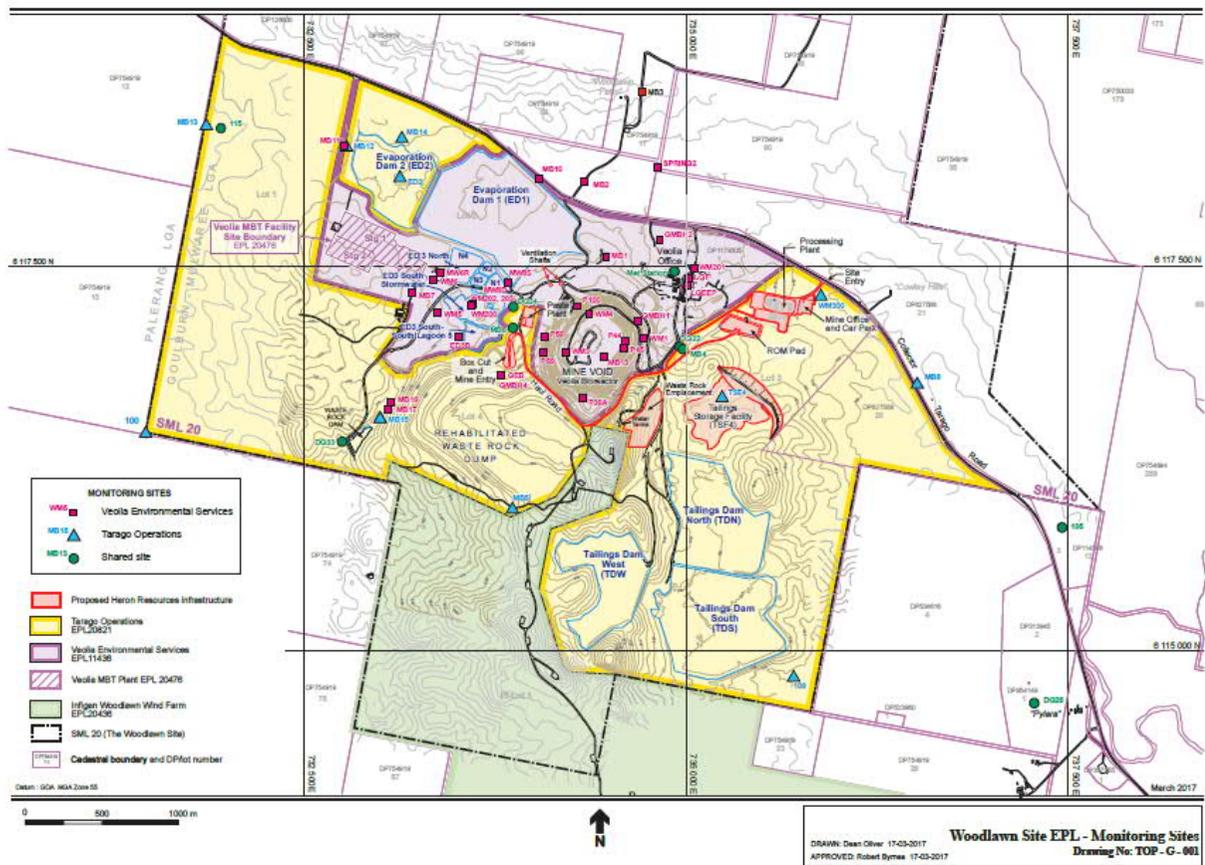
Figure 2 Layout of the Woodlawn Bioreactor

The layout of the Development is shown on Figure 2.

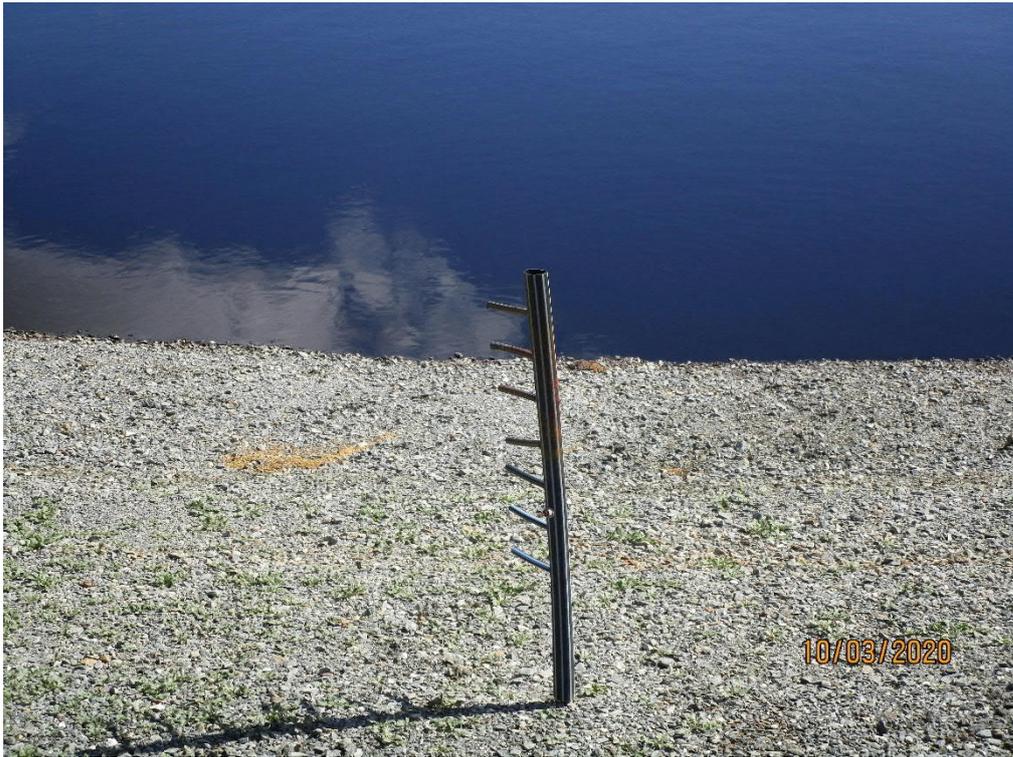
Photo 15 – Informal Depth Marker at ED3SS

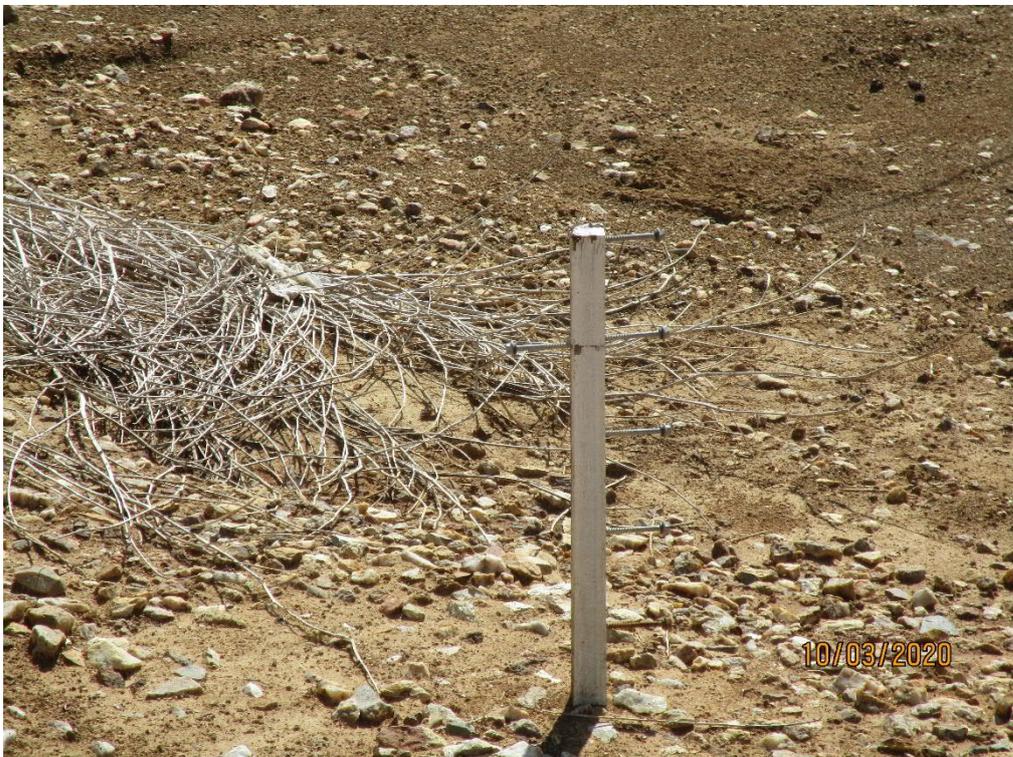
Photo 16 – Informal Depth Marker

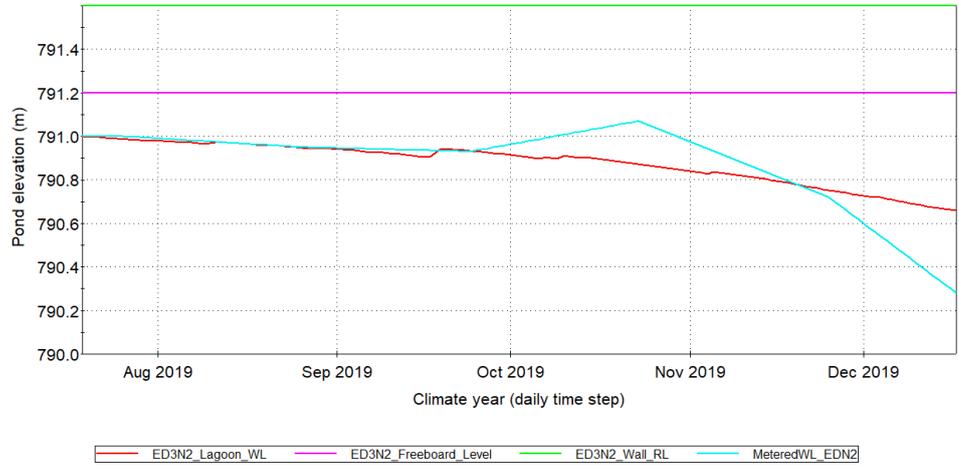
Figure A.1 ED3N2 Calibration Model Results

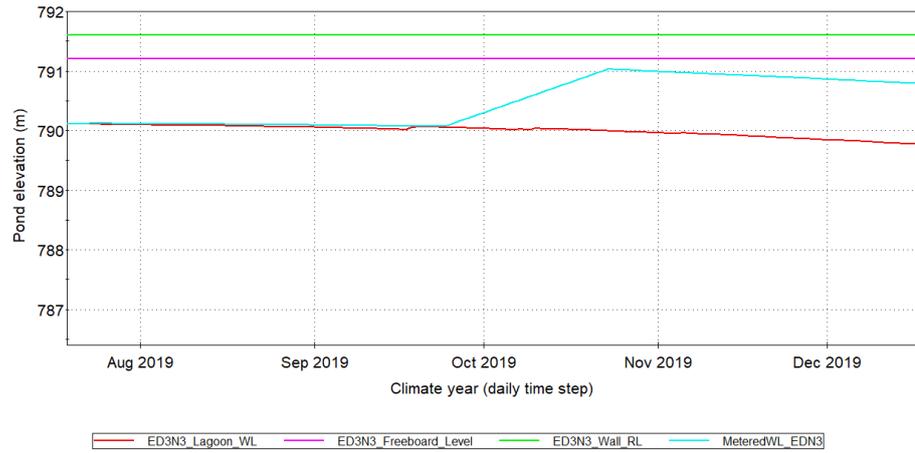
Figure A.2 ED3N3 Calibration Model Results

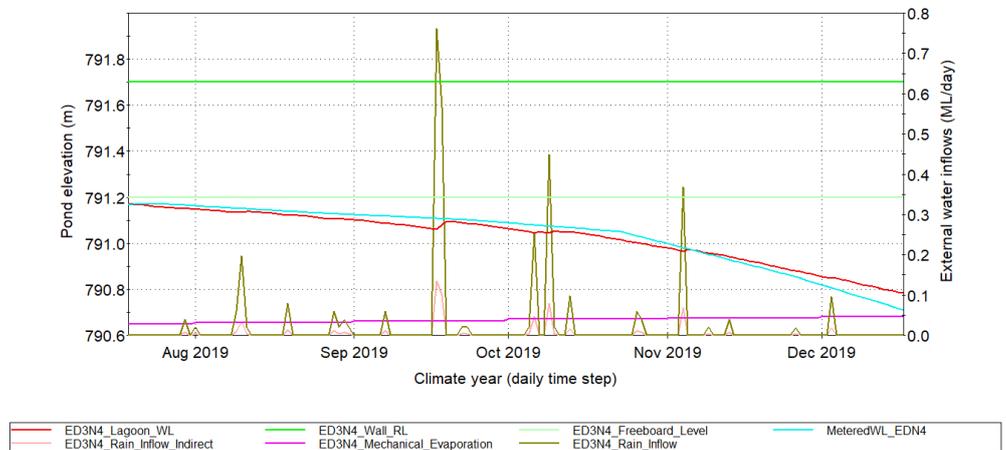
Figure A.3 ED3N4 Calibration Model Results

The calibration simulation found the mechanical evaporators at ED3N4 were not operating to full capacity. Veolia confirmed this may be due to maintenance and repair issues experienced on site. However, Veolia provided the assumption that all mechanical evaporators are now operating to full capacity and this assumption was applied to the future design simulations.

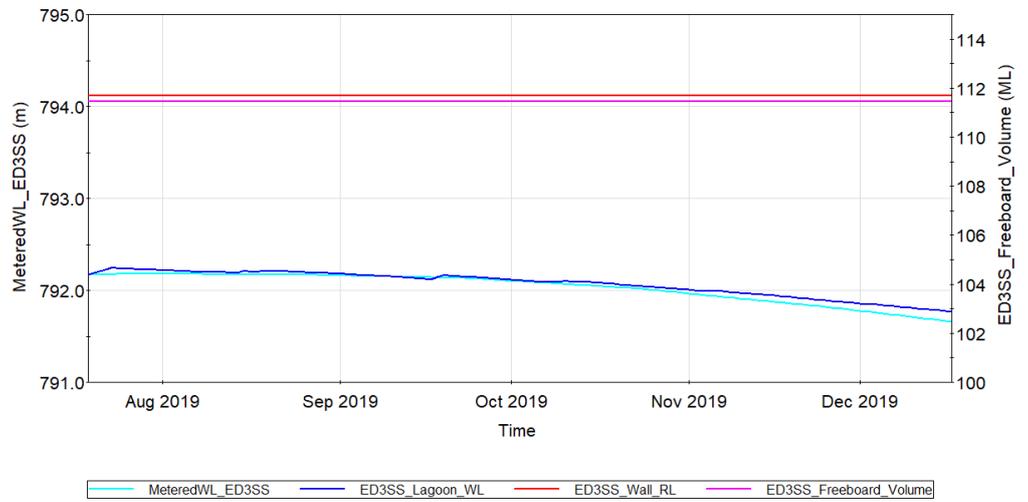
Figure A.4 ED3SS Calibration Model Results

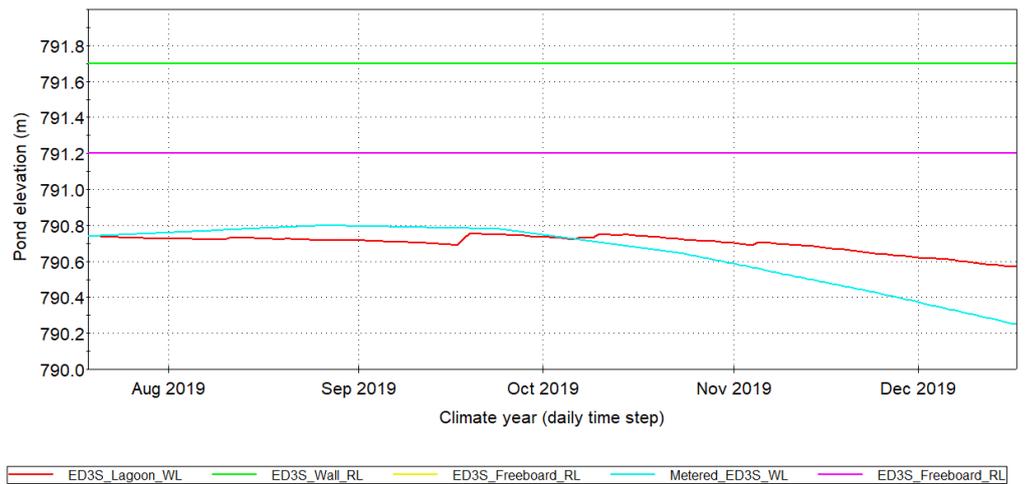
Figure A.5 ED3S Calibration Model Results

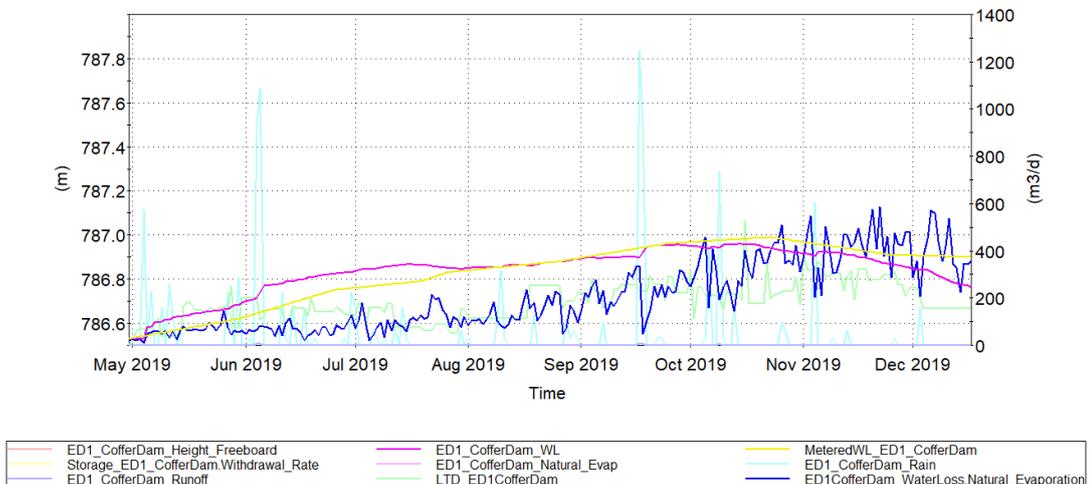
Figure A.6 ED1 Cofferdam Calibration Model Results

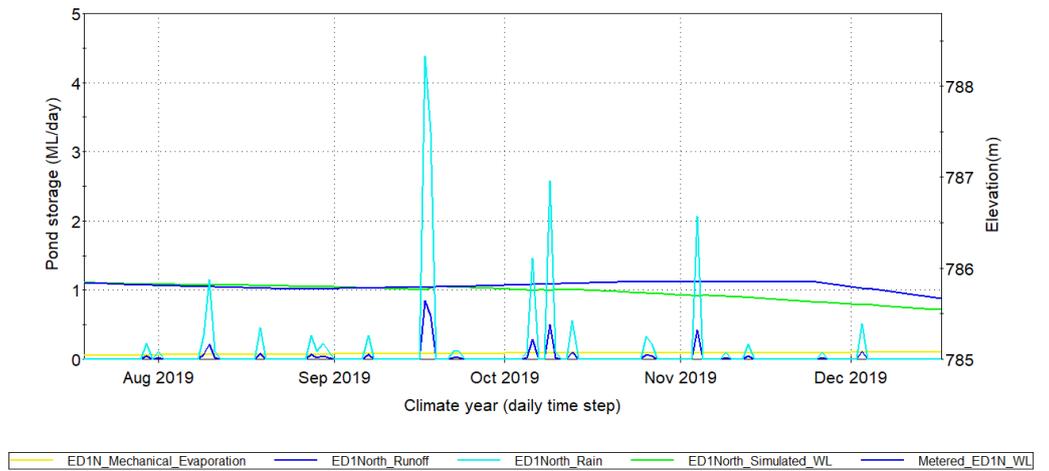
Figure A.7 ED1 Calibration Model Results

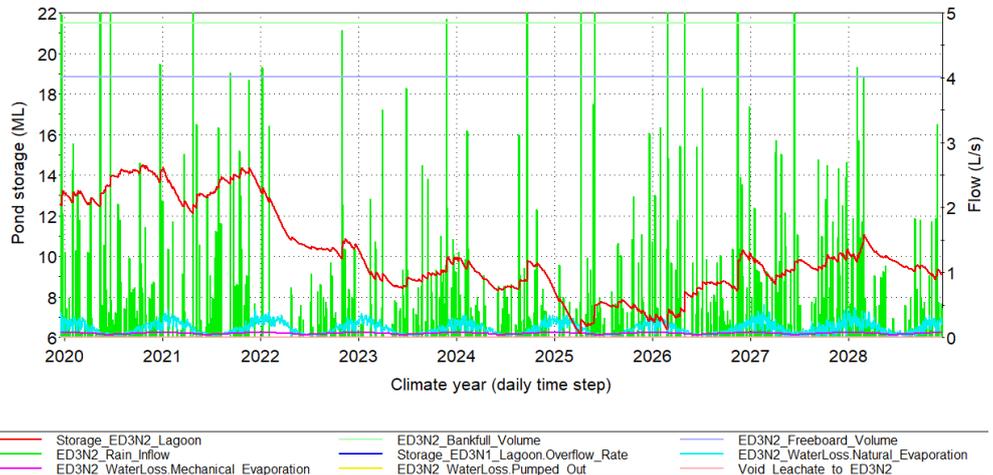
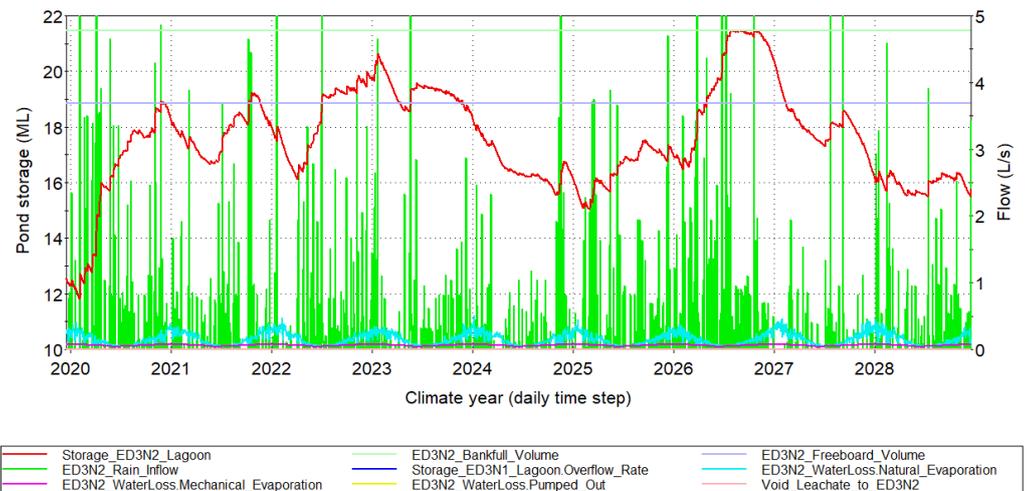
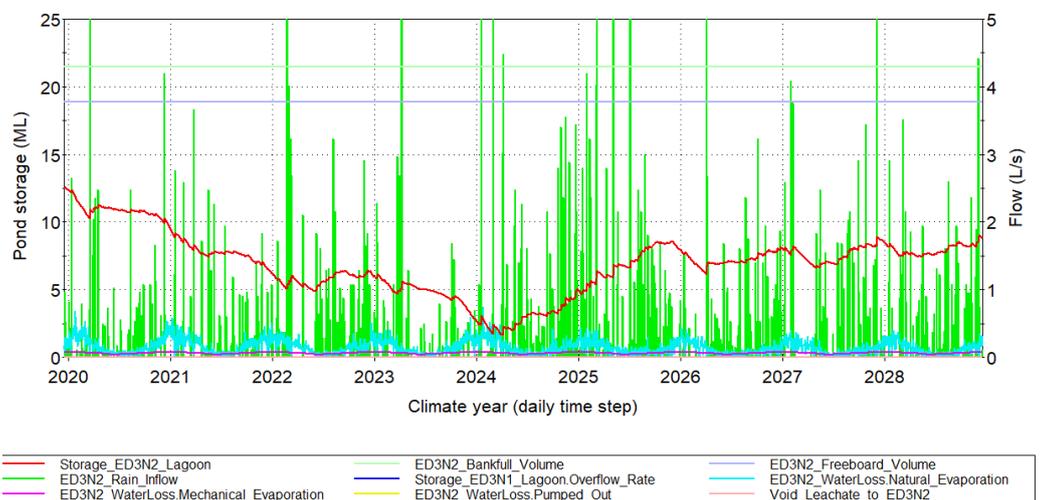
B.1 SIMULATED RESULTS FOR ED3N2

Figure B.1 Simulated results for average climatic sequence ED3N2

Figure B.2 Simulated results for wettest climatic sequence ED3N2

Figure B.3 Simulated results for driest climatic sequence ED3N2

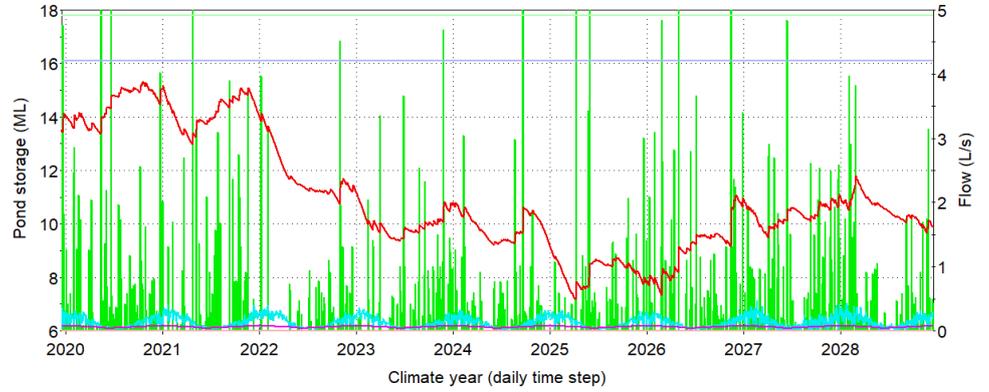
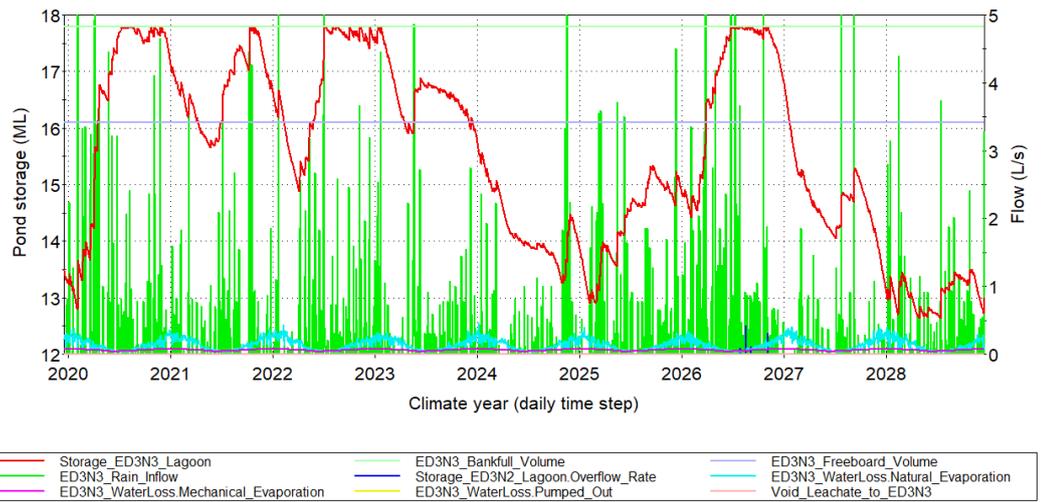
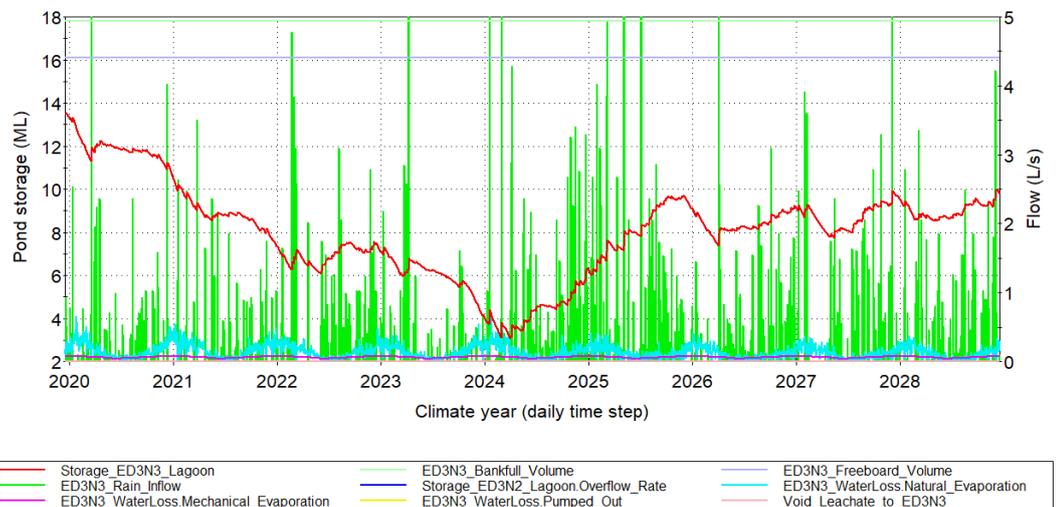
B.2 SIMULATED RESULTS FOR ED3N3

Figure B.4 Simulated results for average climatic sequence ED3N3

Figure B.5 Simulated results for wettest climatic sequence ED3N3

Figure B.6 Simulated results for driest climatic sequence ED3N3

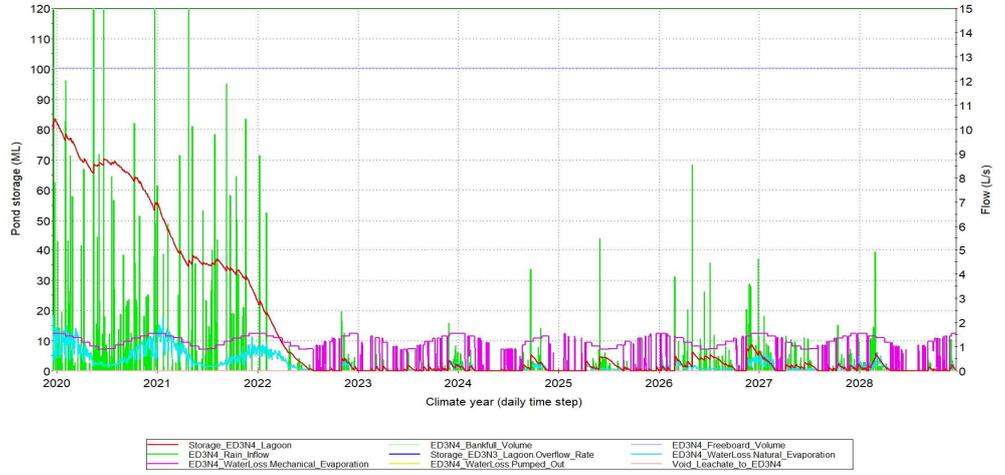
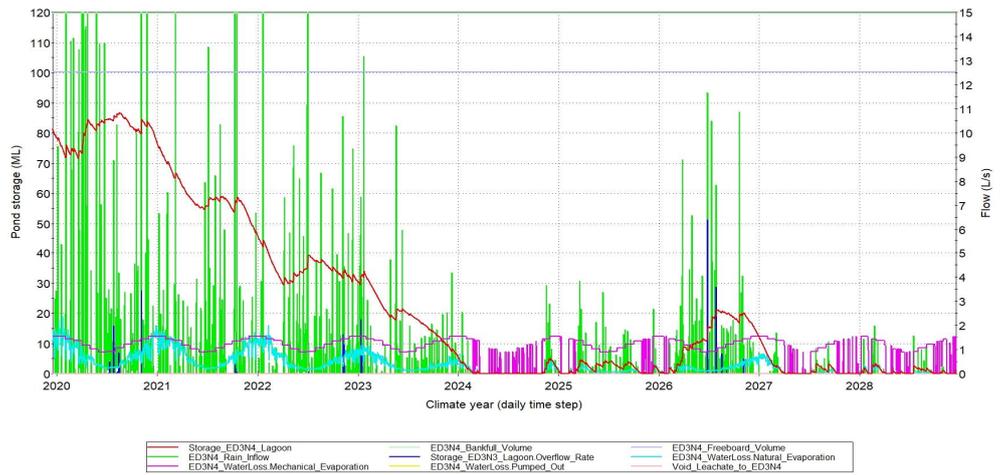
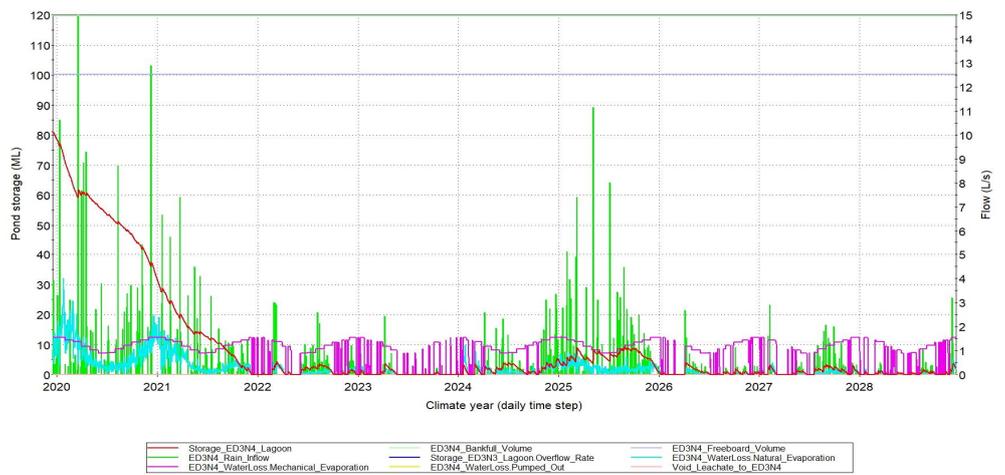
B.3 SIMULATED RESULTS FOR ED3N4

Figure B.7 Simulated results for average climatic sequence ED3N4

Figure B.8 Simulated results for wettest climatic sequence ED3N4

Figure B.9 Simulated results for driest climatic sequence ED3N4

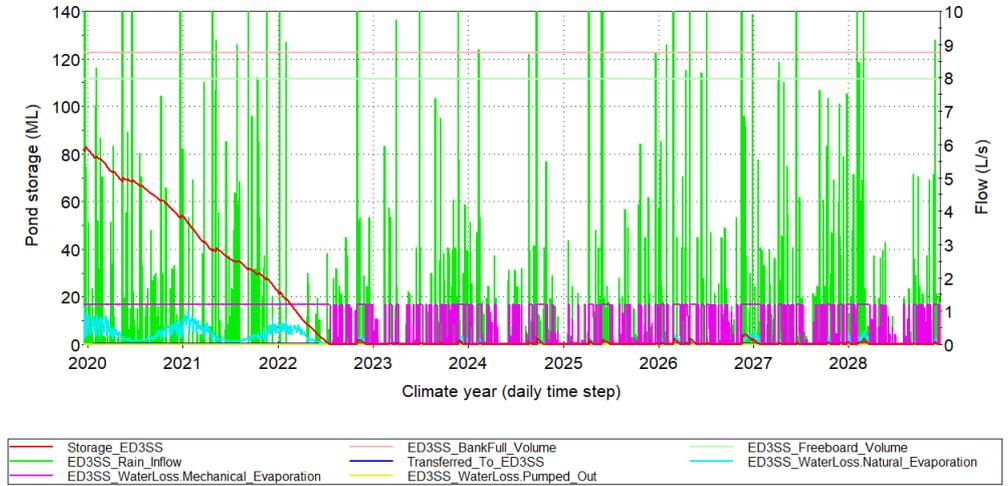
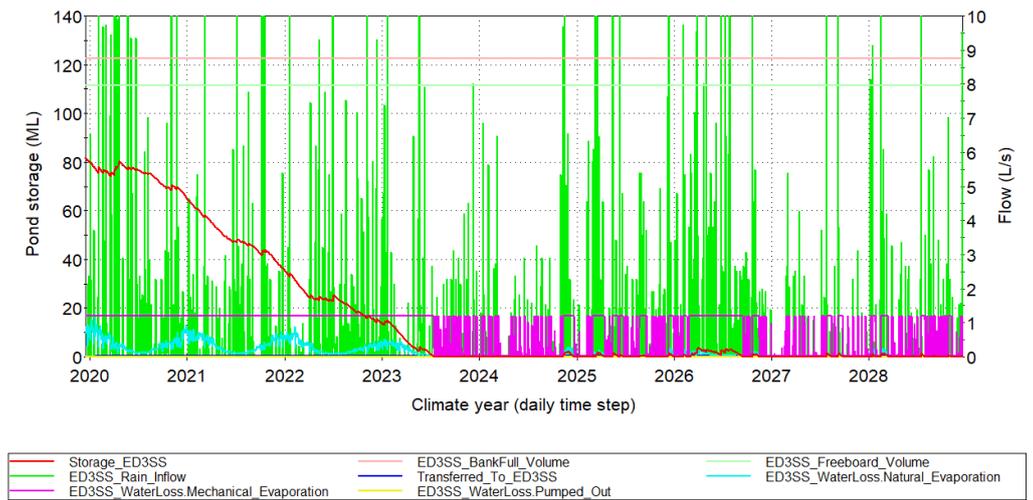
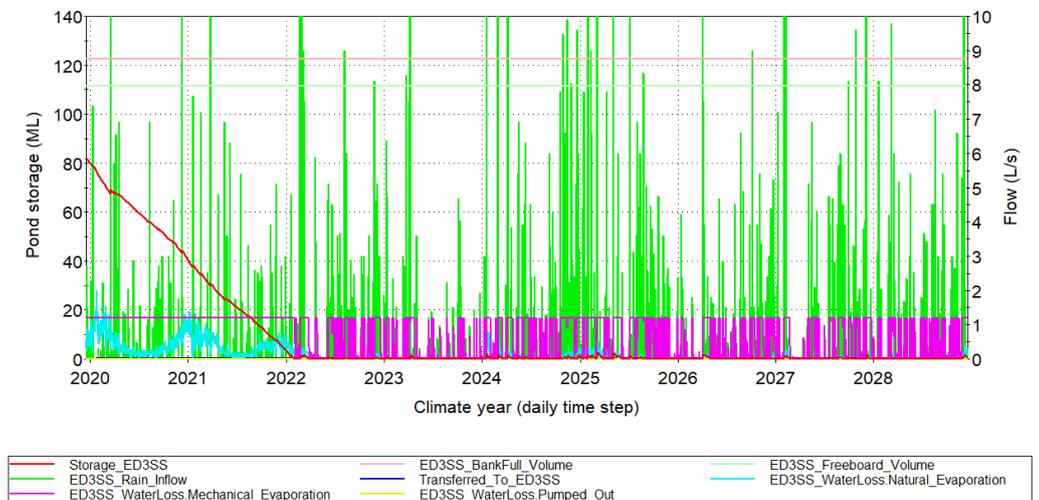
B.4 SIMULATED RESULTS FOR ED3SS

Figure B.10 Simulated results for average climatic sequence ED3SS

Figure B.11 Simulated results for wettest climatic sequence ED3SS

Figure B.12 Simulated results for driest climatic sequence ED3SS

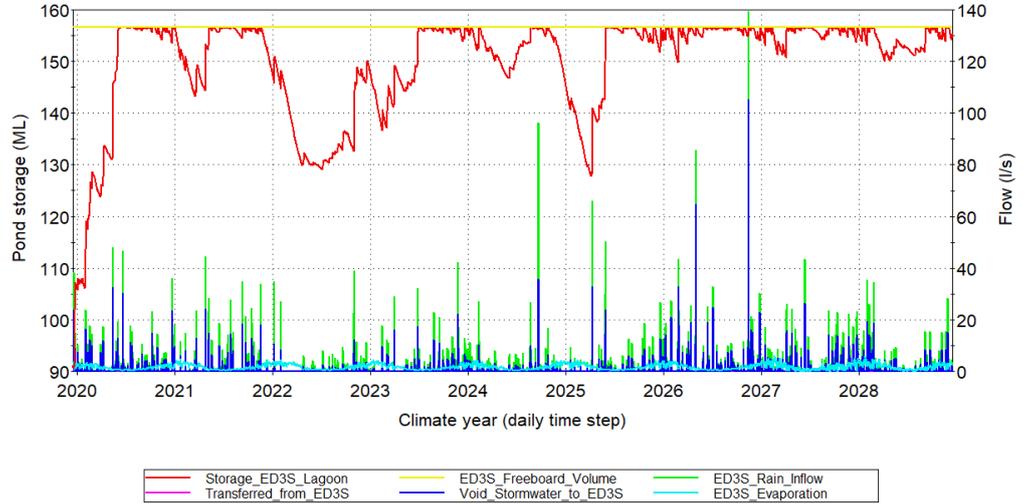
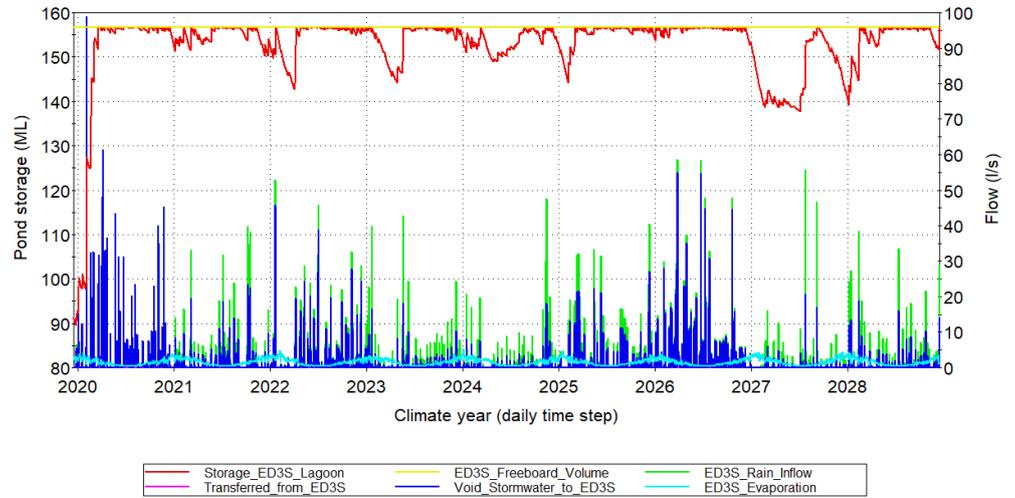
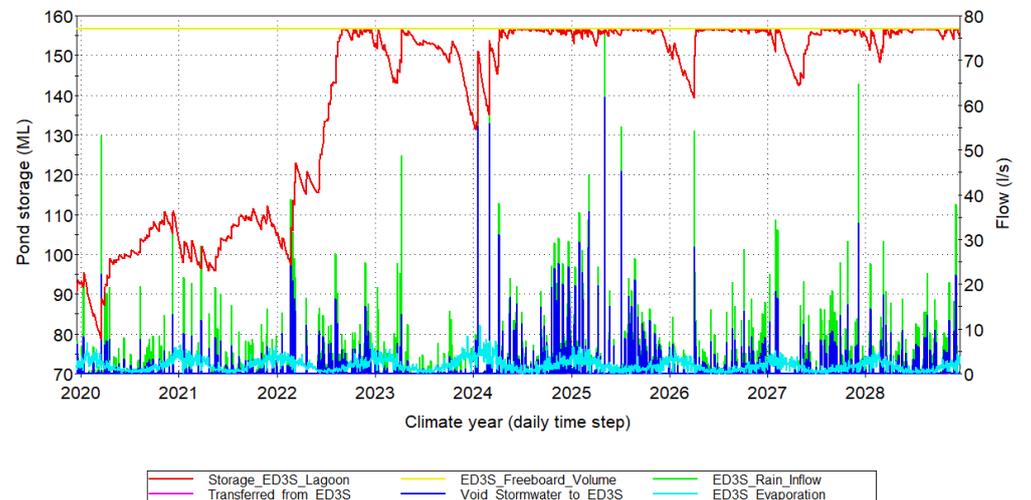
B.5.1 SCENARIO 1 (HERON USES 0 L/S)

Figure B.13 Simulated results for average climatic sequence ED3S Scenario 1

Figure B.14 Simulated results for wettest climatic sequence ED3S Scenario 1

Figure B.15 Simulated results for driest climatic sequence ED3S Scenario 1

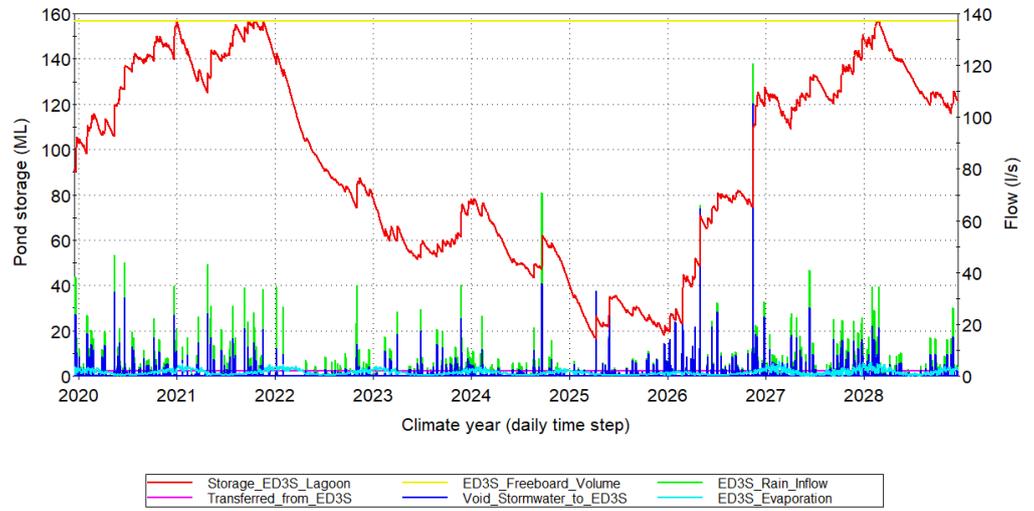
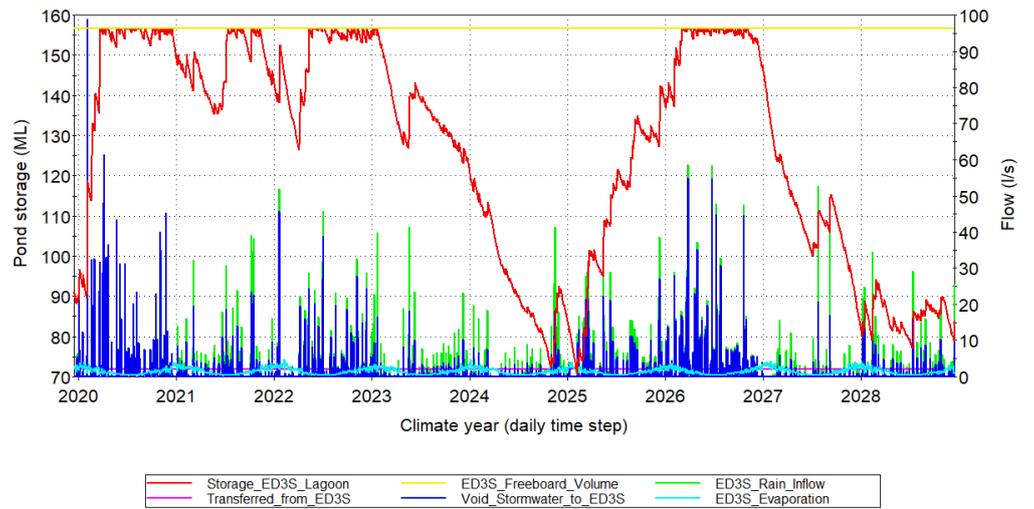
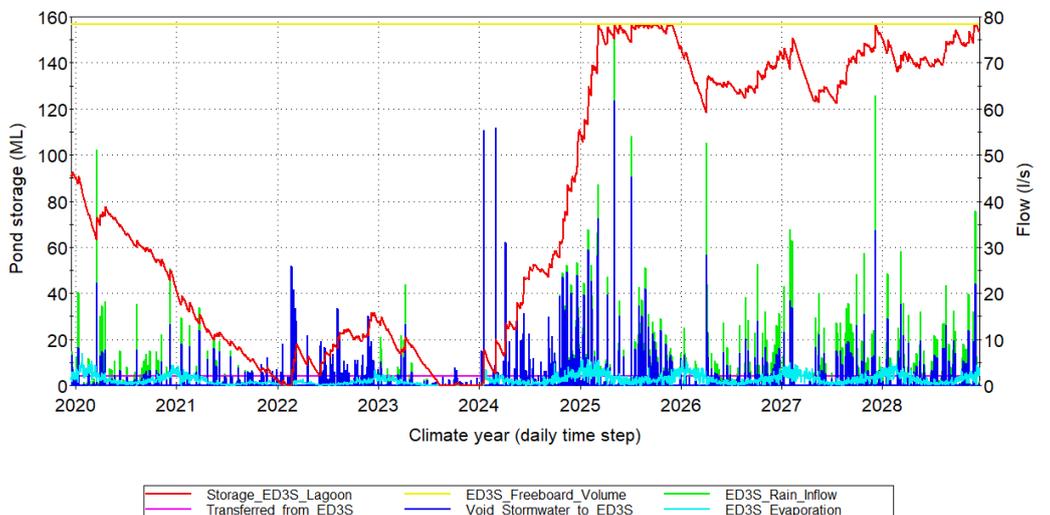
B.5.2 SCENARIO 2 (HERON USES 2 L/S)

Figure B.16 Simulated results for average climatic sequence ED3S Scenario 2

Figure B.17 Simulated results for wettest climatic sequence ED3S Scenario 2

Figure B.18 Simulated results for driest climatic sequence ED3S Scenario 2

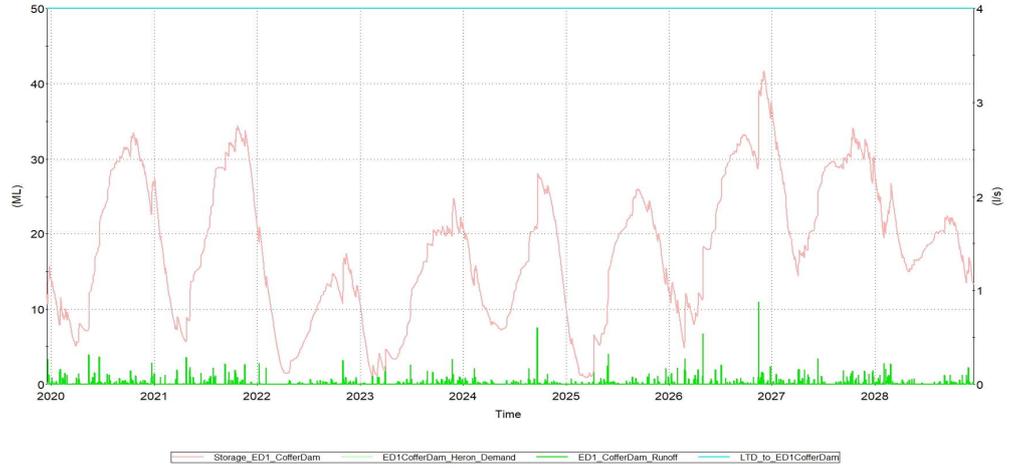
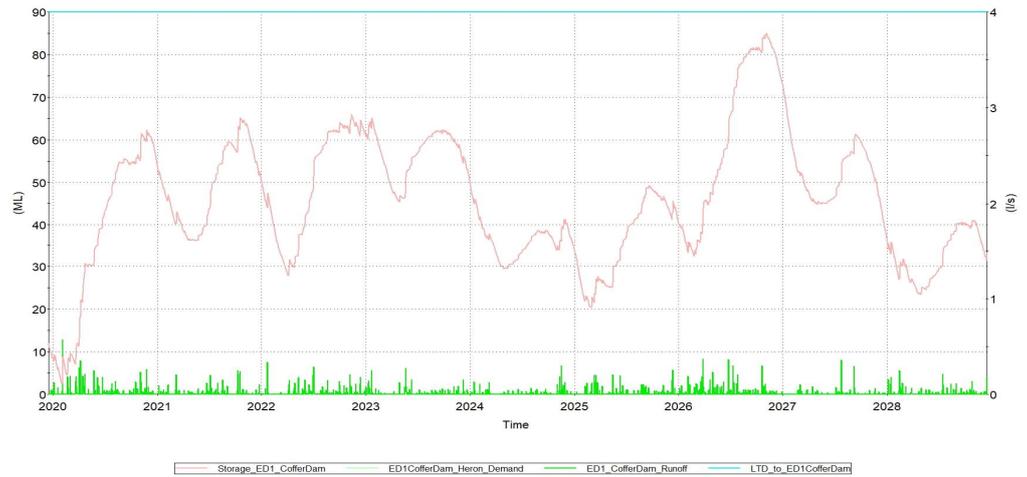
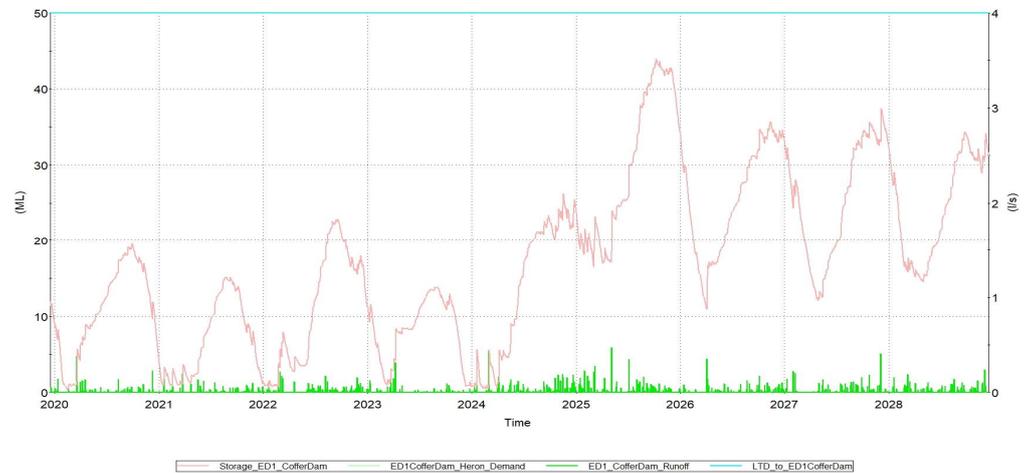
B.6.1 SCENARIO 1 (HERON USES 0 L/S)

Figure B.19 Simulated results for average climatic sequence ED1 Coffe Dam Scenario 1

Figure B.20 Simulated results for wettest climatic sequence ED1 Coffe Dam Scenario 1

Figure B.21 Simulated results for driest climatic sequence ED1 Coffe Dam Scenario 1

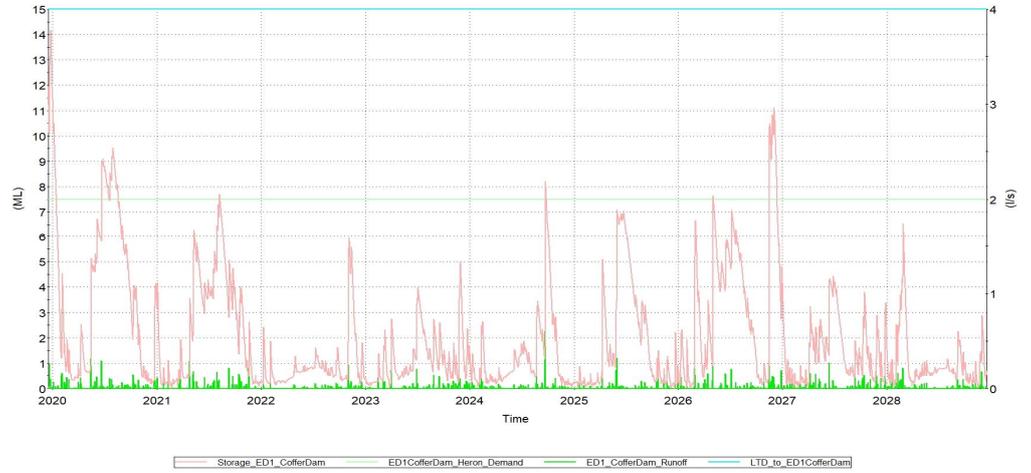
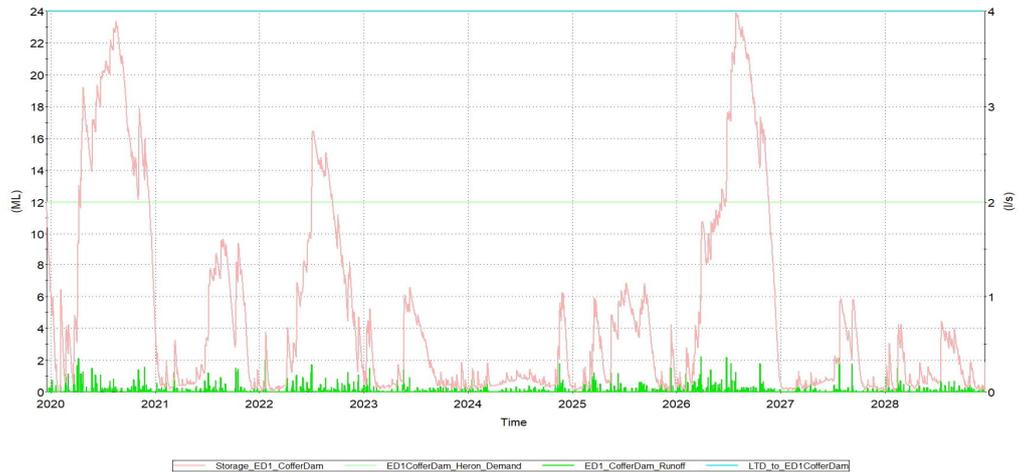
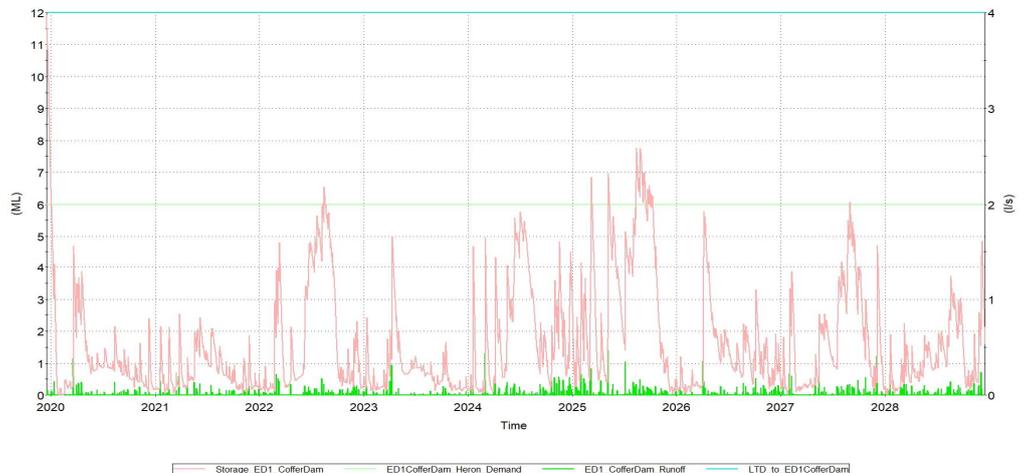
B.6.2 SCENARIO 2 (HERON USES 2 L/S)

Figure B.22 Simulated results for average climatic sequence ED1 Cofferdam Scenario 2

Figure B.23 Simulated results for wettest climatic sequence ED1 Cofferdam Scenario 2

Figure B.24 Simulated results for driest climatic sequence ED1 Cofferdam Scenario 2

Following Veolia's review of the ED1 Cofferdam water balance model results, Veolia confirmed the system being installed will be modified such that the total mechanical evaporators output will be similar to the total leachate input of 4 l/s. This proposed operating arrangement will increase the predicted water levels in the ED1 Cofferdam. Modifying the water balance model to incorporate this proposed operating arrangement is not included in the current water balance model results.

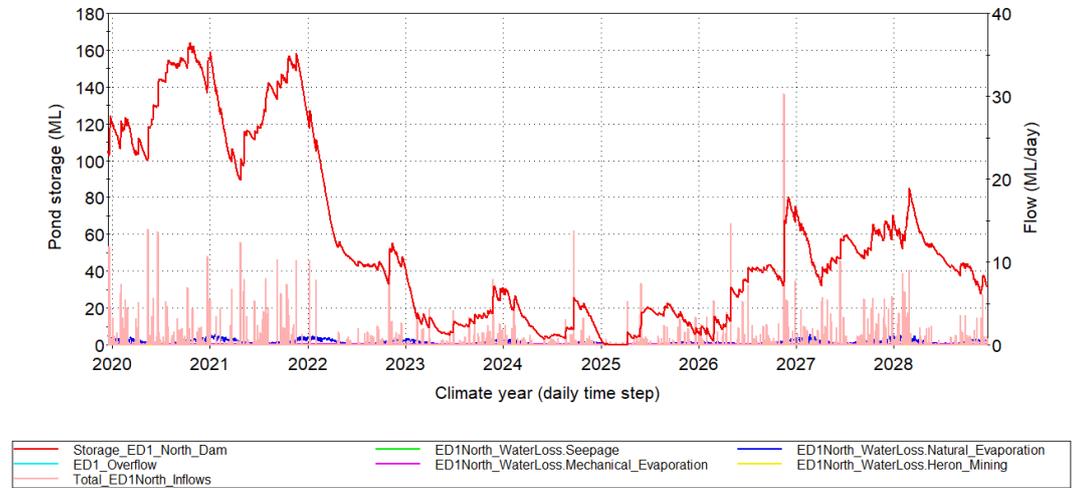
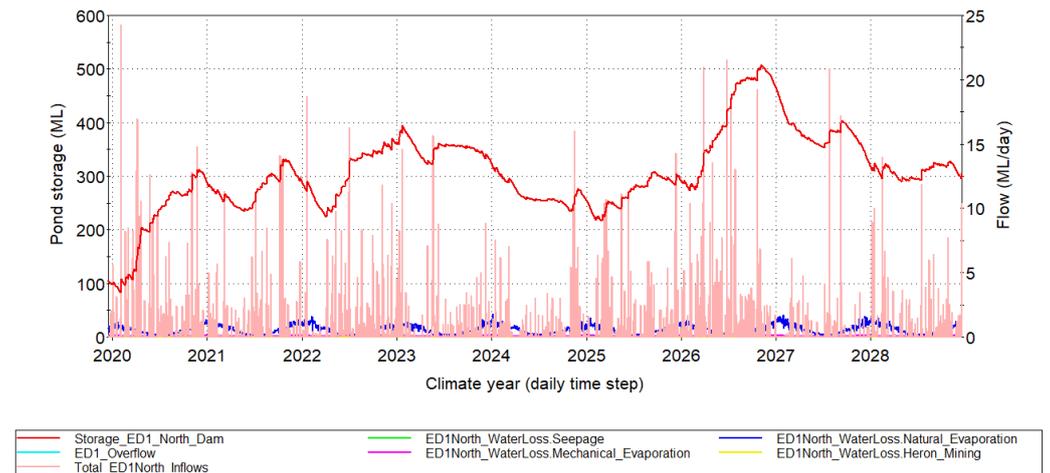
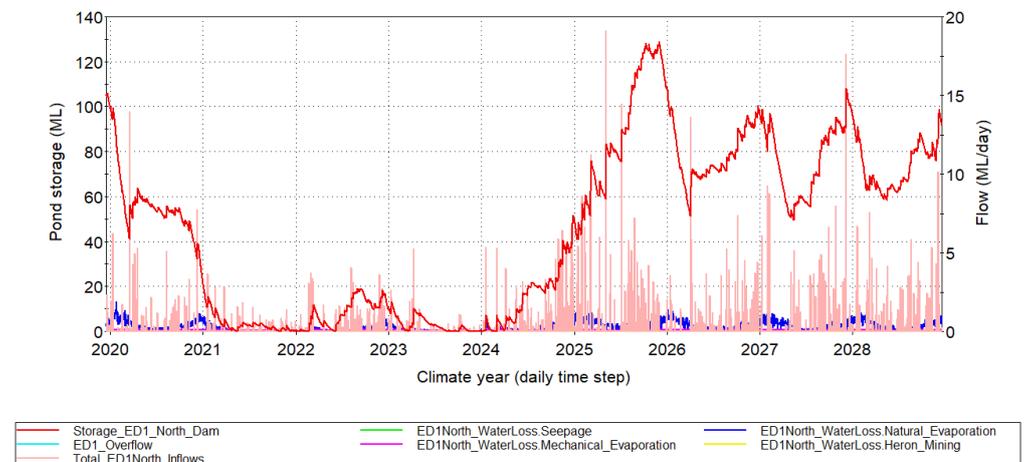
B.7 SIMULATED RESULTS FOR ED1

Figure B.25 Simulated results for average climatic sequence ED1

Figure B.26 Simulated results for wettest climatic sequence ED1

Figure B.27 Simulated results for driest climatic sequence ED1

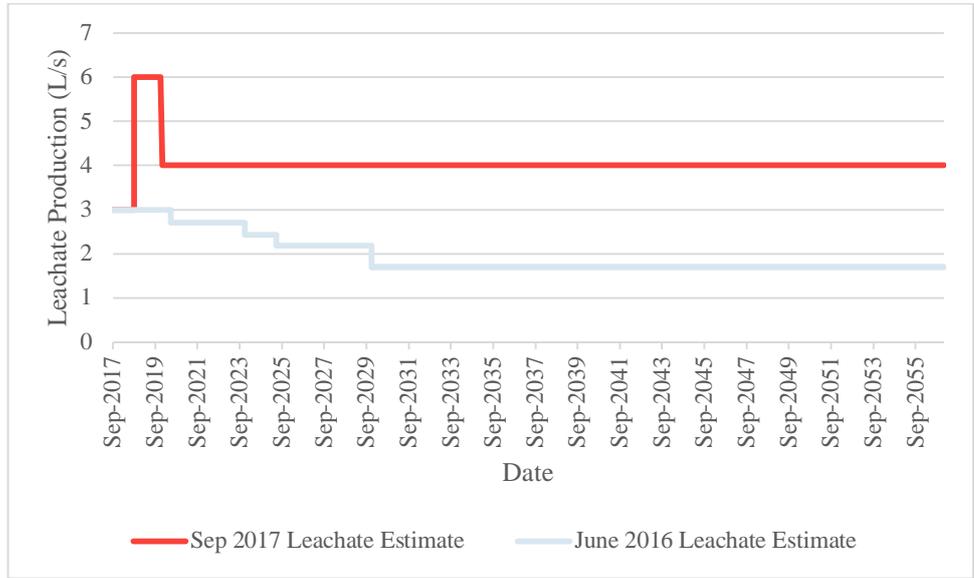
Figure C.1 Comparison of leachate rates between June 2016 and Sep 2017 estimates (source: Veolia)

The June 2016 modelled assessment suggested that Heron’s mining operation may assist Veolia in reducing the water storage requirement for the planned leachate production from 2018 for the next 40 years by using some of the water stored in the dam.
