Annual Environmental Management Report - Camellia Materials Recycling Facility 2019-2020

NSW Camellia Annual Environmental Management Report

Issue Date 3/9/2020

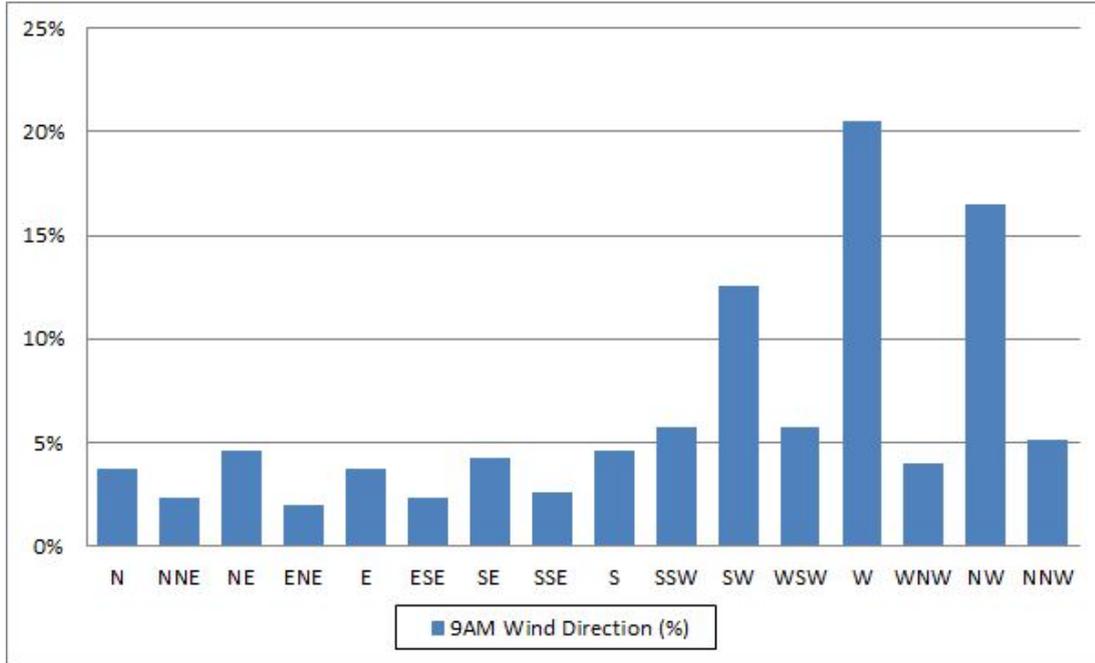
Figure 2.1 Distribution of 9AM wind direction data during the reporting period

A summary of daily wind speeds and wind directions at 9am at the nearby BoM weather station is presented in Figure 2.1 and Figure 2.2. During the reporting period, the 9am prevailing wind directions were westerly and north-westerly and the wind speeds were most frequently between 1 – 10 m/s.

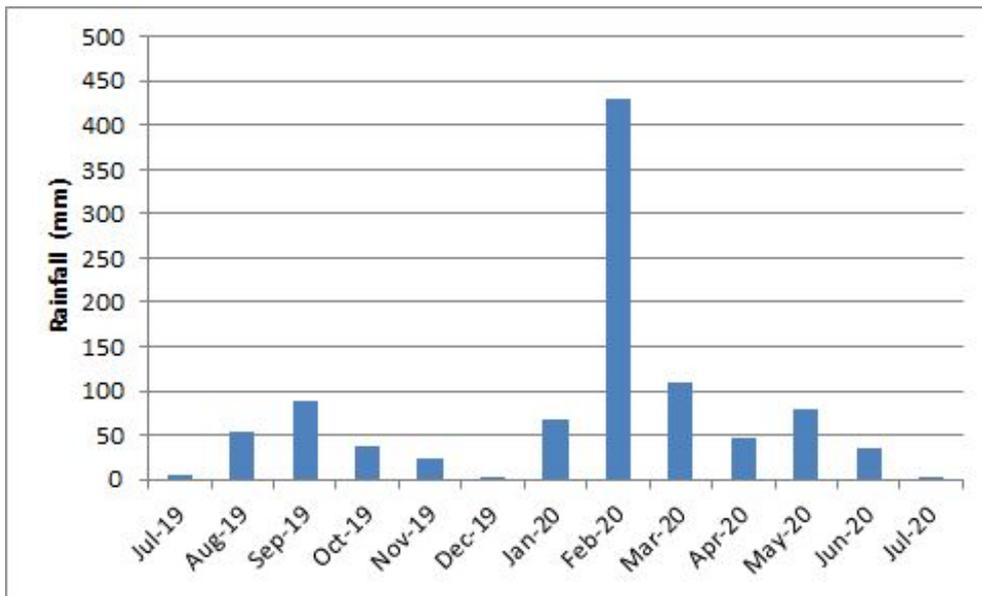
Figure 2.3 Monthly rainfall data during the reporting period

A summary of rainfall data at the Site during the reporting period is presented in Figure 2.3. Overall, the average rainfall for the Site during the reporting period was approximately 75.4mm per month. Significant rainfall (401mm in total) was observed during the first two weeks of February 2020.
