Annual Environmental Management Report - Clyde Transfer Terminal 2020-2021

**NSW Resource Recovery Annual Environmental
Management Report - Clyde Transfer Terminal**

Issue Date 15/03/2021

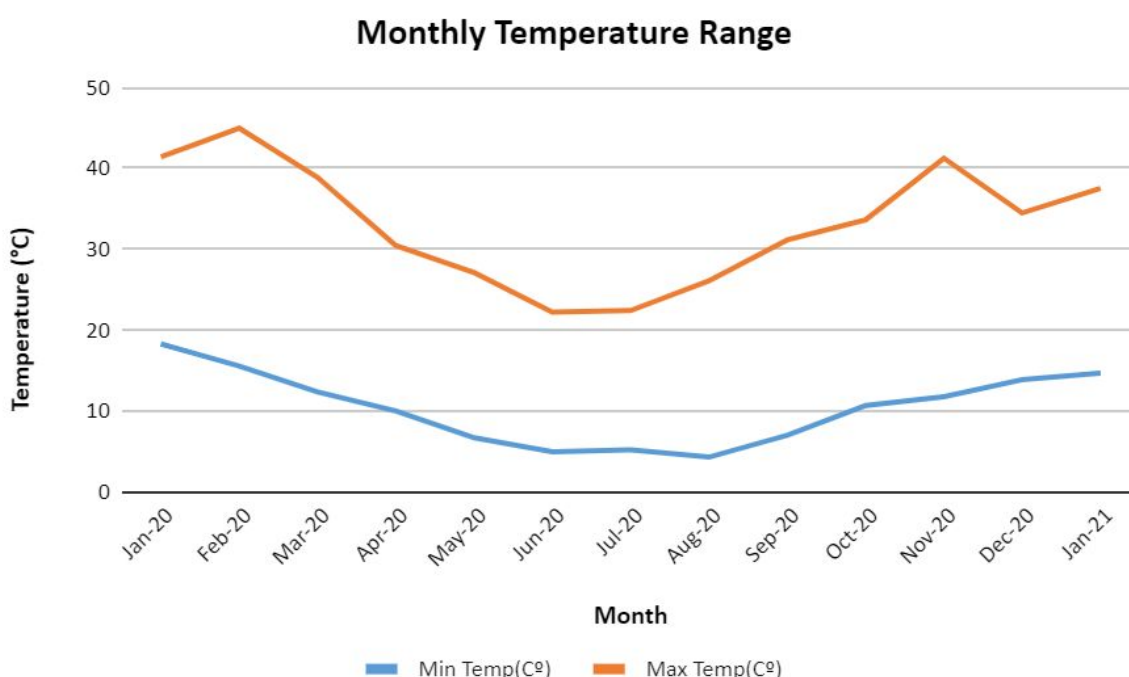
A summary of monthly rainfall and evaporation rates, as well as minimum and maximum monthly temperatures at the Terminal during this reporting period is presented below in **Figures 2.1** and **2.2** respectively.

Figure 2.1 - Average Monthly Temperature rates at the Terminal

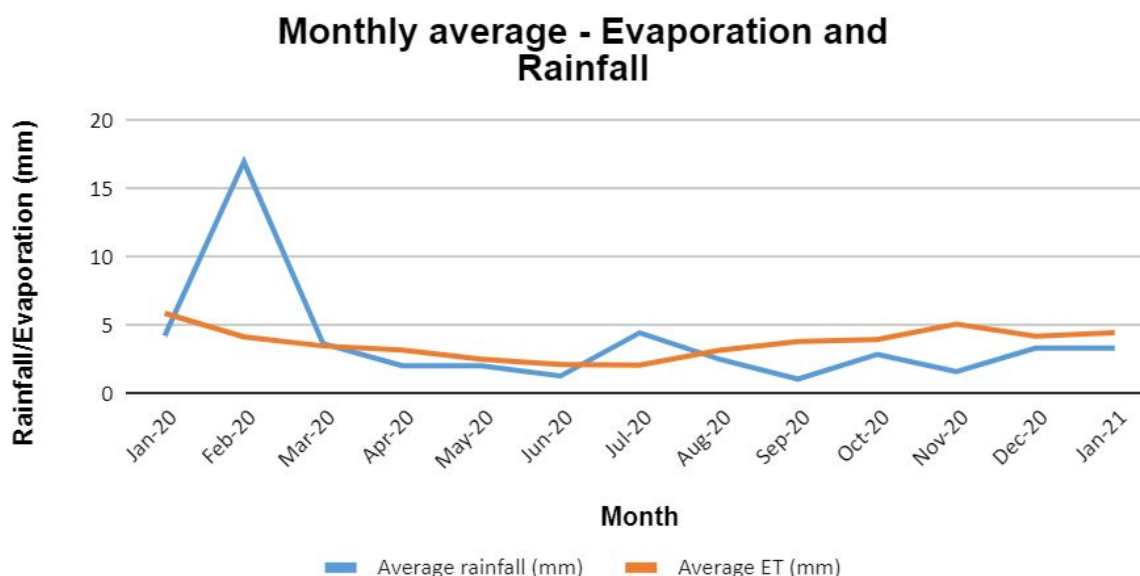
Overall, the average rainfall for the Terminal during this reporting period was recorded at 104.08mm per month.

Figure 2.2 - Average Evaporation and Rainfall rates at the Terminal

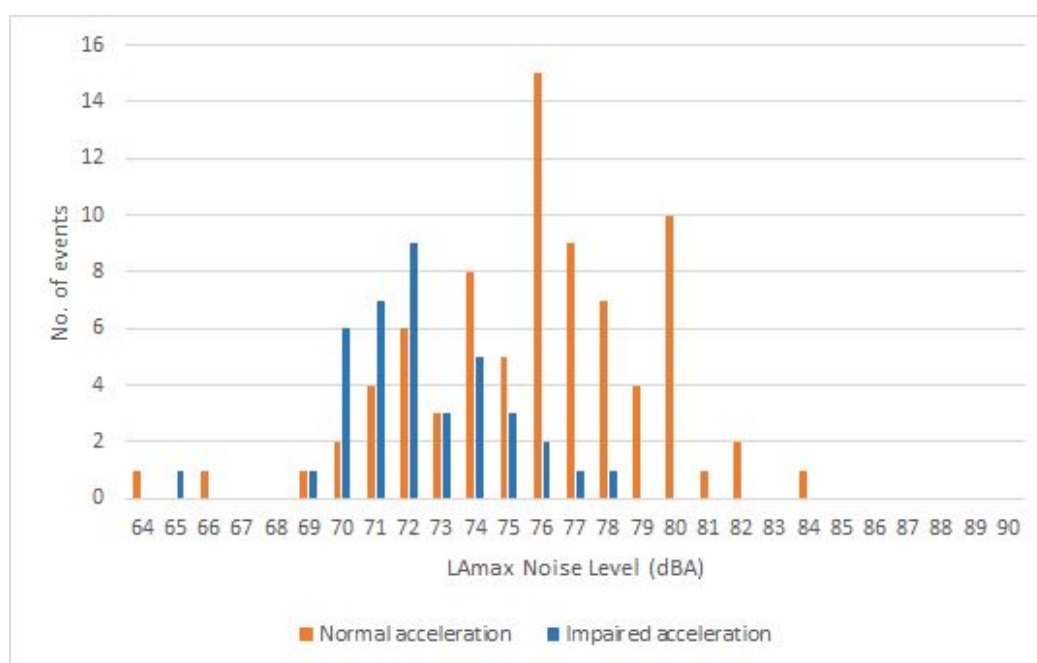
Figure 2.3 -Noise level distribution from Truck Noise Monitoring – 21 September 2020

All trucks monitoring were between 64dBA to 84dBA, and fell within or below the thresholds of 81dBA to 87dBA for Heavy Goods Vehicles with a GVM > 12 tonne in accordance with the Australian Design Rules (ADR) 28/01

The truck noise monitoring was undertaken on the 21st of September 2020 in accordance with Consent Condition 112 for this reporting period. Noise levels of 119 truck movements out of a daily total of 297 truck movements were measured, equivalent to 40.07% of truck movements. A

summary of the results is illustrated in **Figure 2.3**. Further details regarding truck movements at the site is discussed in **Section 2.4.1**.

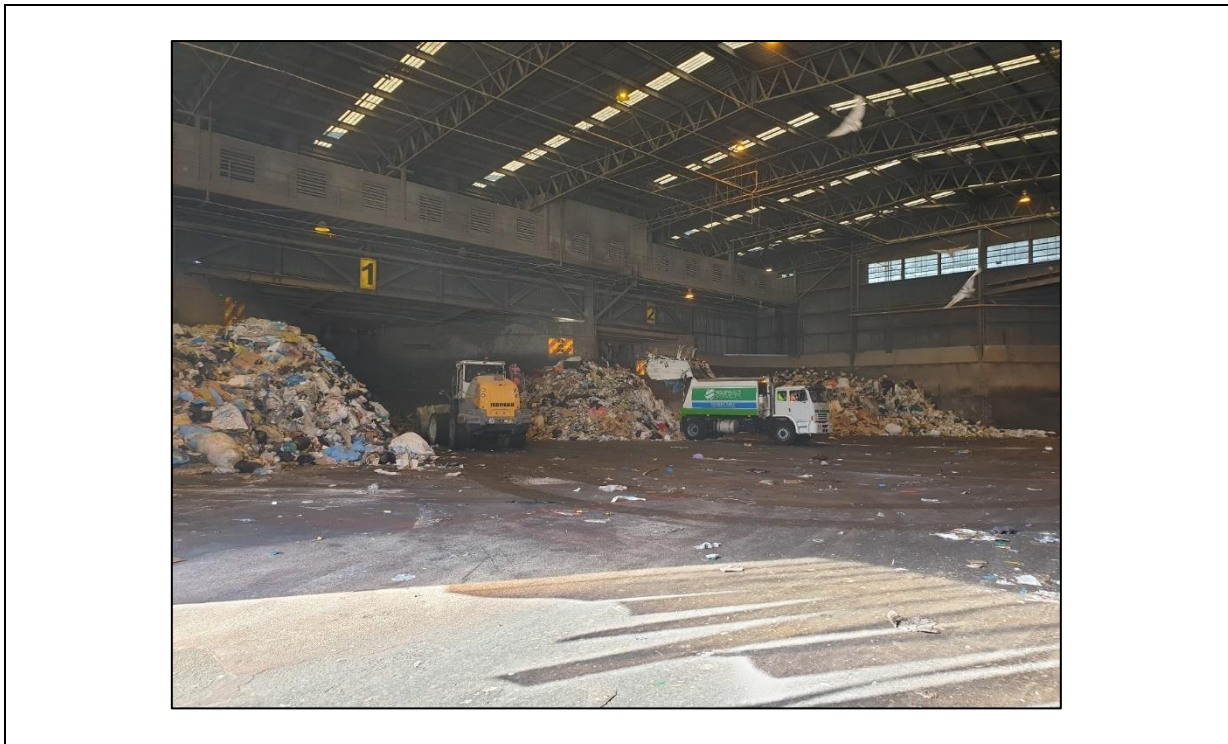
During the Odour Audit visit, there were approximately 250 to 300 tonnes of waste on the floor. This tonnage is considered to be within the normal operating range of the Transfer Terminal Building (TTB). The TTB floor area not covered by waste material was observed to be reasonably clean, with little evidence of leachate or aged material. General housekeeping procedures of the TTB were good, as found during several truck-unloading sequences. It was also observed that the TTB's front-end loaders cleared the floor area of waste on a regular basis, minimising the exposed area of waste.

As with previous audits, and consistent with TOU's experience at other waste transfer stations, there was a weak to distinct level of odour observed within the TTB. A photo of the waste on the floor as found during the Odour Audit visit is shown in **Photo 2.1**.

Photo 2.1 – TTB waste on-floor as found on 6 May 2020

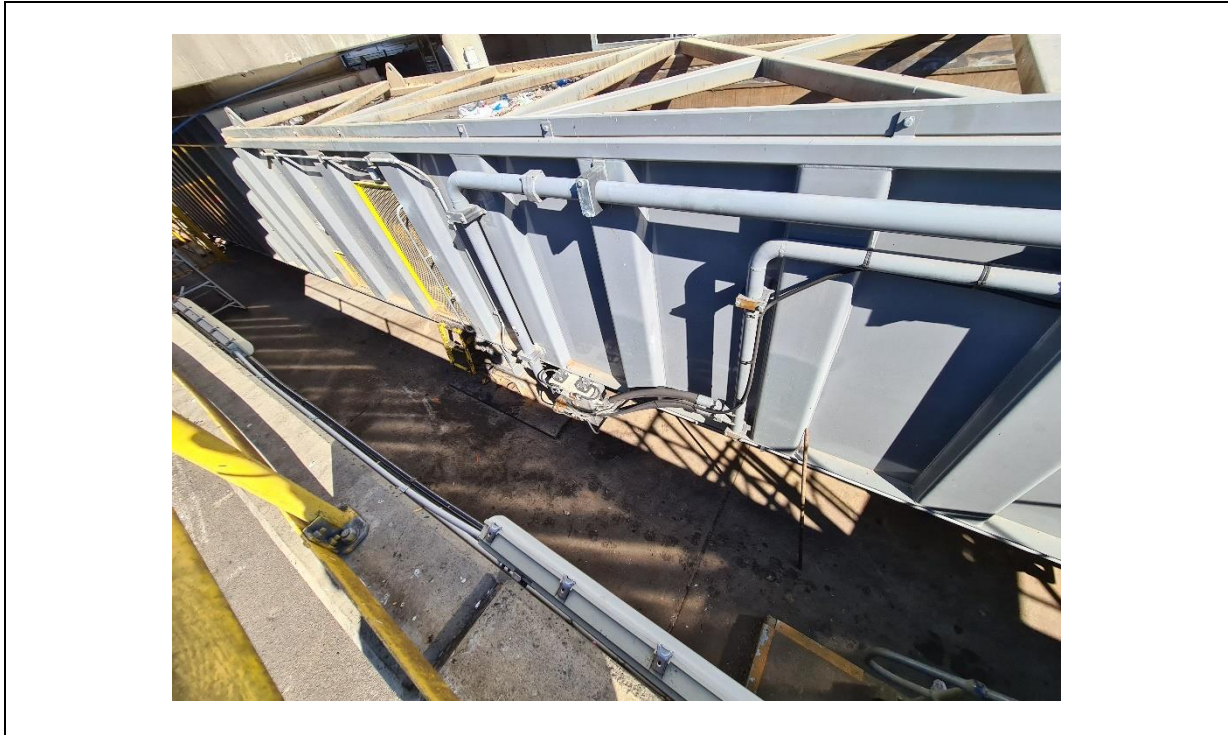
housekeeping around this area was observed to be of high quality, with no evidence to suggest otherwise.

As with previous Odour Audits, the containers are cleaned off-site at Veolia's Woodlawn Bioreactor Facility before being returned to the Site. The weight of each container is monitored to determine if there is any waste that has not been removed completely from each container, which in turn reduces the likelihood of the containers contributing to the Site's odour levels.

Photo 2.2 – A view of the container compacting/packing area as found on 6 May 2020

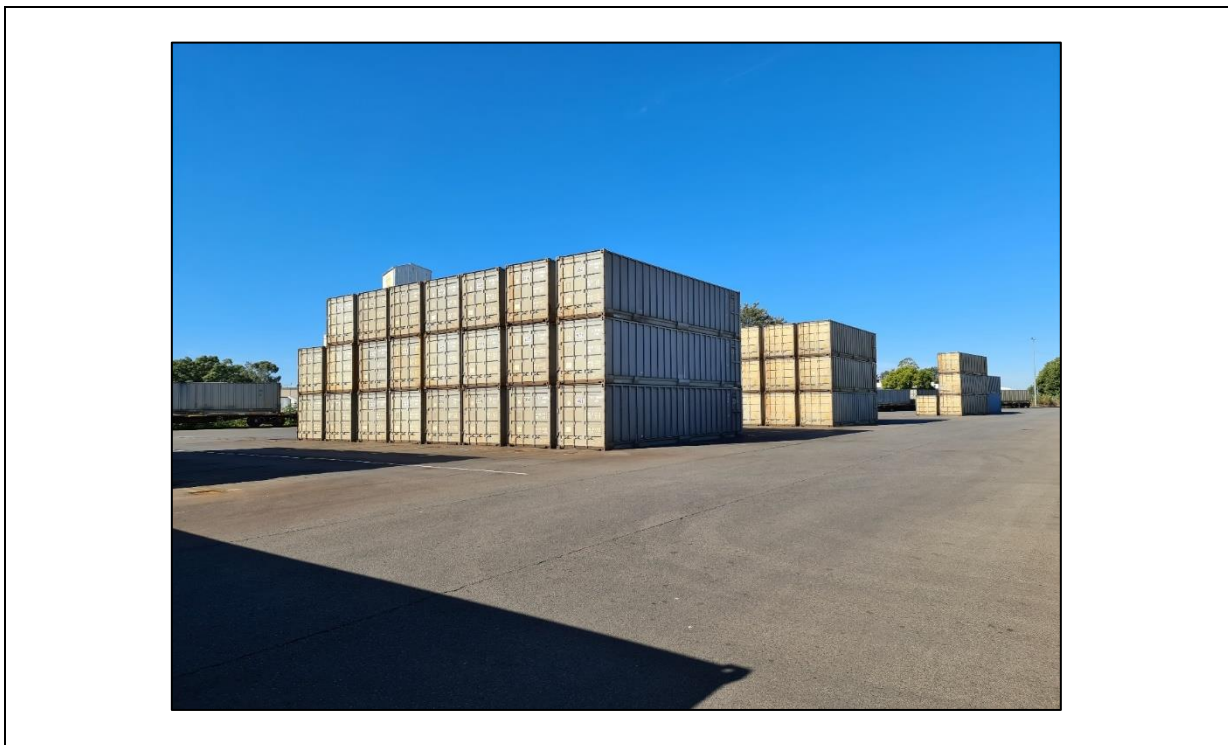
As per the Odour Management Plan dated February 2010 (**the February 2010 OMP**) for the Site, following the compaction of waste, all filled containers are entirely sealed and remain so while at the Site. All containers used are required to be in good condition, and unused/returned containers adequately clean. The Odour Audit finds that this continues to be current practice at the Site. A view of the condition of the compactor area as found on 6 May 2020 is shown in **Photo 2.3**.

Photo 2.3 – A view of the container area as found on 6 May 2020

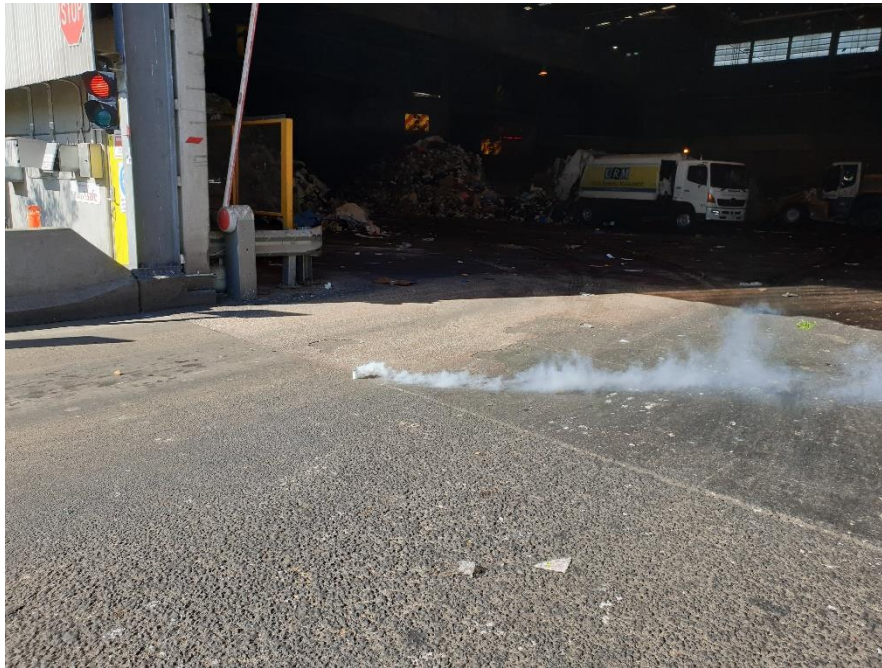
Photo 2.4 – A view of the truck entrance plastic strips as found on 6 May 2020

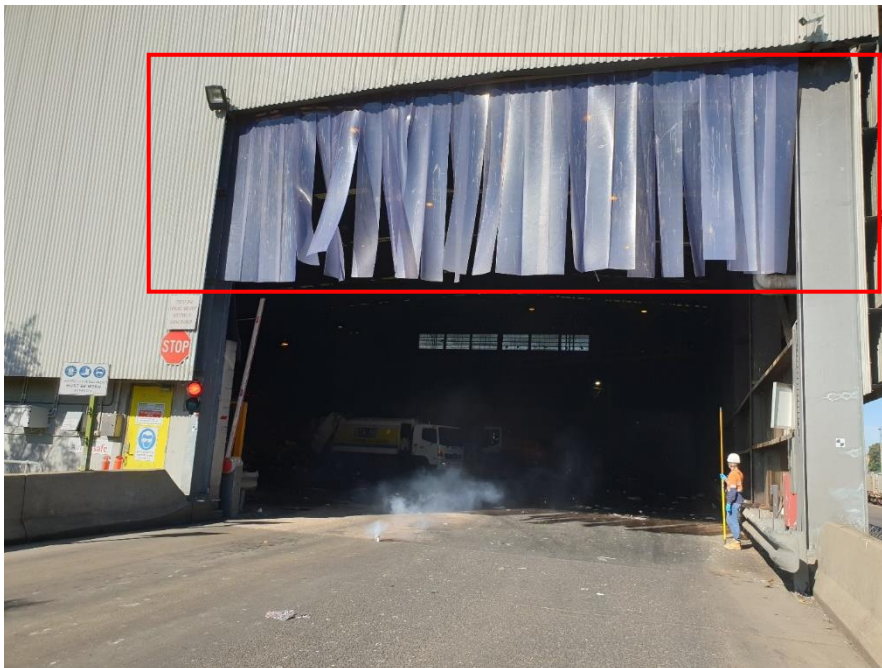
Photo 2.5 – A view of the truck entrance plastic strips during smoke testing on 6 May 2020

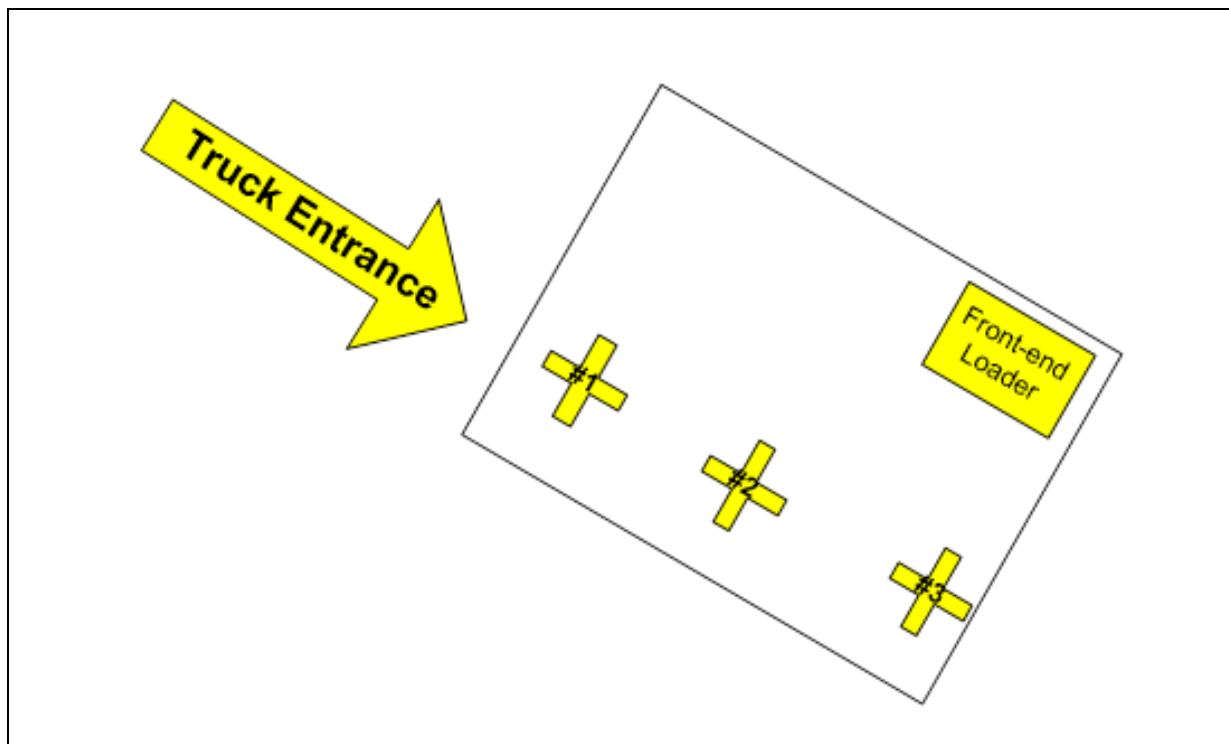
As per previous audits, smoke testing was carried out within the TTB to assist in determining the effectiveness of the forced air extraction system, as well as the extent to which the TTB has been sealed from leaks. As per previous audits, smoke was released from within the TTB at three points within the TTB. **Figure 2.1** shows the three points where the smoke was released within the TTB. **Photo 2.5** shows smoke testing at the truck entrance of the TTB, which reflects an additional test location to the normal smoke testing release points shown in **Figure 2.1**.

Figure 2.1 - Smoke testing release points within the TTB on 6 May 2020

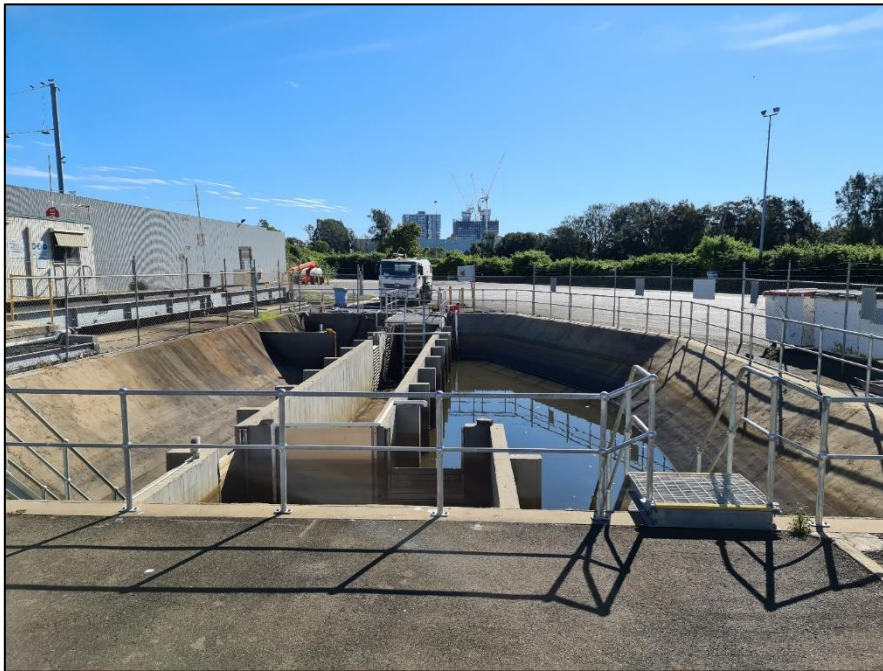
The auditor observed that there was effluent in this pond at the time of the Odour Audit visit. **Photo 2.6** shows the state of the pond as found on 6 May 2020.

Photo 2.6 – Stormwater retention pond as seen on 6 May 2020

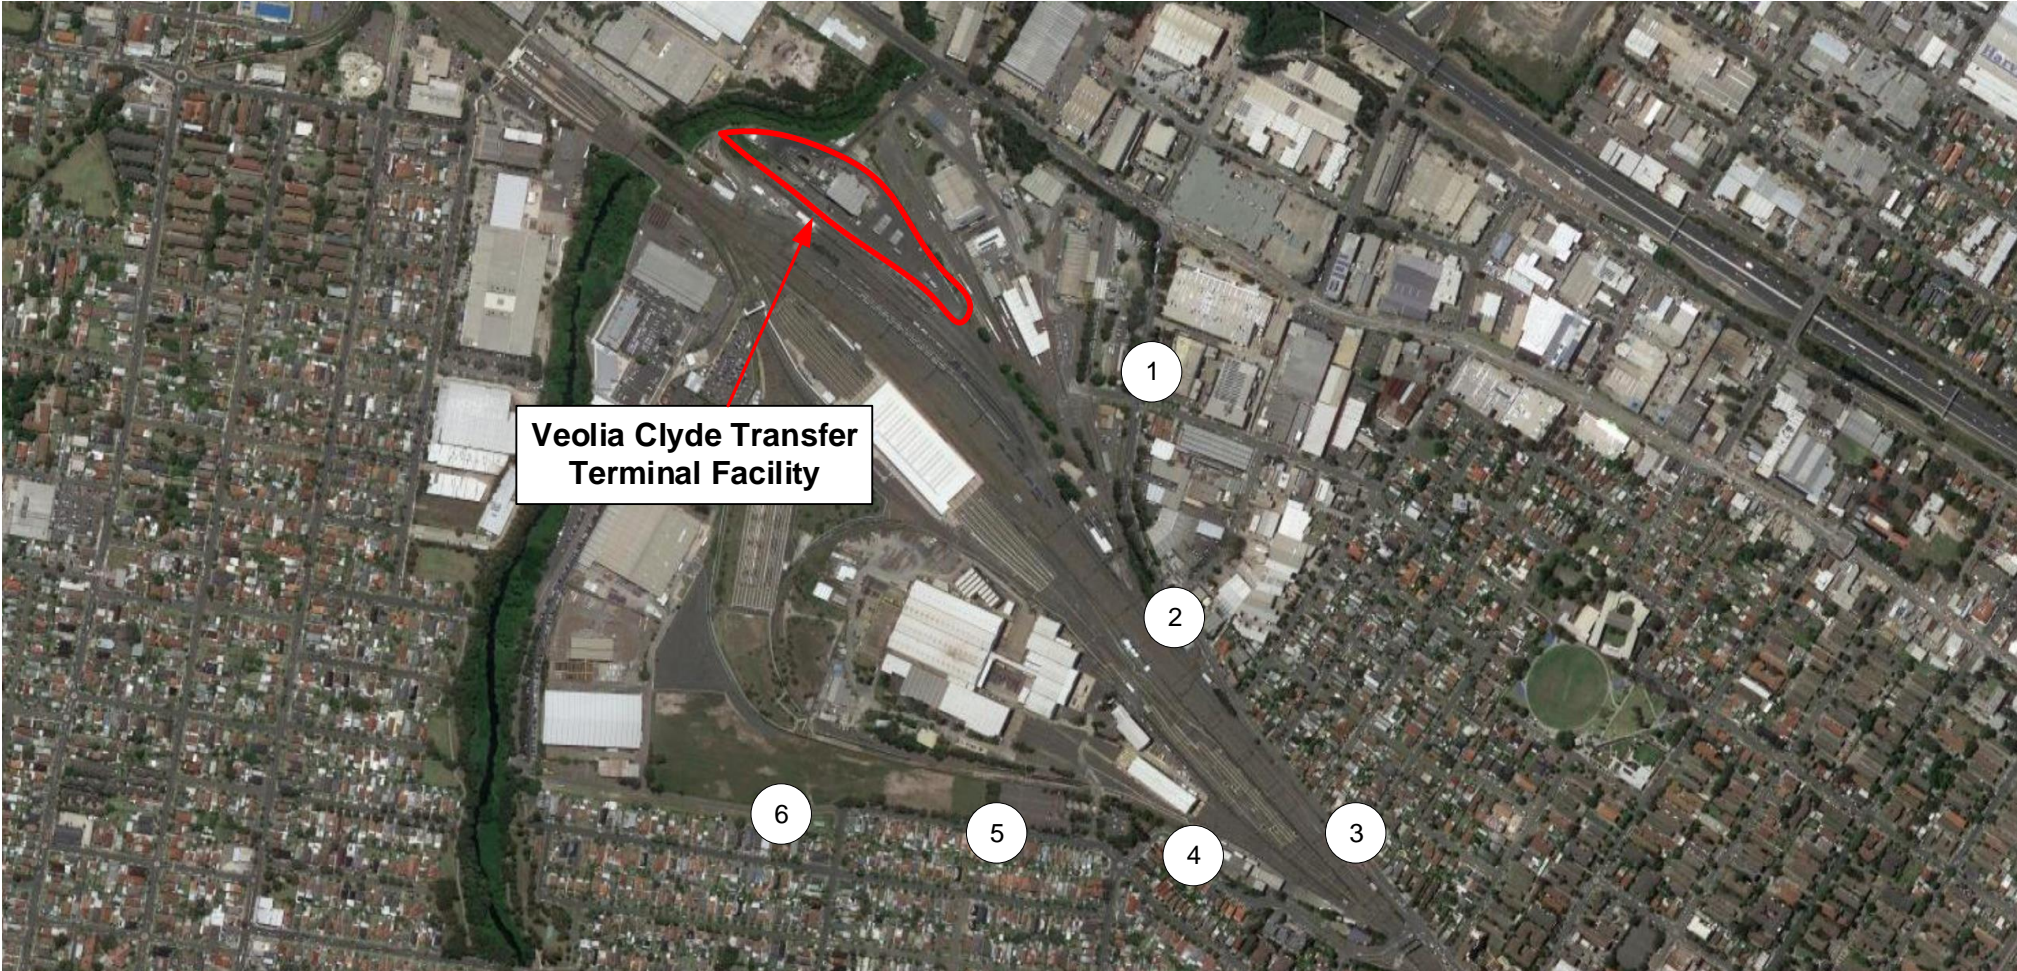
**FIELD AMBIENT ODOUR ASSESSMENT PLOT AND FIELD SHEETS (6
MAY 2020)**

DESCRIPTION Field Ambient Odour Assessment Survey Modified German Standard VDI 3940		LEGEND German Intensity Scale VDI3882 0 Not detectable 1 Very weak 2 Weak 3 Distinct 4 Strong 5 Very strong 6 Extremely strong

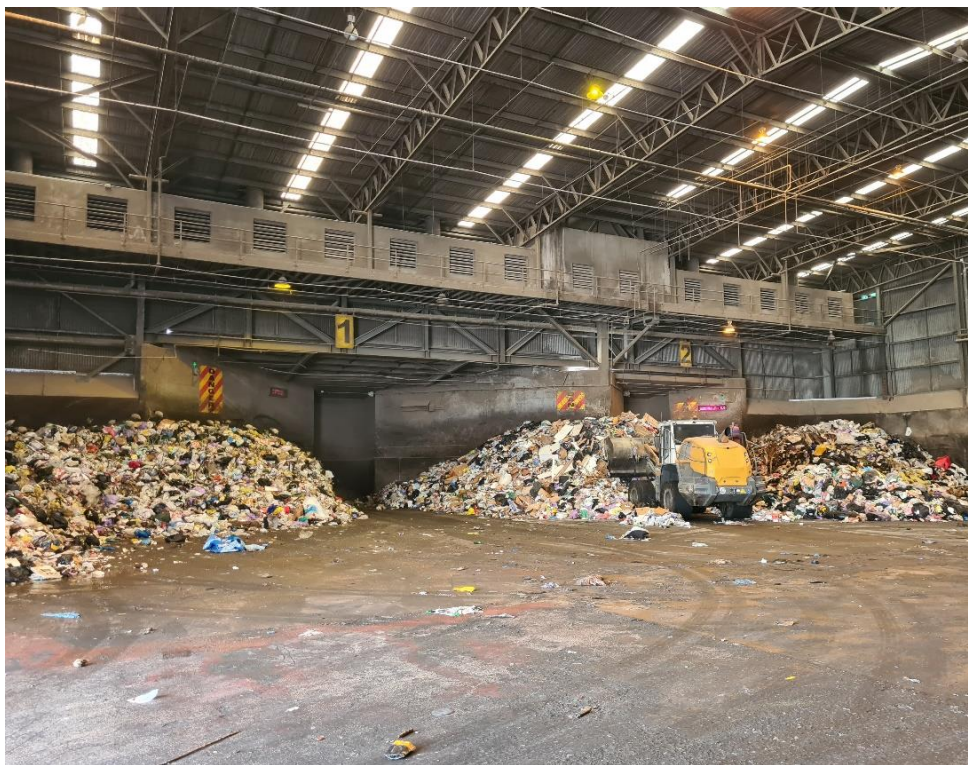
During the Odour Audit visit, there were approximately 300 to 400 tonnes of waste on the floor. This tonnage is considered to be within the normal operating range of the Transfer Terminal Building (TTB). The TTB floor area not covered by waste material was observed to be reasonably clean, with little evidence of leachate or aged material. General housekeeping procedures of the TTB were good, as found during several truck-unloading sequences. It was also observed that the TTB's front-end loaders cleared the floor area of waste on a regular basis, minimising the exposed area of waste.

As with previous audits, and consistent with TOU's experience at other waste transfer stations, there was a weak to distinct level of odour observed within the TTB. A photo of the waste on the floor as found during the Odour Audit visit is shown in **Photo 2.1**.

Photo 2.1 – TTB waste on-floor as found on 19 November 2020

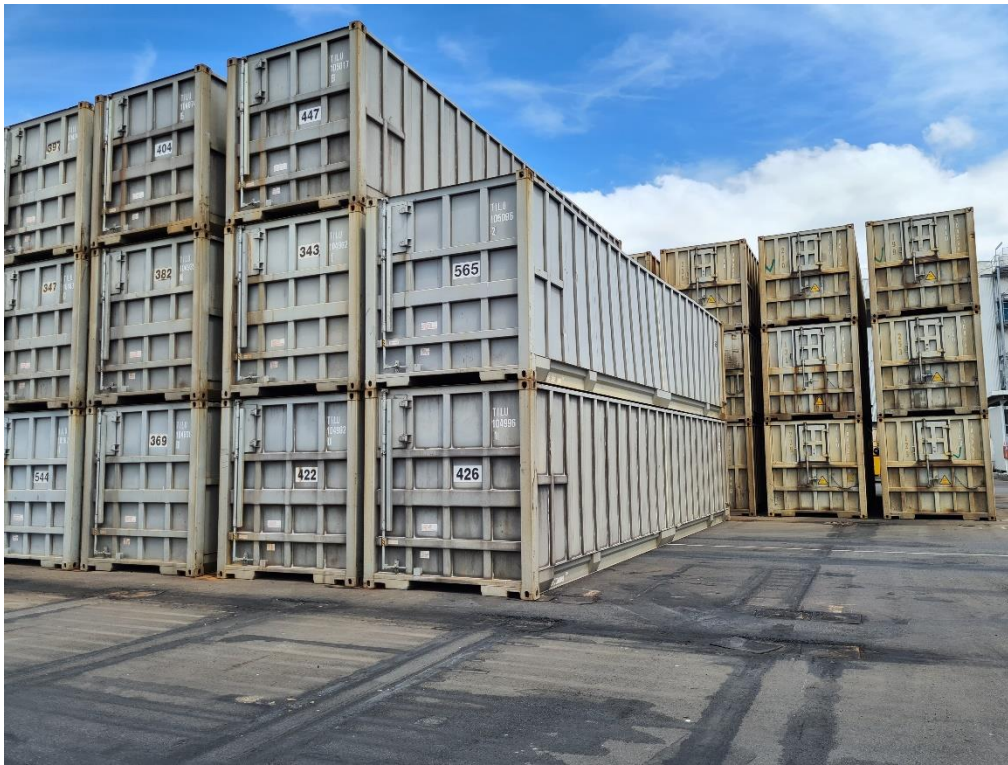
As per the Odour Management Plan dated February 2010 (**the February 2010 OMP**) for the Site, following the compaction of waste, all filled containers are entirely sealed and remain so while at the Site. All containers used are required to be in good condition, and unused/returned containers adequately clean. The Odour Audit finds that this continues to be current practice at the Site. A view of the condition of the container area as found on 19 November 2020 is shown in **Photo 2.2**.

Photo 2.2 – A view of the container area as found on 19 November 2020

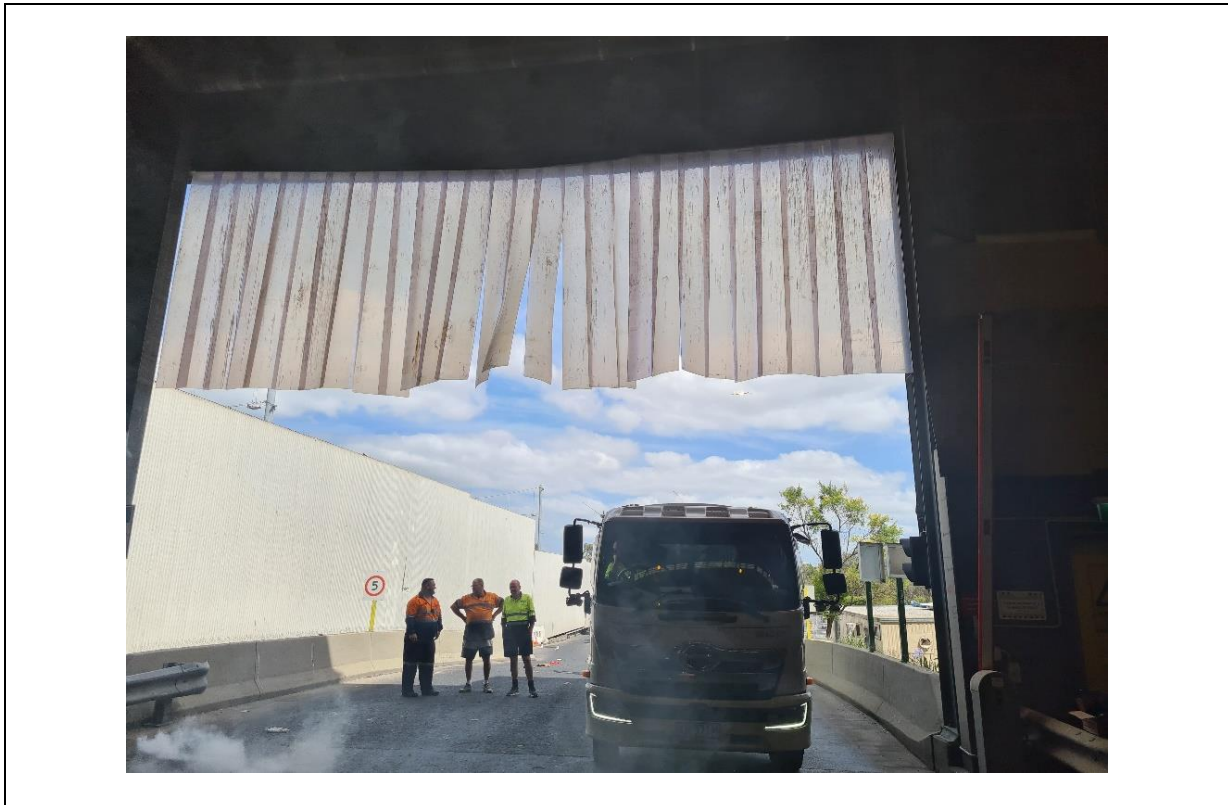
Photo 2.3 – A view of the truck entrance plastic strips as found on 19 November 2020

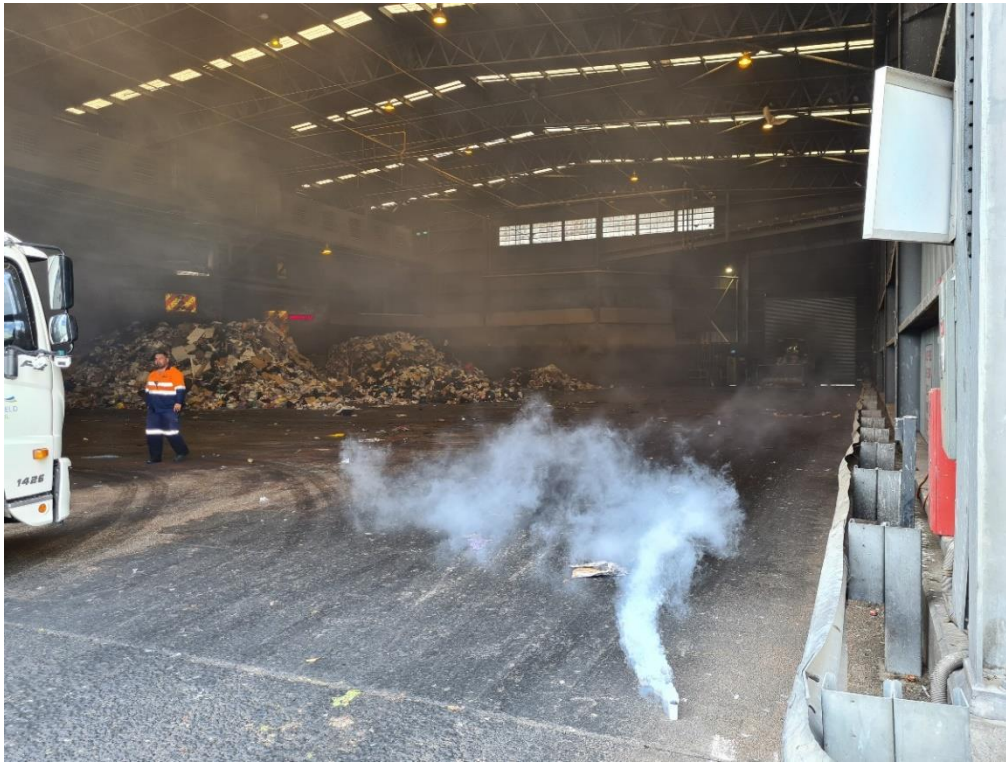
Photo 2.4 – A view of the truck entrance plastic strips during smoke testing on 19 November 2020

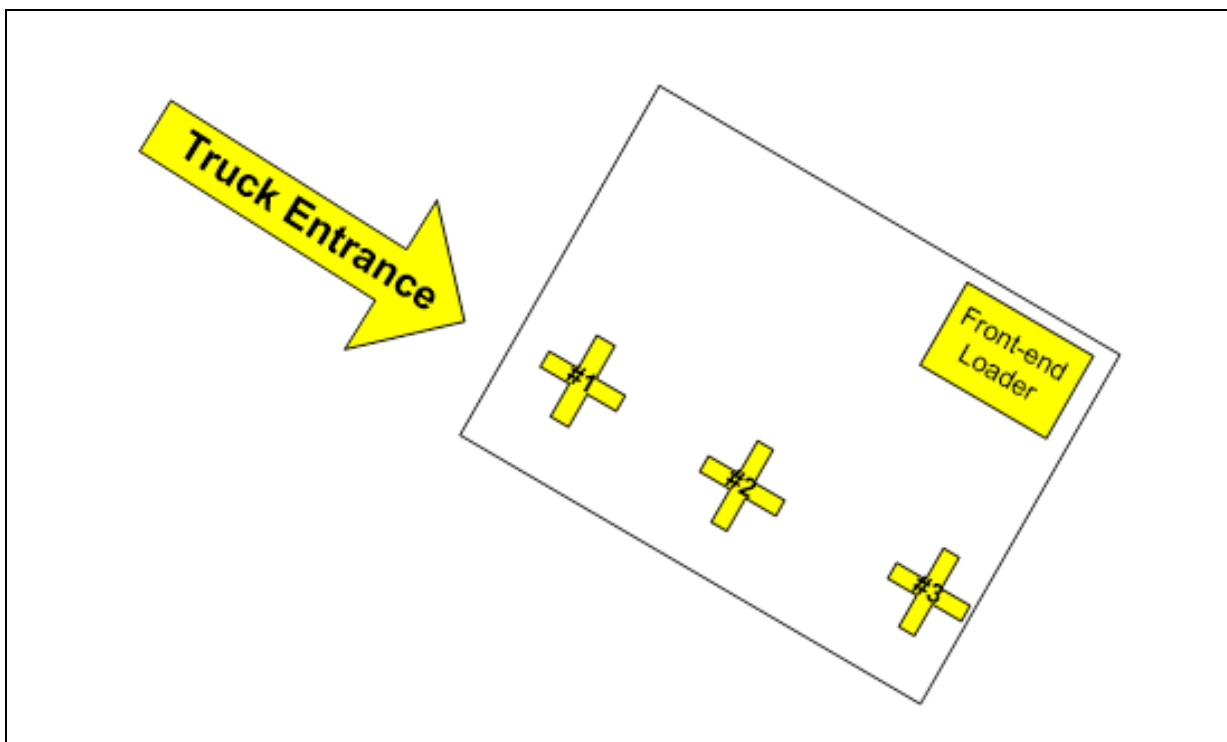
As per previous audits, smoke testing was carried out within the TTB to assist in determining the effectiveness of the forced air extraction system, as well as the extent to which the TTB has been sealed from leaks. As per previous audits, smoke was released from within the TTB at three points within the TTB. **Figure 2.1** shows the three points where the smoke was released within the TTB. **Photo 2.4** shows smoke testing at the truck entrance of the TTB, which reflects an additional test location to the normal smoke testing release points shown in **Figure 2.1**.

Figure 2.1 - Smoke testing release points within the TTB on 19 November 2020

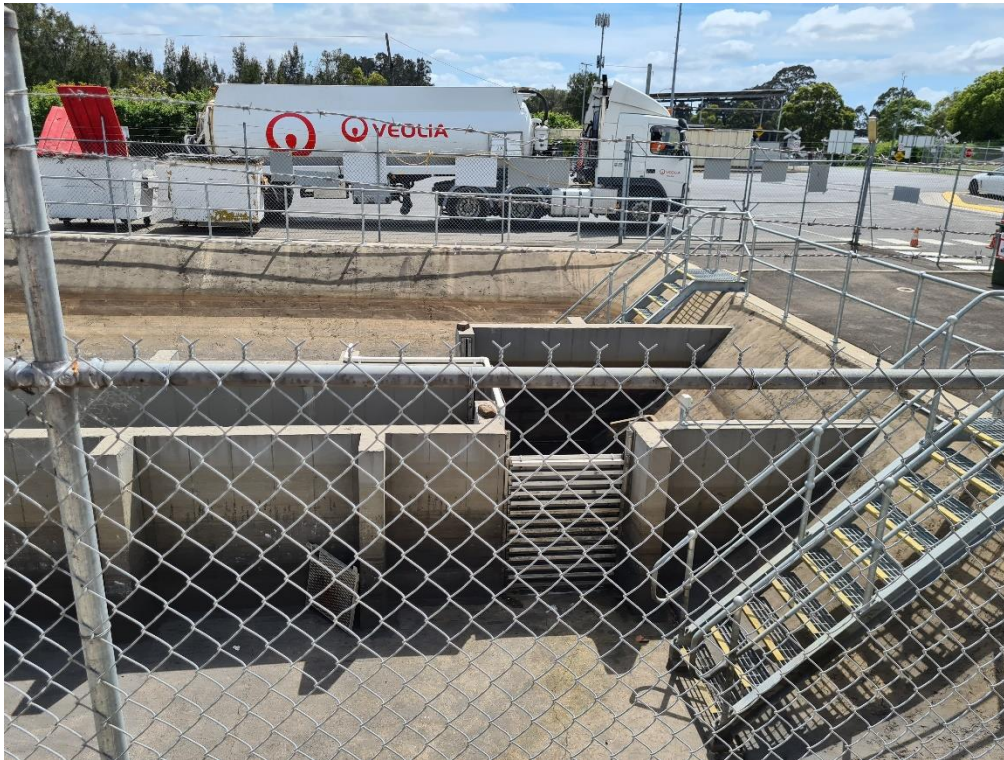
The stormwater retention pond during the Odour Audit visit was empty, as shown in **Photo 2.5**.

Photo 2.5 – Stormwater retention pond as seen on 19 November 2020

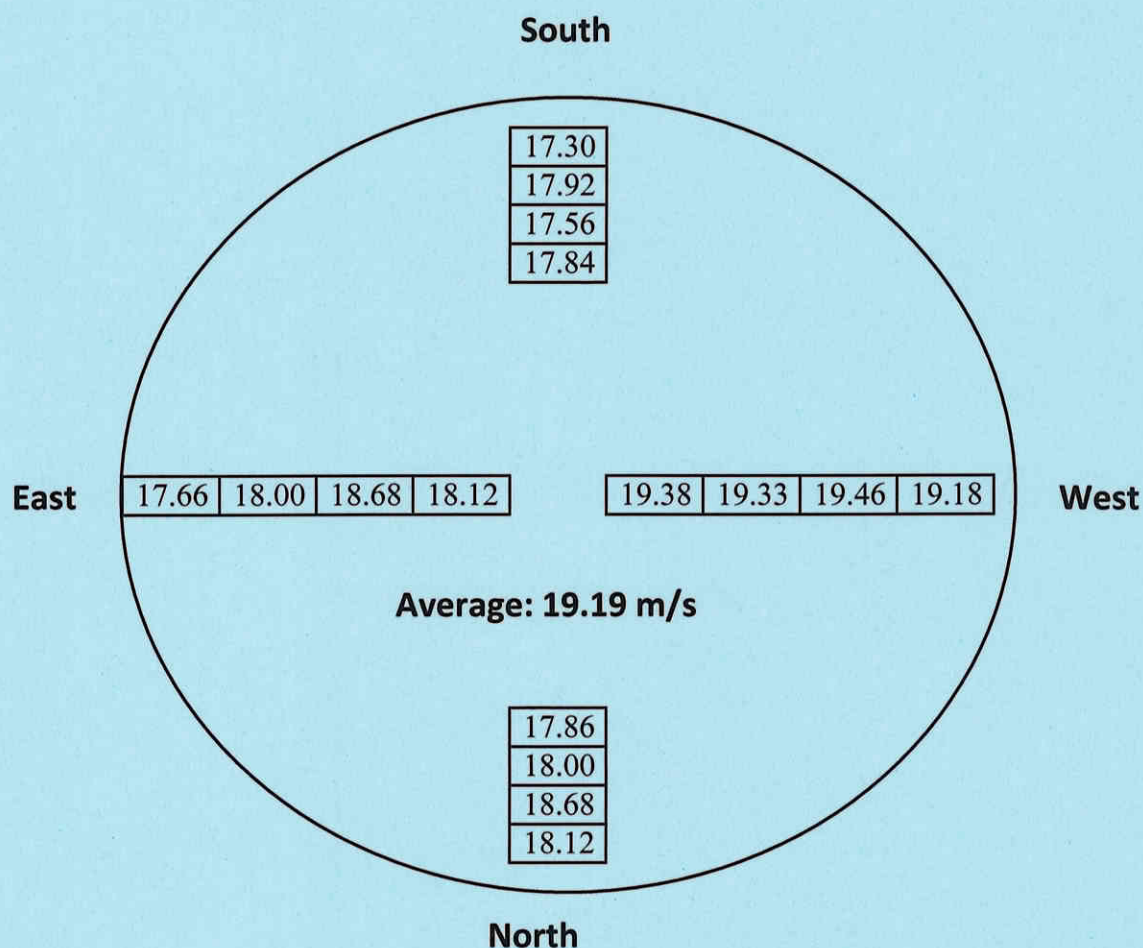
AIR VELOCITY PROFILES

Exhaust Stack

All readings in meter per second - m/s

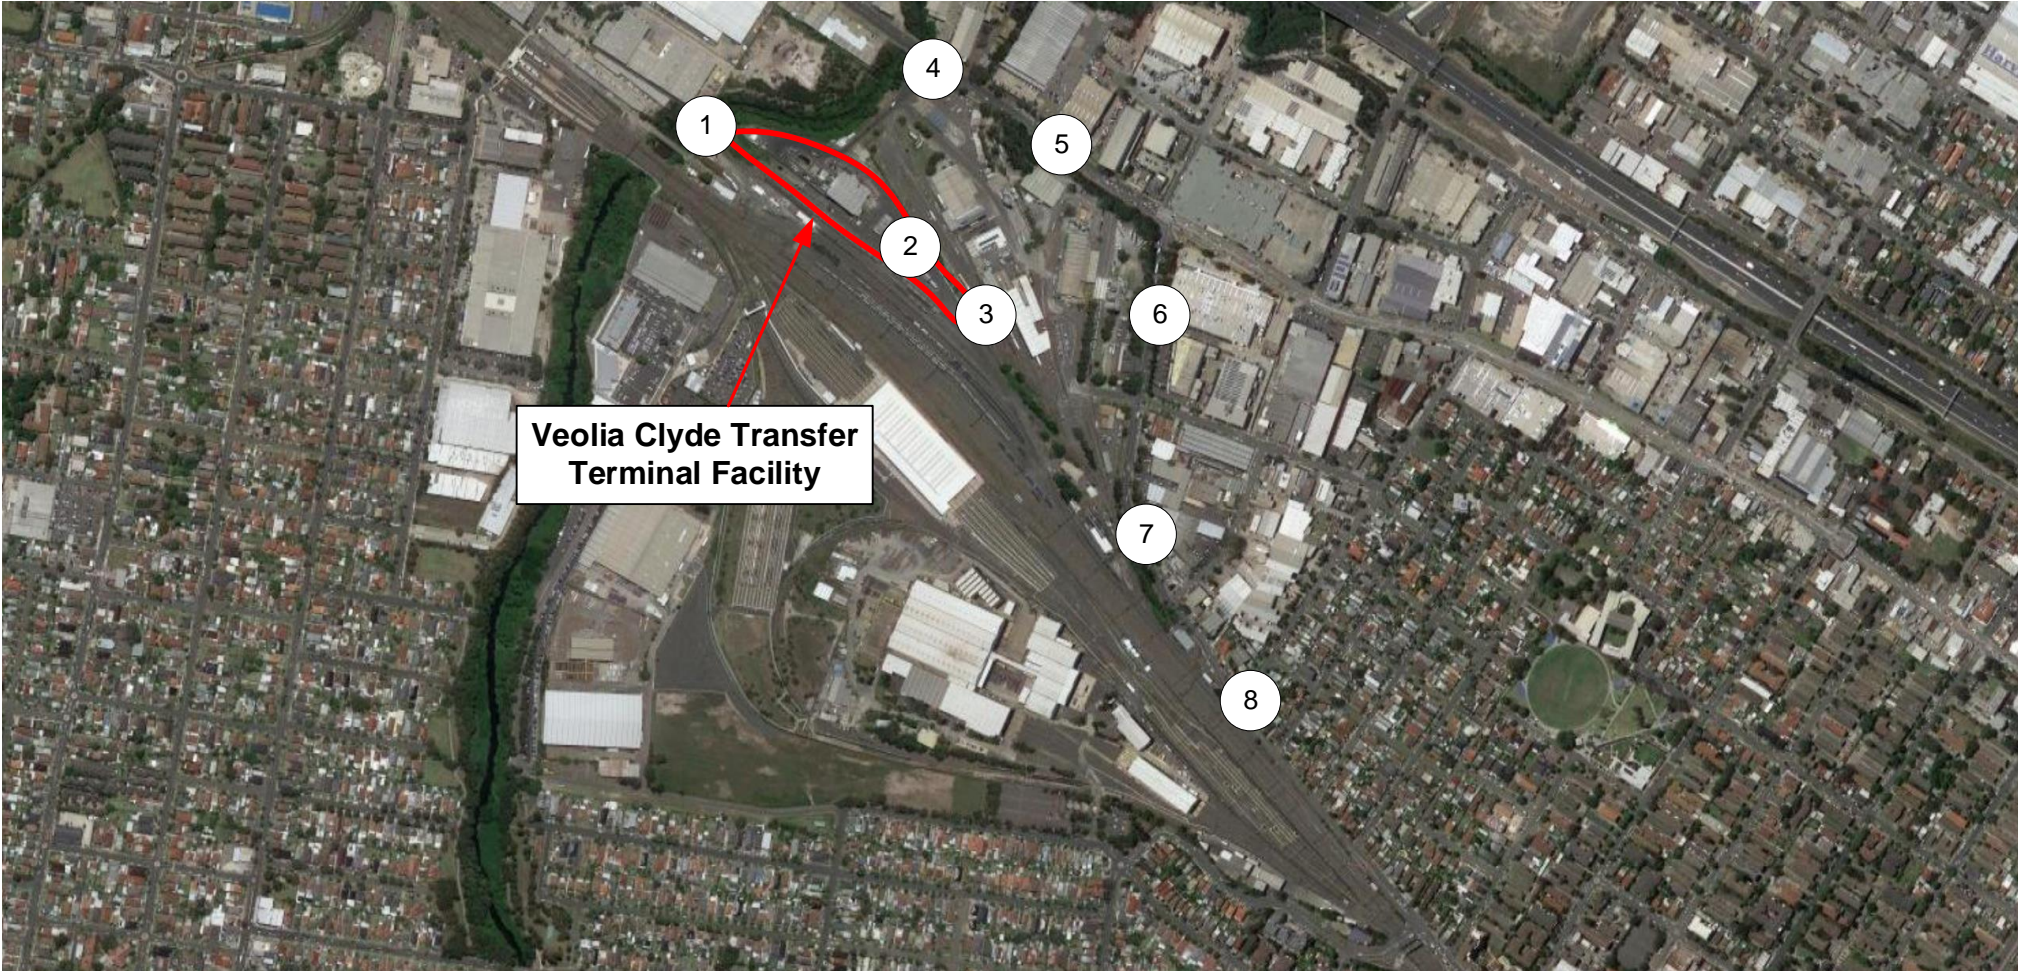
FIELD AMBIENT ODOUR ASSESSMENT PLOT AND FIELD SHEETS (19
NOVEMBER 2020)

DESCRIPTION Field Ambient Odour Assessment Survey Modified German Standard VDI 3940		LEGEND German Intensity Scale VDI3882 0 Not detectable 1 Very weak 2 Weak 3 Distinct 4 Strong 5 Very strong 6 Extremely strong

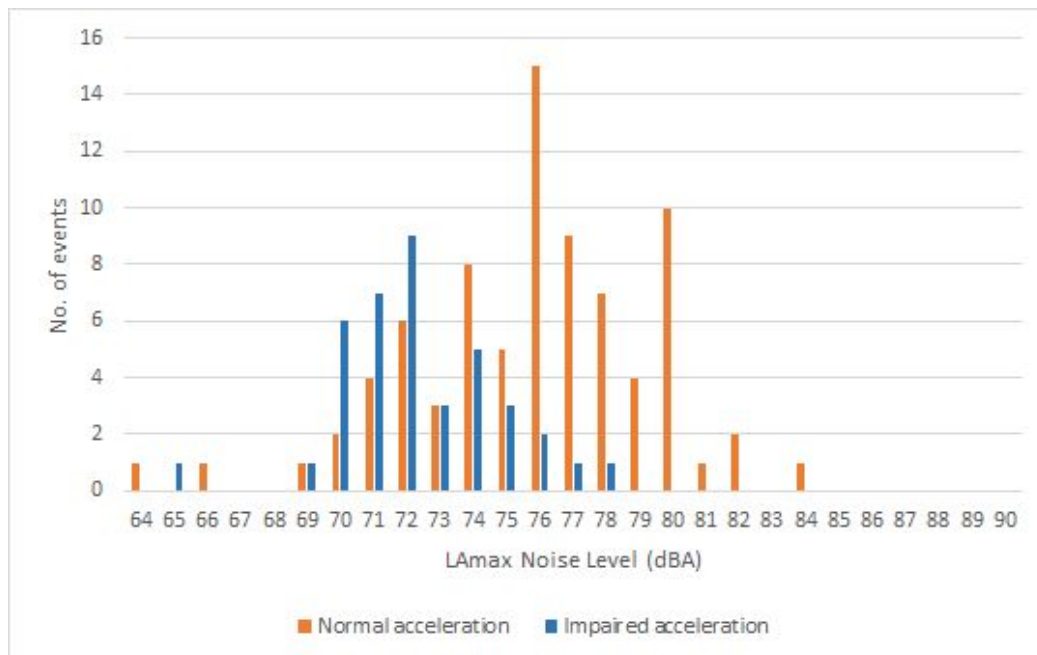
Measurements of 'normal' truck acceleration ranged from 64dBA to 84dBA with the highest frequency occurring between 76dBA to 80dBA. Impaired acceleration readings due to the impeded traffic conditions ranged from 65dBA to 78dBA, with the highest frequency occurring 72dBA. Impaired acceleration readings were plotted separately from the normal accelerating vehicles on Figure 1.

Figure 1: Noise level distribution from Truck Noise Monitoring – 21st of September 2020

A total measurement of 40.07% of all truck movements (297) was achieved during this monitoring round, which satisfies the minimum requirements of Condition 112 (25% of daily truck movements). Figure 1 presents the distribution of recorded sound level frequencies which were measured in A-weighted decibels (dBA).
