Clyde Waste Transfer Terminal

Odour Audit VI

Final Report

August 2006

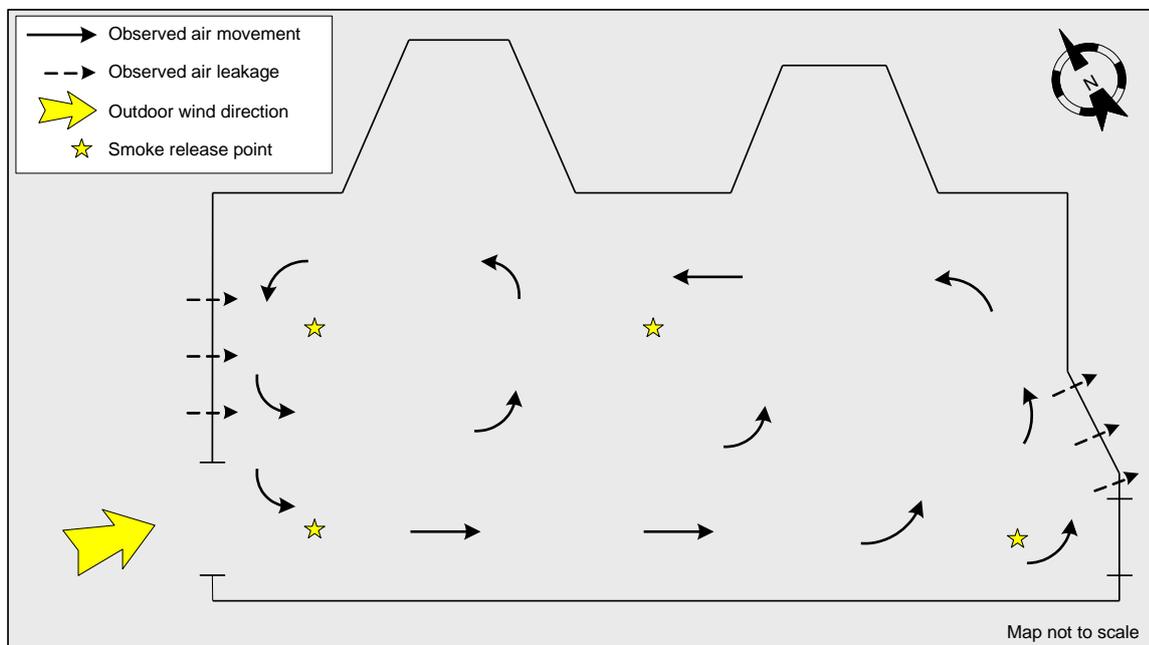
Figure 2.1 – Transfer Building smoke release locations and observed air flow patterns.

The principal finding of the smoke testing re-confirmed what was found in previous odour audits; that there was minimal visible airflow towards the extraction fans. The bulk of the smoke dispersed inside the building as if there were little mechanically induced air movement, circulating slowly around the building in a counter-clockwise direction (see

Figure 2.1). The predominantly westerly airflow through the doorway was the main influencing factor in this airflow pattern.

The smoke was observed to rise above the breezeways of the western wall indicating that there was air movement into the building through gaps, helping to pressurise the building. The smoke descended from above the open doorway and returned into the main westerly flow near the surface. The recent installation of a plastic strip curtain covering the upper-third of the open doorway has effectively prevented the smoke exiting from out the top of the doorway.

In addition, smoke released at the southeastern corner showed clearly that air was escaping the building through gaps in the sealed breezeway of the eastern wall, in particular the un-sealed breezeway directly north of the roller-door.

It has been acknowledged in previous odour audits that the Clyde facility and the large number of truck movements could 'pressurise' the Transfer Building due to wind pressure on the open doorway. It is therefore essential that continued work be performed on improving the sealing of the breezeways and other 'gaps' in the building.

The proposed new extraction system, using a single tall stack, will result in the changes to the airflows within the building. The effect of this system will need to be assessed, once this system is commissioned.

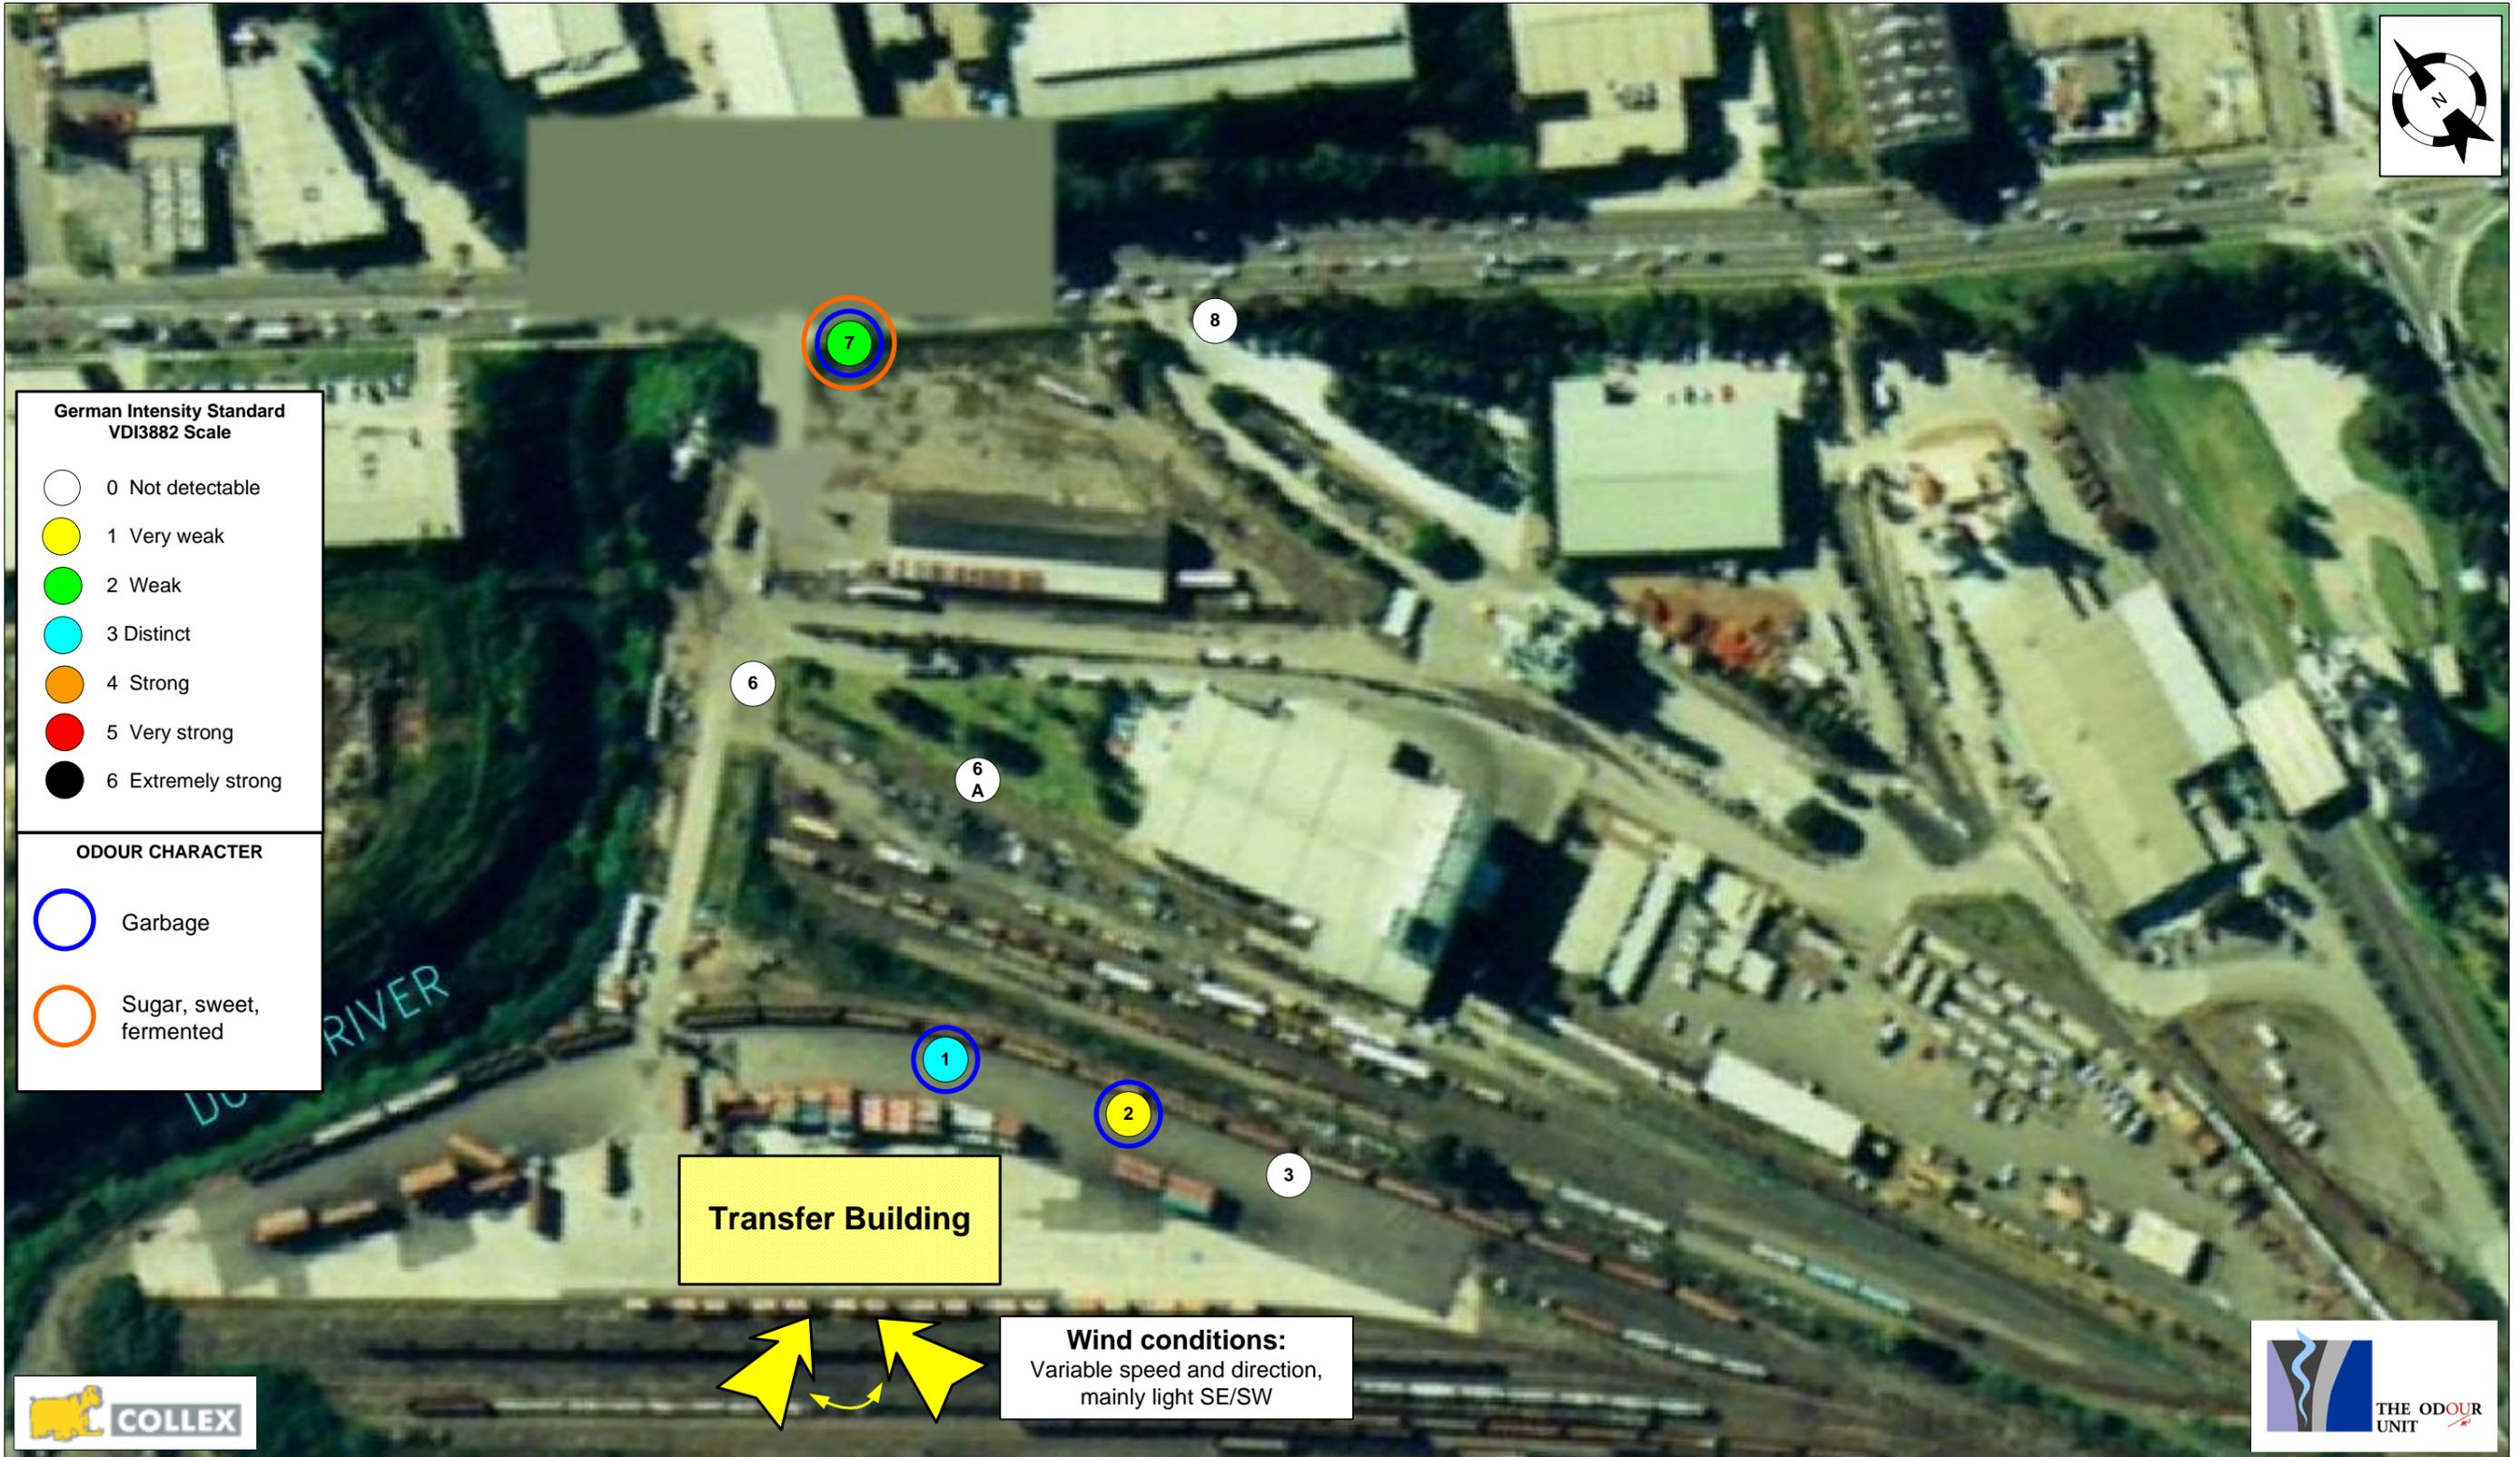
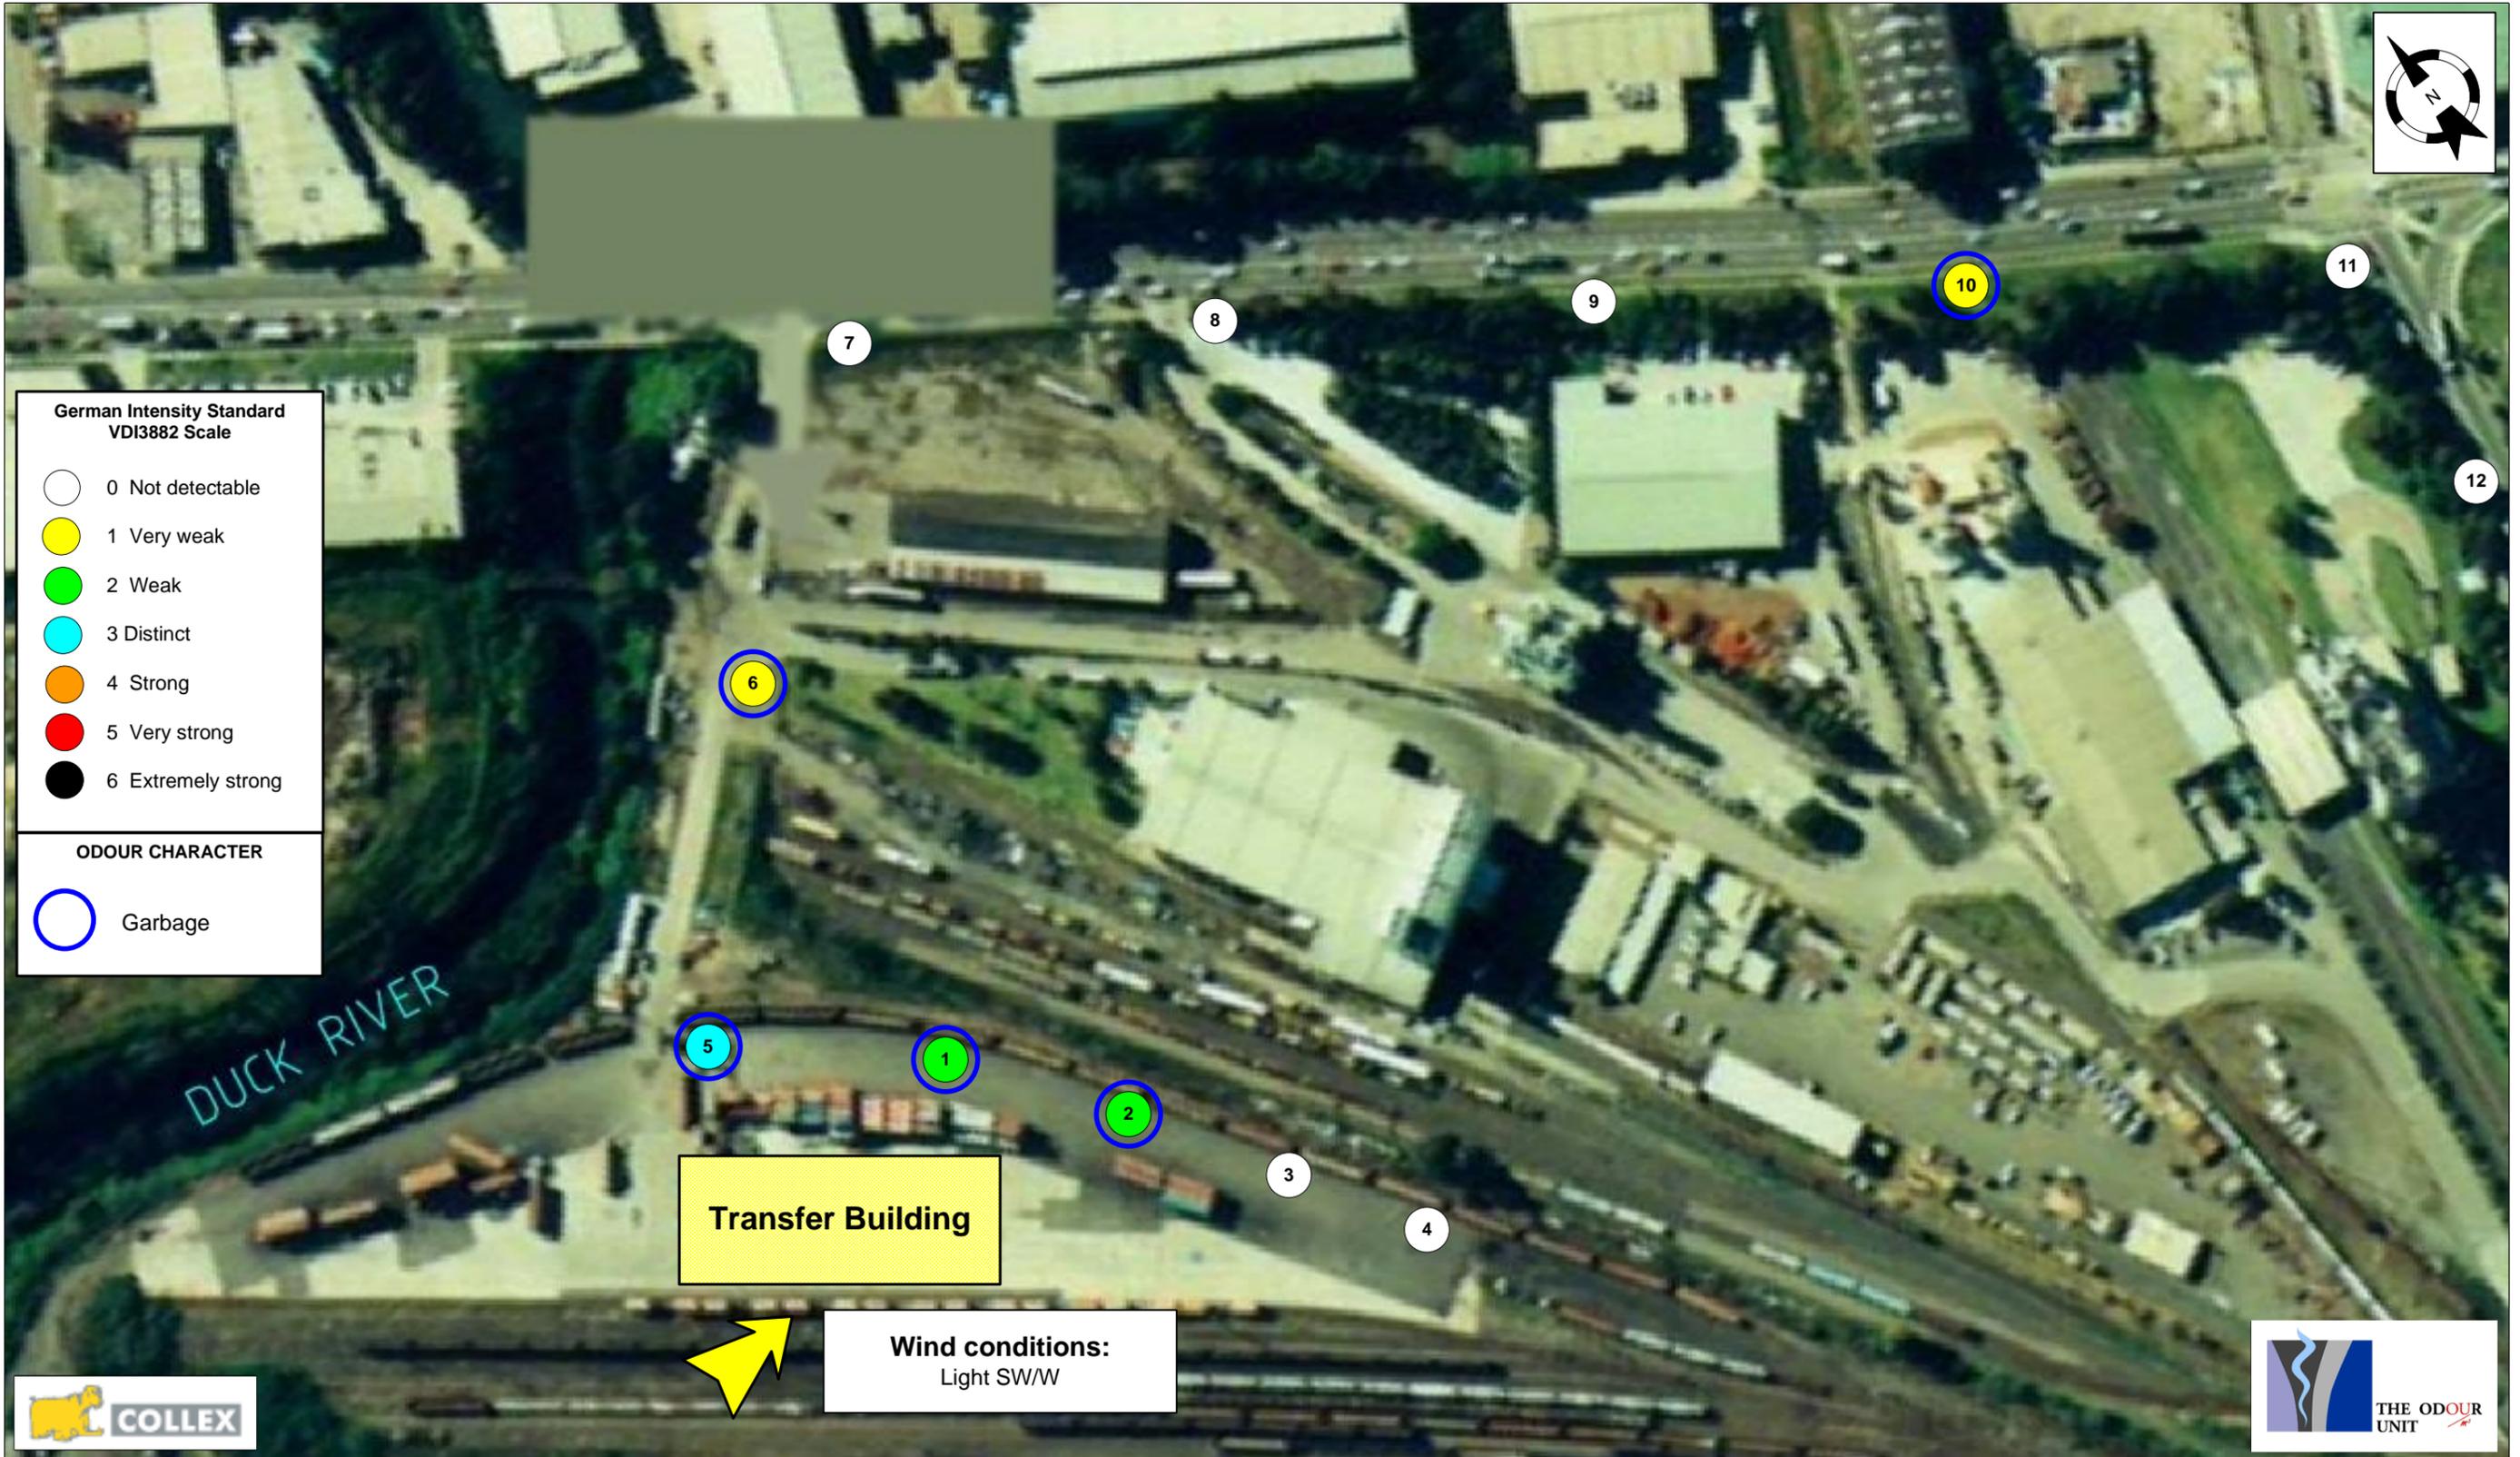
Ambient Assessment Log Sheets and Location Map

The results of the ambient assessment surveys are depicted in two principal ways. The field log sheets completed by the assessors contain the unprocessed data for each location and the derived result of the survey is illustrated as an odour impact map. The map illustrates the locations assessed, and the level of odour intensity detected downwind of the Clyde facility.

As **Appendix A** illustrates, the characteristic garbage smell was localised to the access roads around the transfer building, eliciting a peak intensity score of 3 (distinct). Very weak

to weak intensity (score: 1 – 2), intermittent garbage odour was also detected along Parramatta road on both occasions.
