Annual Environmental Management Report

Banksmeadow Transfer Terminal

June 2018

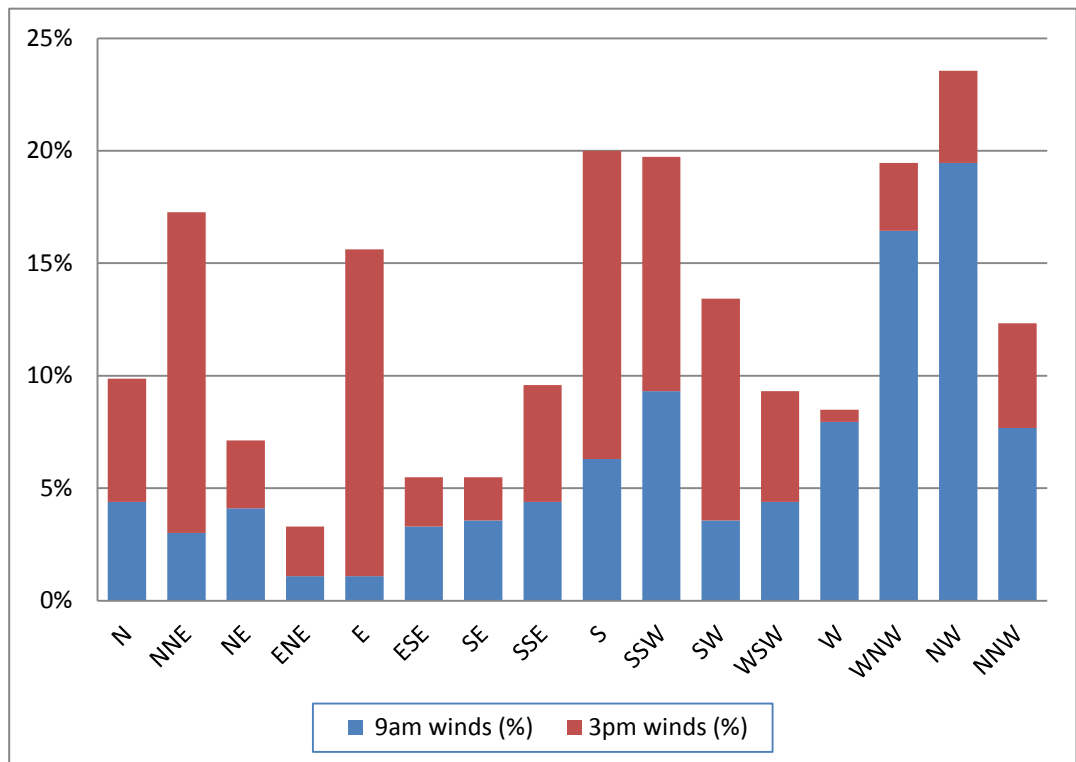
Figure 2-1 9AM and 3PM wind direction data during the reporting period

A summary of daily wind speeds and wind directions at 9am and 3pm at the nearby BoM weather station is presented in Figure 2-1 and Figure 2-2. During the reporting period the 9am and 3pm the prevailing wind directions were north-westerly and south-westerly and the wind speeds were most frequently between 11 – 20 m/s.

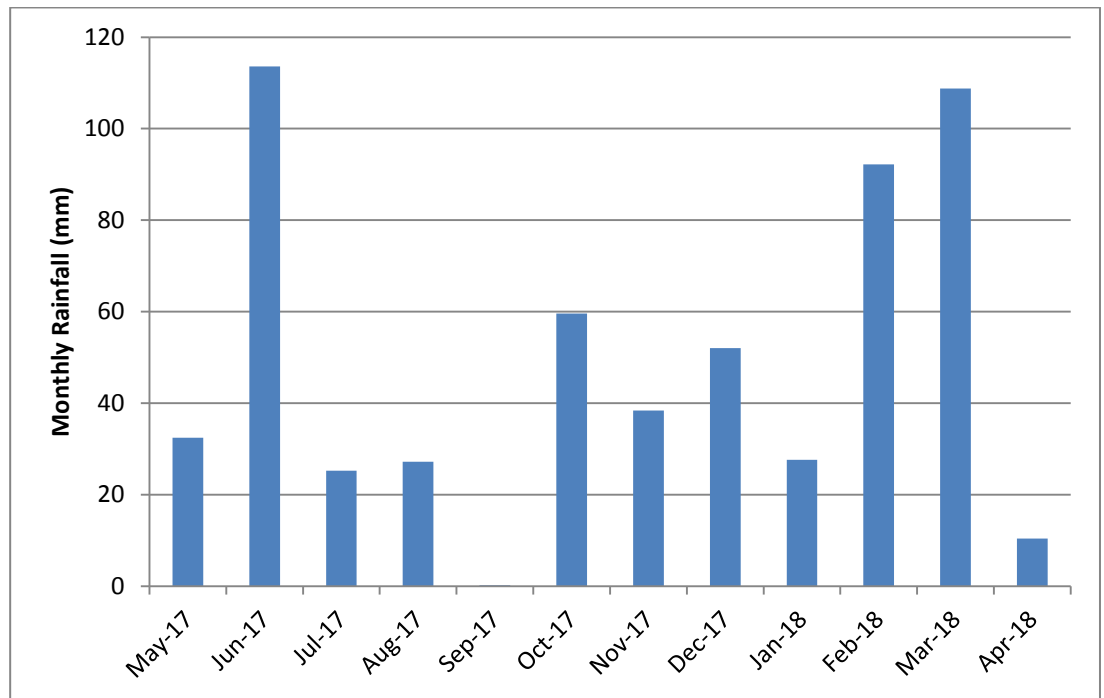
Figure 2-3 Monthly rainfall data during the reporting period

A summary of rainfall data at the Terminal during the reporting period is presented in Figure 2-3. Overall, the average rainfall for the Terminal during the reporting period was approximately 49mm per month.

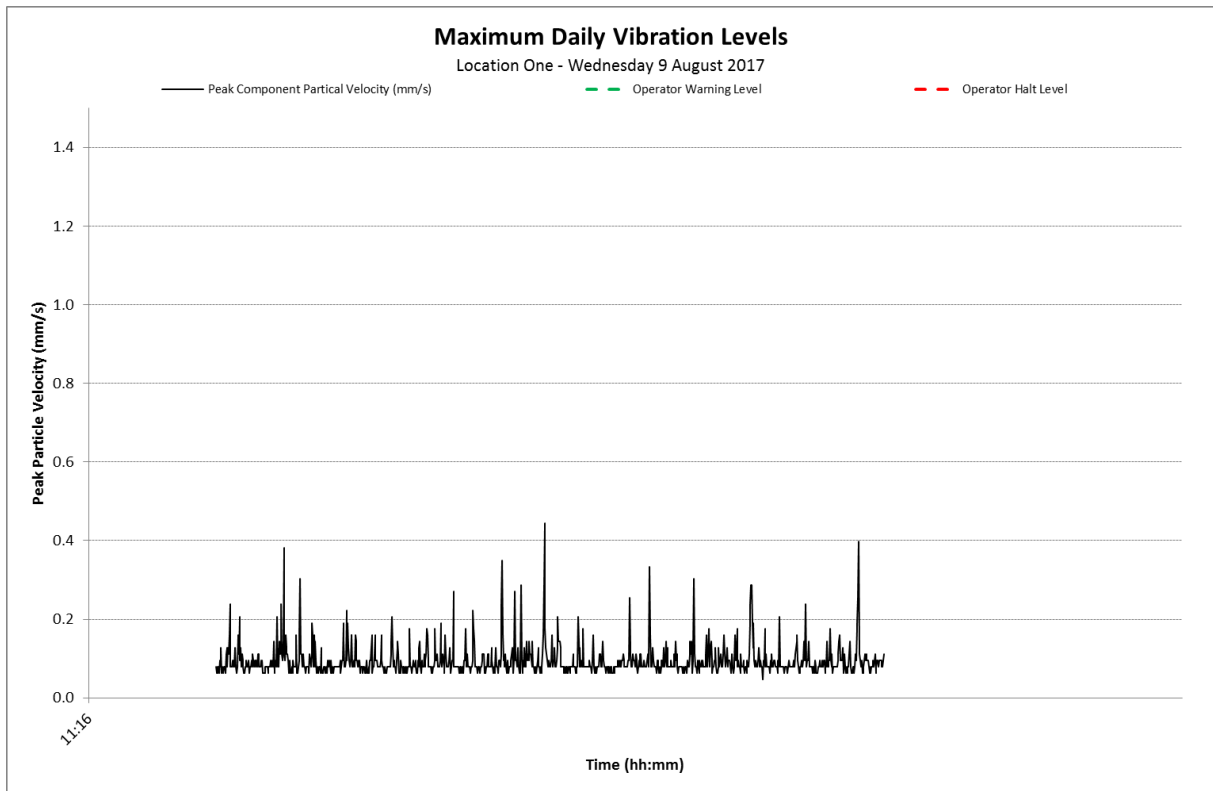
Figure 2 Peak Vibration Levels – Location One

Measured maximum PPV levels recorded in 15 second intervals are shown in **Figure 2** and **Figure 3**.

Location	Date / Time	Measured Maximum PPV (mm/s)	Frequency	Vibration Criteria (mm/s)	Compliance
Loc 1	09-08-2017 11:23 am	0.4 mm/s	32 Hz	0.56 (17.0)	Yes
Loc 2	09-08-2017 12:13 pm	0.5 mm/s	>100 Hz	0.56 (17.0)	Yes
