Clyde Waste Transfer Terminal

Odour Audit XXXIV

Final Report

January 2020

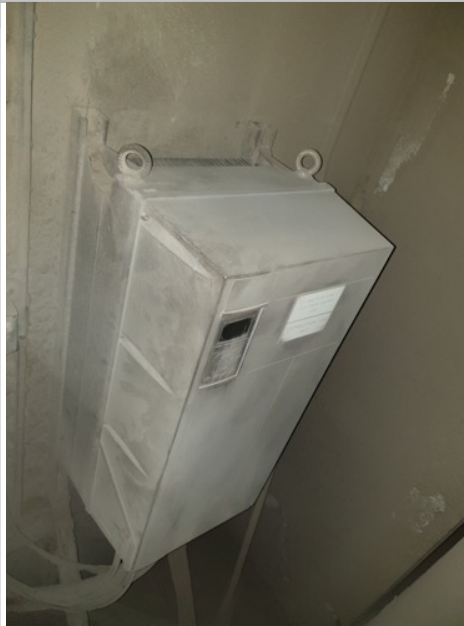
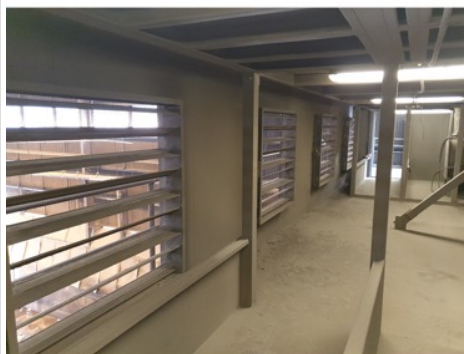
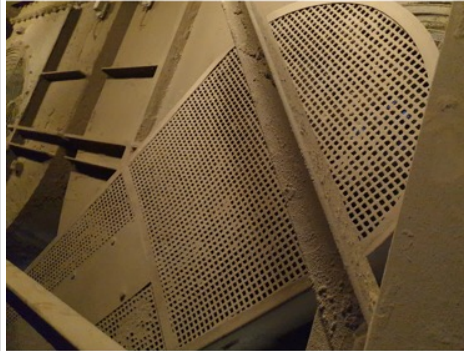
Description of Work Done Went u to the plant room and isolated the fans and the fan alarm and locked out and tagged. Proceeded to clean all dampers on dust and all VSD, isolators, fans and lights. Checked the pulleys belts and found all to be okay. Removed tag and turned the fans back on and the alarm.
