Annual Environmental Management Report -Clyde Transfer Terminal 2022-2023

Name of operation	Clyde Transfer Terminal
Name of operator	Veolia Environmental Services
Development consent / project approval #	DA 205-08-01
Name of holder of development consent / project approval	Veolia Environmental Services
Mining lease #	NA
Name of holder of mining lease	NA
Water licence #	NA
Name of holder of the water licence	NA
MOP/RMP start date	NA
MOP/RMP end date	NA
Annual Review start date	15th of January 2022
Annual Review end date	14th of January 2023

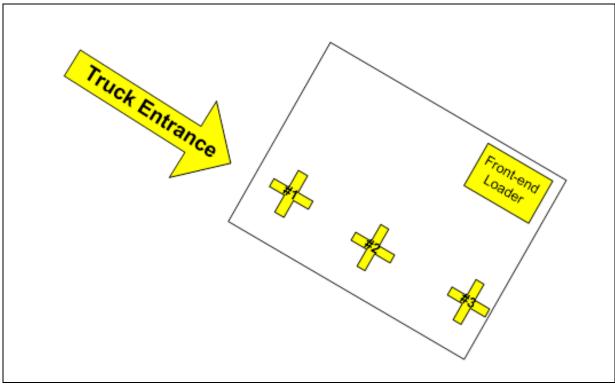
Figure 2.1 – Smoke testing release points within the TTB on 8 June 2022

at the truck entrance of the TTB, which reflects an additional test location to the normal smoke testing release points shown in **Figure 2.1**.

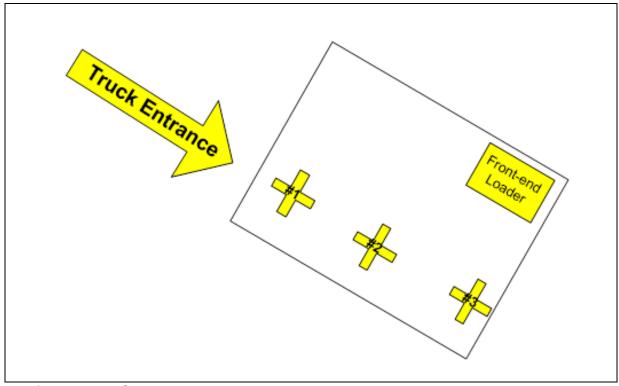
Figure 2.1 – Smoke testing release points within the TTB on 21 December 2022

As per previous audits, smoke testing was carried out within the TTB to assist in determining the effectiveness of the forced air extraction system, as well as the extent to which the TTB has been sealed from leaks. As per previous audits, smoke was released from within the TTB at three points within the TTB. **Figure 2.1** shows the three points where the smoke was released within the TTB. **Photo 2.4** shows smoke testing at the truck entrance of the TTB, which reflects an additional test location to the normal smoke testing release points shown in **Figure 2.1**.

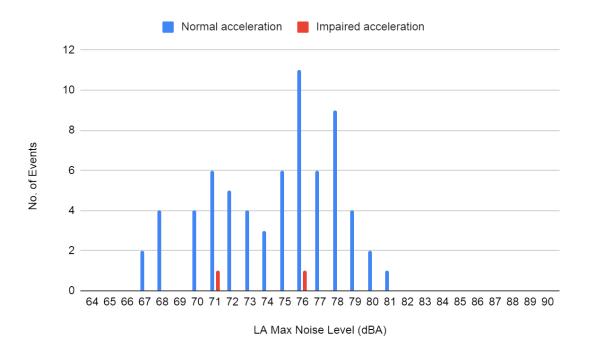
Figure 1: Noise level distribution from Truck Noise Monitoring – 4th of October 2022

A total measurement of 27% of all truck movements (255) was achieved during this monitoring round, which satisfies the minimum requirements of Condition 112 (25% of daily truck movements). **Figure 1** presents the distribution of recorded sound level frequencies which were measured in A-weighted decibels (dBA).

Measurements of 'normal' truck acceleration ranged from 67.2dBA to 81.8dBA with the highest frequency occurring between 76 - 78dBA. Impaired acceleration readings due to the impeded traffic conditions ranged from 69dBA to 79dBA, with the highest frequency occurring between 73-74dBA. Impaired acceleration readings were plotted separately from the normal accelerating vehicles on Figure 1.
