# Annual Environmental Management Report

*Banksmeadow Transfer Terminal*

*June 2017*

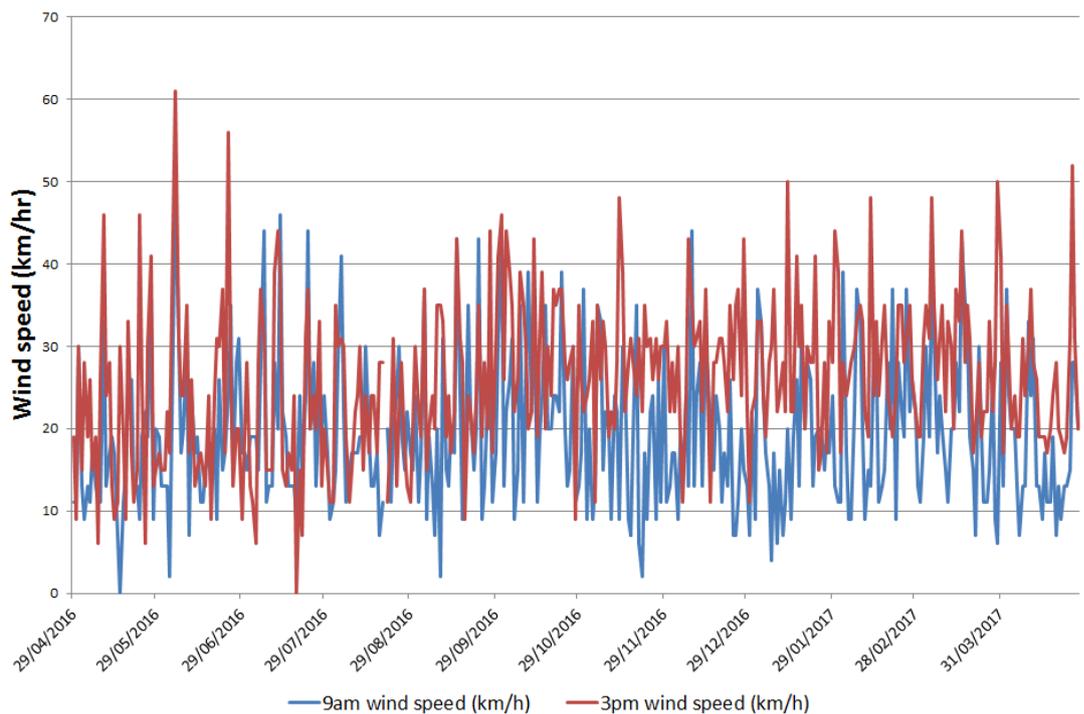
**Figure 3-1 9AM and 3PM wind speed data at the closest BoM weather station**

A summary of daily wind speeds at 9am and 9pm at the nearby BoM weather station is presented in **Figure 3-1**. Overall the wind speeds during the warmer months have a greater spread between 9am and 3pm compared to the colder months. Wind directions during the reporting period were in a general north-east and north-western direction.

Wind speed and direction monitoring was used to investigate and respond to odour complaints in this reporting period (refer Section 4.3). This data was used to determine the source and spread of potential odours travelling offsite.

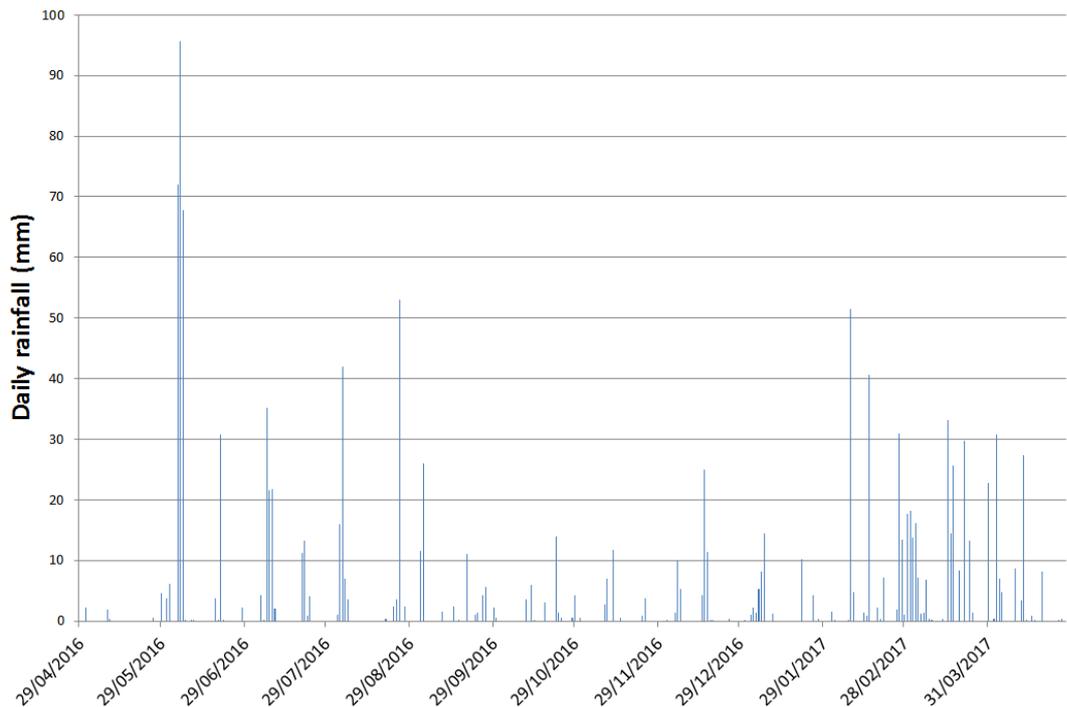
Figure 3-2 Rainfall data at the closest BoM weather station

A summary of rainfall data at the Terminal during the reporting period is presented in **Figure 3-2**. Overall, the average rainfall for the Terminal during the reporting period was approximately 104.72mm per month.

Ongoing rainfall data was monitored to supplement stormwater system operation and discharge, as well as for general housekeeping management such as inspection and maintenance of stormwater pits.

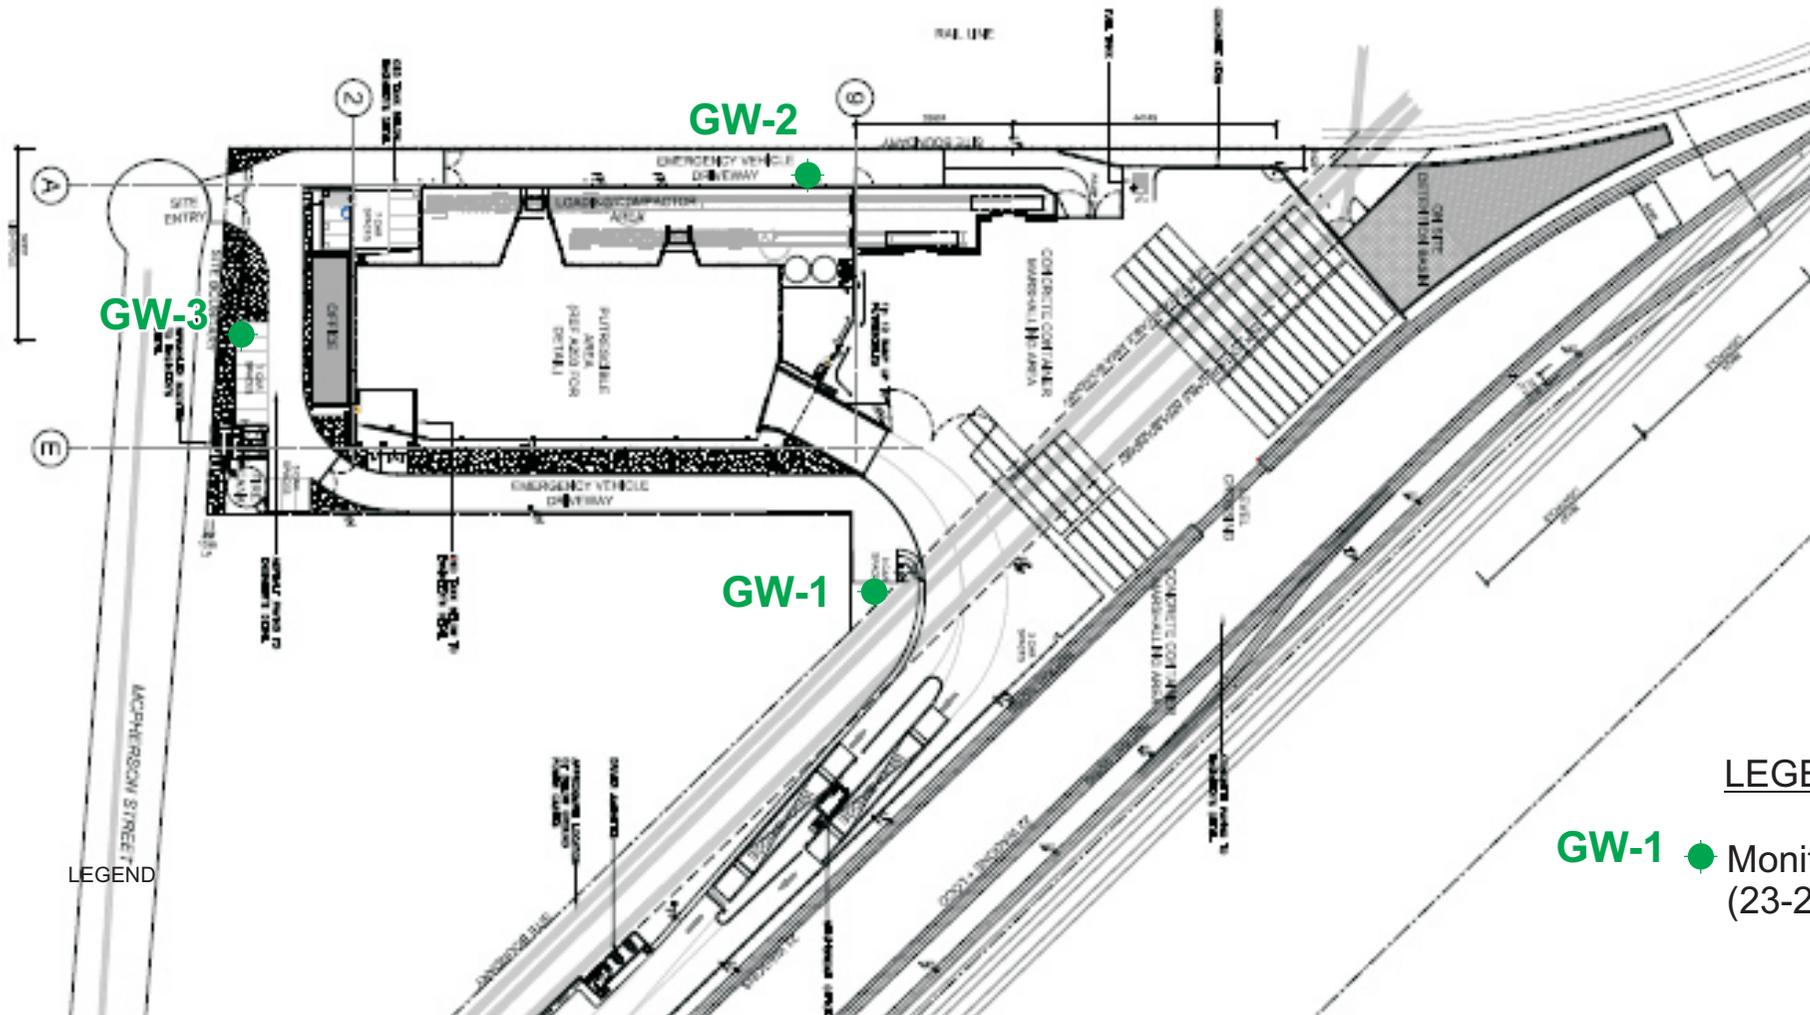
Appendix C: Borelogs & Well Construction Records

**GW-1** ● Monitoring well  
 (23-2-2017)
