# Annual Environmental Management Report 2021-22

For Woodlawn Waste Expansion Project  
& Woodlawn Alternative Waste  
Technology Project

*December 2022*

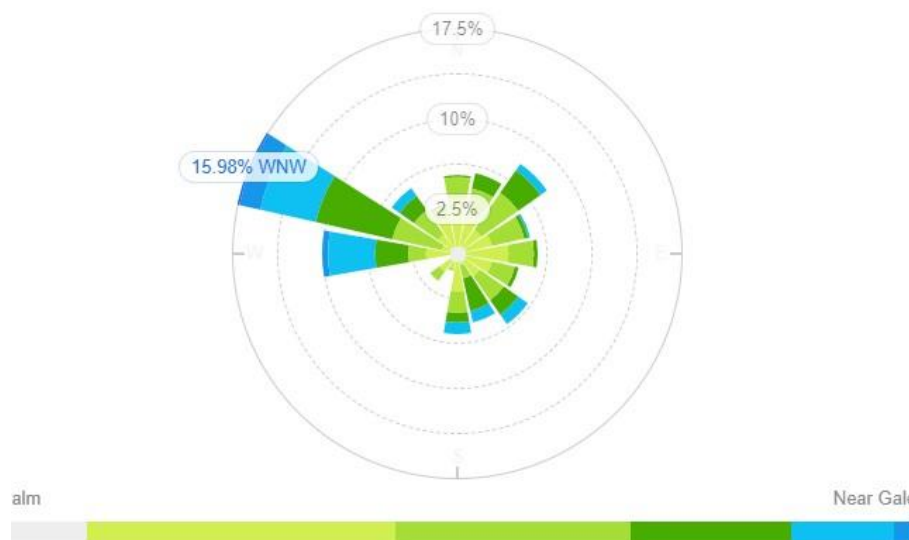
**Figure 1.5.8 Average Wind Speed (km/h) and Direction**

The wind rose above depicts the average wind speed and direction recorded at 10m above ground level from September 2021 to September 2022. Average wind speeds over the reporting period ranged from 0 km/h to 43.3km/h with strong prevailing winds typically from the West North West (WNW) directly toward Tarago and surrounding areas.

**Figure 1.5.8** below indicates average wind speed and direction during the reporting period.

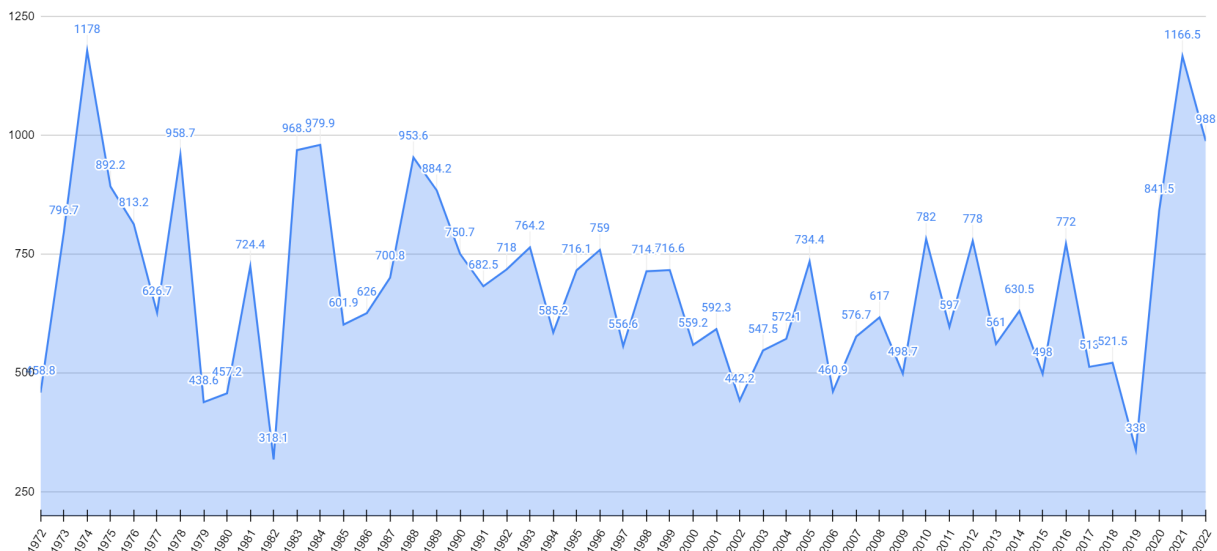
**Figure 1.5.7 50 Year Rainfall Pattern**

Using Lake Bathurst and Woodlawn rainfall data, the graph below illustrates the rarity of the recent consecutive La Nina events in 2020-2021 in comparison to the past 50 years. These weather patterns have had a detrimental impact on the entire east coast of NSW, which includes the Premises.

As demonstrated above (refer **Figure 1.5.7**), a total of 1,166.5mm rainfall was recorded in 2021. This was the highest annual rainfall since 1974 (1,178.0mm), and the third highest rainfall since 1950 (1,305.1mm). According to the Woodlawn Weather Station, total rainfall over the reporting period was 1085.5mm, which is approximately 100 mm above the previous reporting period (983.5mm).
